JOSIAH HENSON PARK - FACILITY PLAN REPORT

ARCHITECTURE / ENGINEERING DESIGN

MAY 28, 2013

Architecture/Engineering Facility Plan Report

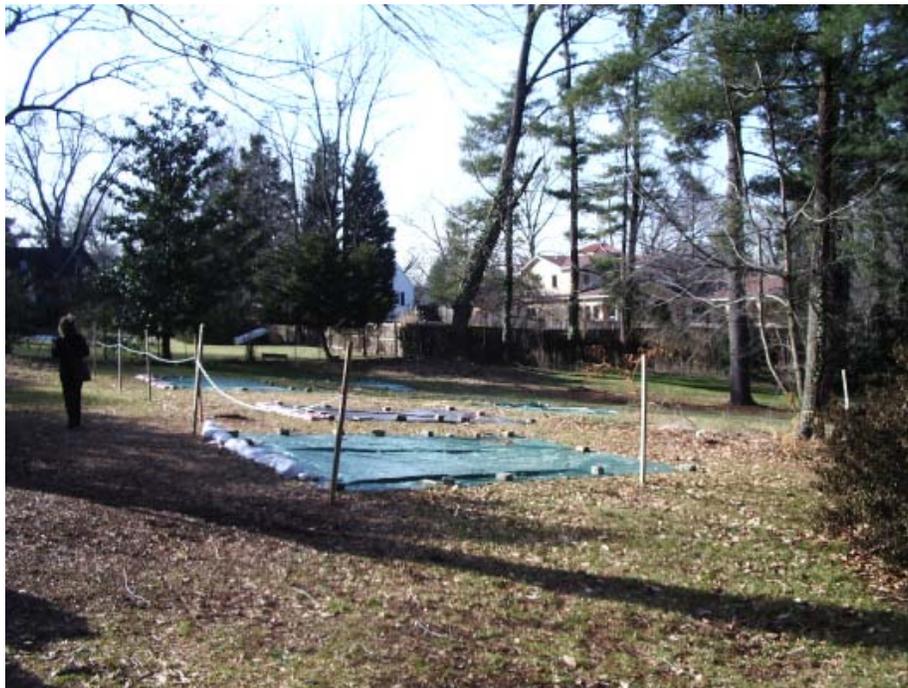
Open archaeological excavations in rear yard.

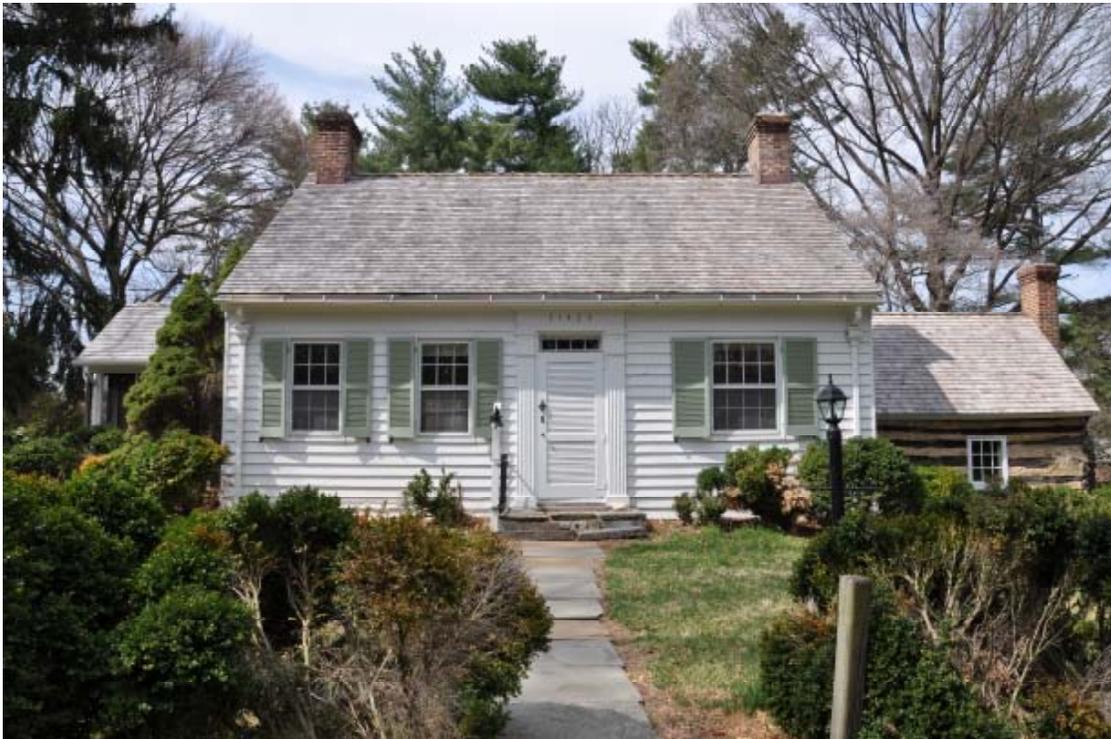
- Water and moisture problems in basement and crawl spaces. Main point source for water infiltration is located right below the front entrance door into the house.

Front view of historic Riley / Bolten House with Log Kitchen on right and screen porch on left

- Gutter on front façade pools water at mid-length and spilling over into foundation wall.
- The house building envelope has little to no insulation or air barriers.
- Currently, the house has no ADA features. Any future use as an interpretive center will need to introduce ADA accessible entryways and pathways.
- The second floor is under 8,000 sf and is exempt from any ADA scoping requirements as it falls under a Maryland ADA code exception to compliance.
- Screened-in porch is lower than main floor level (ADA issue). Exposed wood posts show woodpecker and insect damage.
- House is devoid of thermal insulation and draft / fire stopping.
- No sprinkler system currently in house.

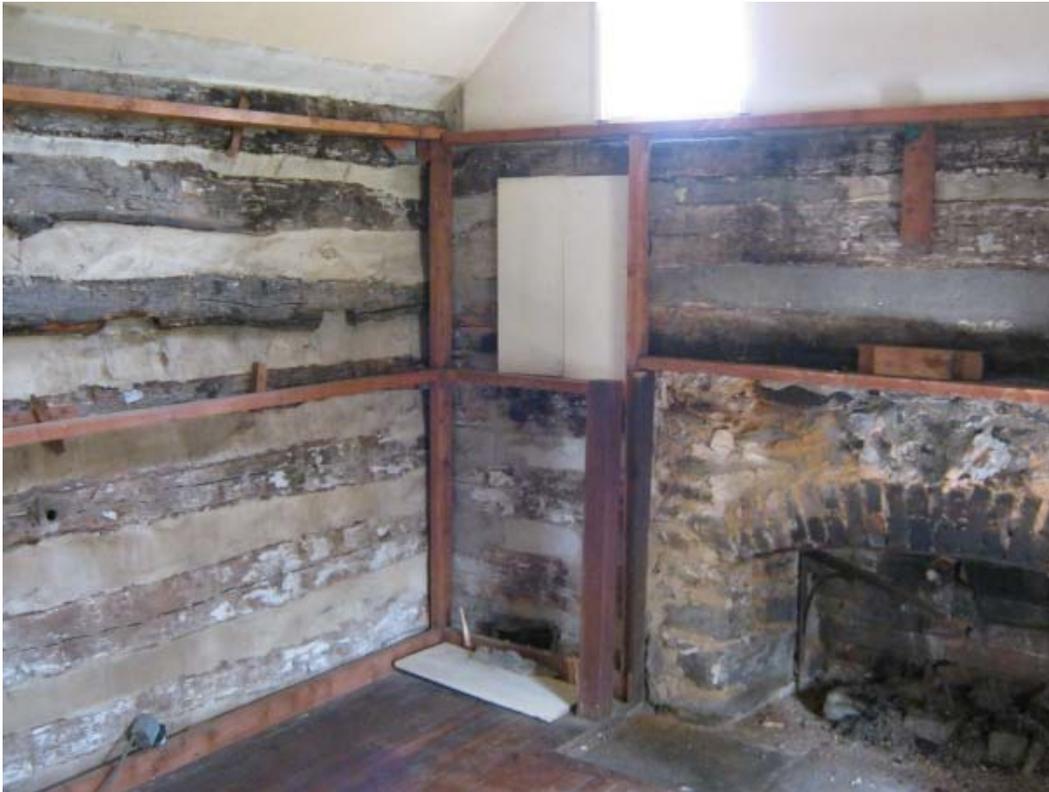
Existing notches in Log Kitchen - evidence of former loft

- Reconstruct a partial loft. Use hand-hewn timbers and pine flooring. Explore using the existing notches located on the west wall for reintroduction of a loft structure. Adding a reconstructed partial loft in the Log Kitchen has been discussed and seems to be a viable option to explore. This would provide headroom for visitors in the majority of the kitchen, but would still provide the spatial experience of an antebellum kitchen where living and working conditions were not ideal. A decision to leave this space of the house as unconditioned to help further reinforce the hardships endured by its inhabitants has been discussed but may not be the best approach for preserving the structure. Furthermore, we suggest removing the floor and leaving an earthen / hard packed dirt floor (see Architectural / Engineering drawings - Log Kitchen sheet 28 of 52).

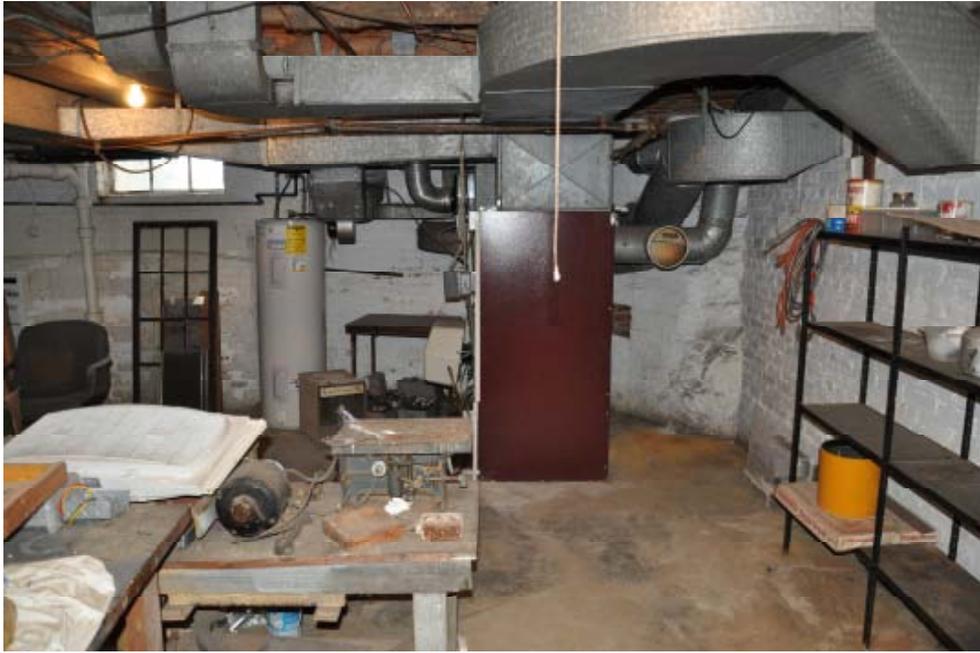
- The house has a forced air heating and air conditioning system. The main branchline ductwork is distributed throughout the basement to feed the upper floors. Many of the supply and return ducts serving the second floor are narrow. The return ducts for the second floor are in the exterior wall. None of the ductwork is insulated.

Existing HVAC equipment in basement of Riley / Bolten house

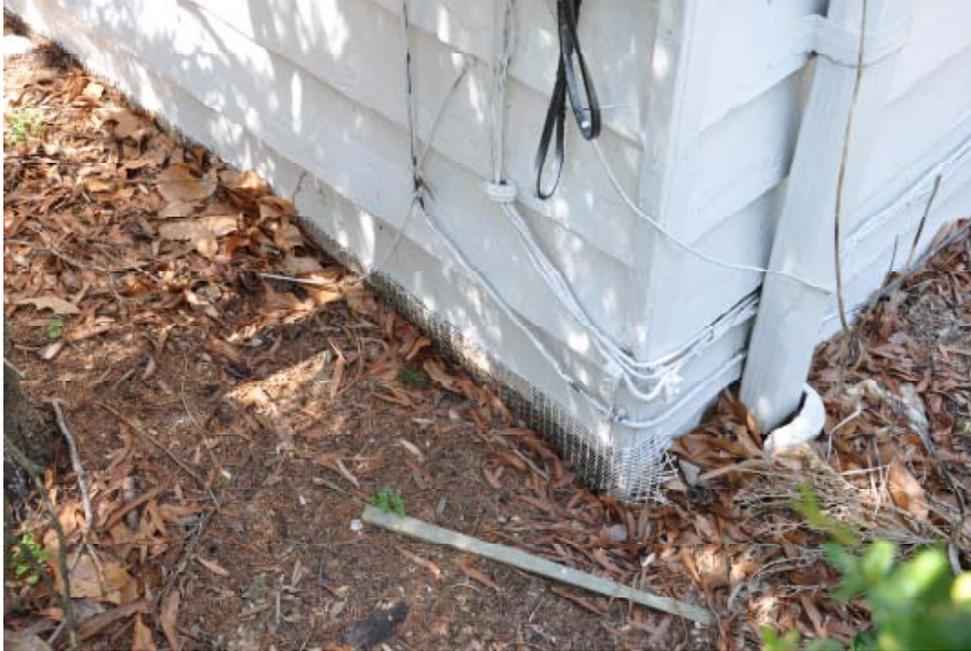
- Lower the soil line abutting the entire house. Excessive soil and debris provides pathways for insect/pest infestation. Wire mesh vents were previously installed around the perimeter of crawlspaces. Address long term solution in which vents will be blocked off with perimeter crawl space walls to be insulated. All crawl spaces should be treated as basement/cellar and dehumidified/air conditioned like the basement. In general, it is recommended to lower the soil lines around the house and institute a water/moisture management plan as soon as possible to prevent further damage to the building.

Existing wire mesh vents

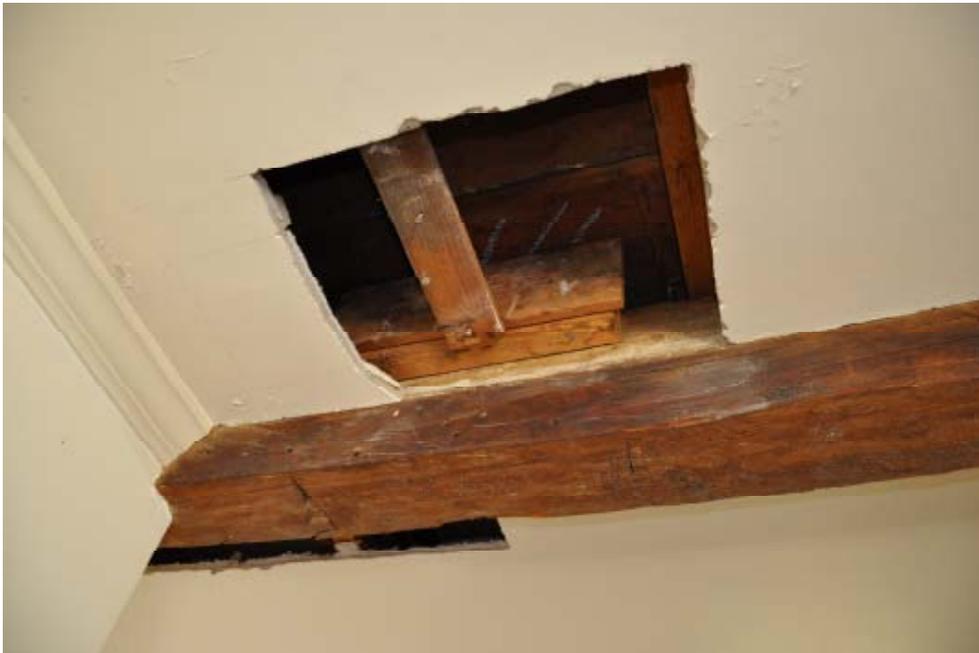
Existing framing in house – temporarily exposed during Facility Plan process

- Shored first floor beam in basement.
- Deteriorated pine sills to be replaced due to significant termite damage.
- Protect against future termite activity.
- Repair of splits where log joists tapered for bearing.
- Provide minimum clearance to soil below wood joists.
- Remove and infill basement stair opening. Remove surrounding first floor walls.

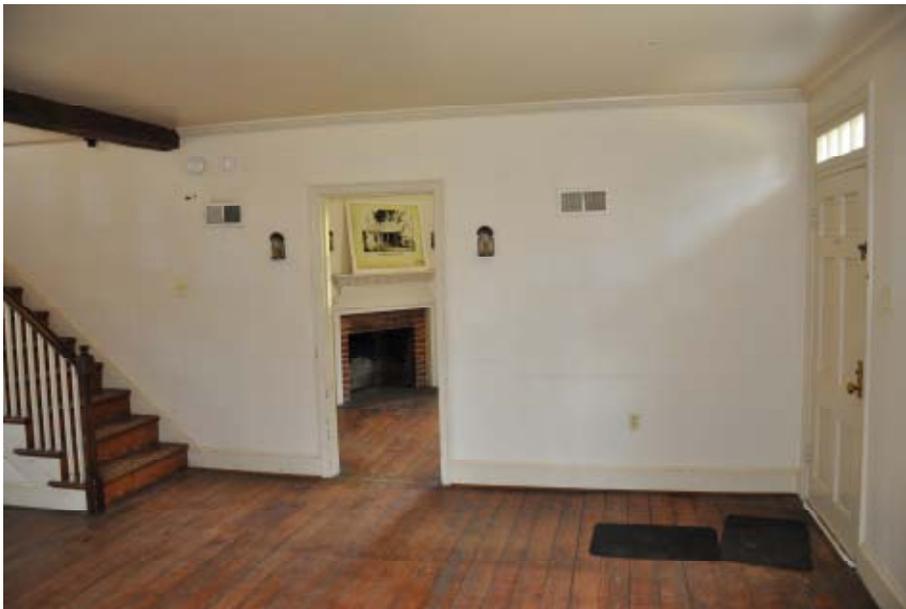
Interior view from main living room to study – existing candle holders

- Refurbish existing wall-mounted candle holders to provide an authentic background.
- Remove the existing wall-mounted Porch light and associated wiring.
- Replace the existing Porch ceiling fixture with architecturally appropriate fixture.
- Add wall-mounted uplights behind exhibits to visually disconnect them from the original space (typical).

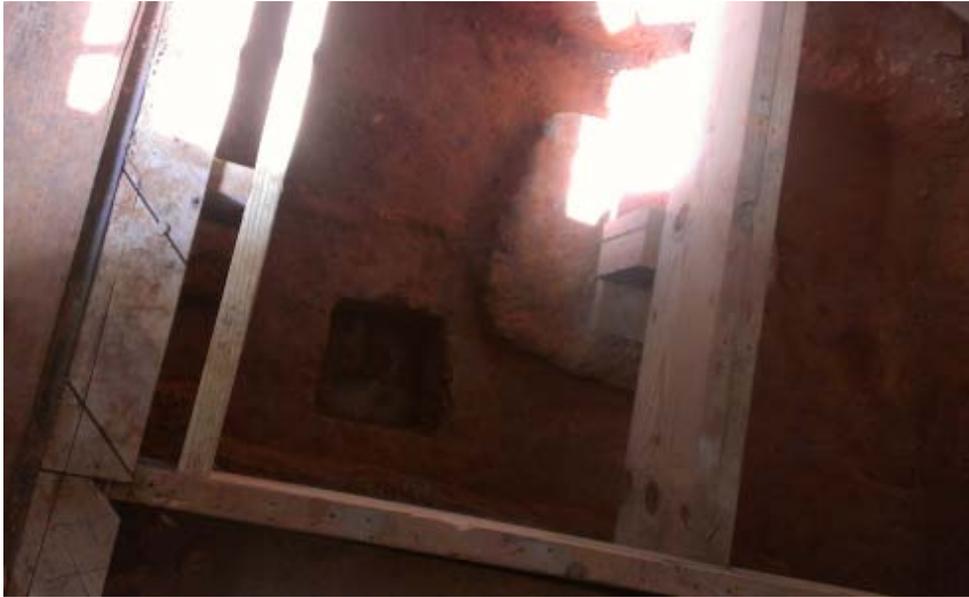
Excavated historic floor levels

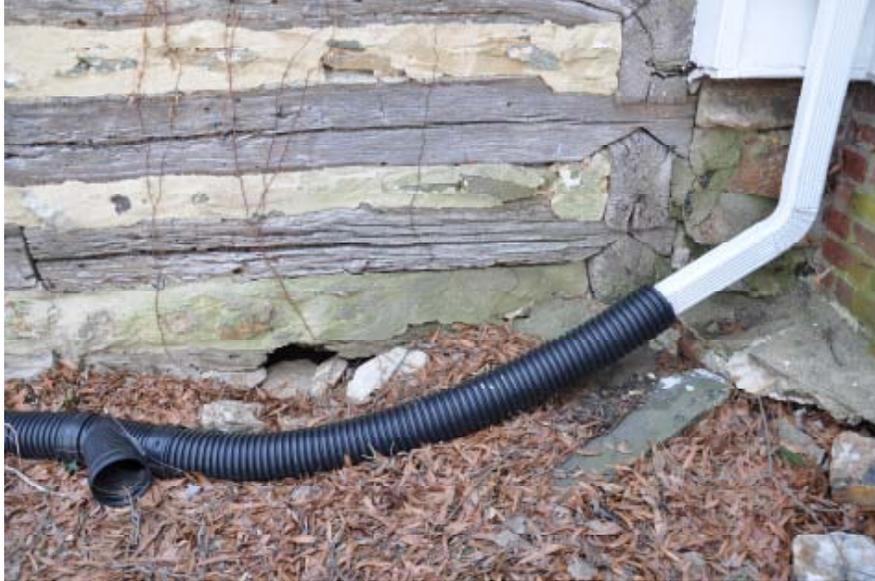
- The sill beams around the perimeter of the main house, where accessible, were found to have sustained significant termite damage.
- The lowest course of log framing in the log kitchen needs to be replaced.

Weather damage at lowest course of Log Kitchen

- Lowest level of logs to be replaced
- Log House – lower / remove floors, add loft
- Other repairs and treatments of logs

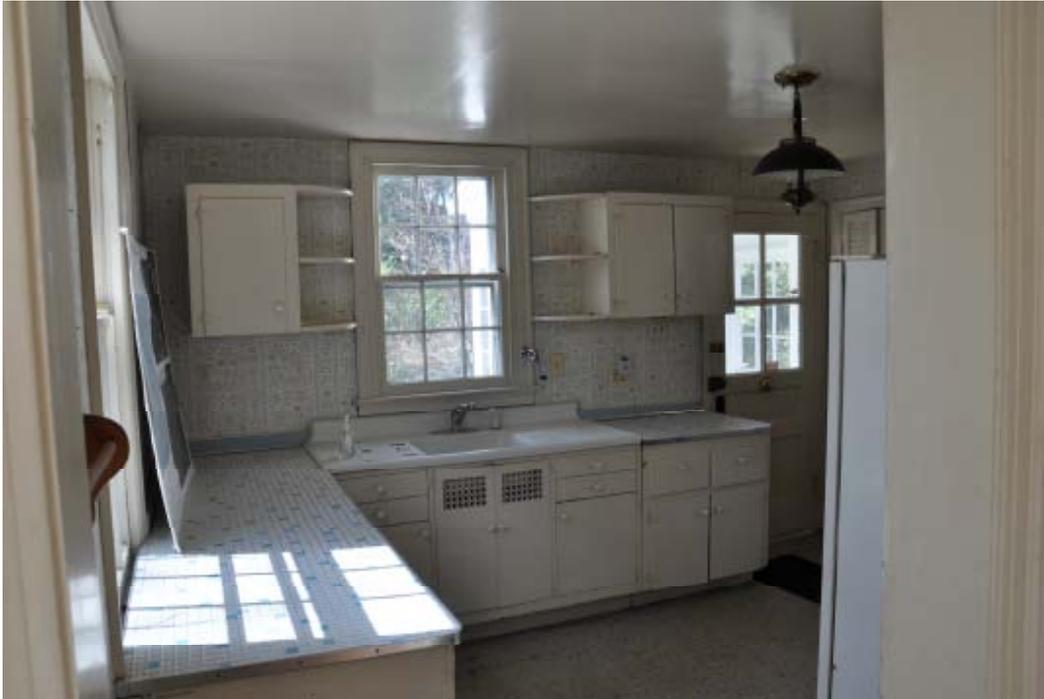
Lorenzo Winslow ell kitchen - cabinets and finishes to be removed.

- Provide interpretive space in first floor ell per recommendation 14.c of the HSR. To accomplish this, the kitchen closet cabinets, fixtures and finishes, basement stair and

walls, and post-1936 half bathroom should be removed. These changes will minimize the need to make other changes to the more historically significant rooms of the house and will ensure ADA-required guidelines for circulation between exhibit spaces (within walls of other rooms) are met. The ductwork going up through stair wall will need to be re-routed to provide conditioning for second-floor offices in existing rooms above.
