Sopers Branch Tributary Assessment

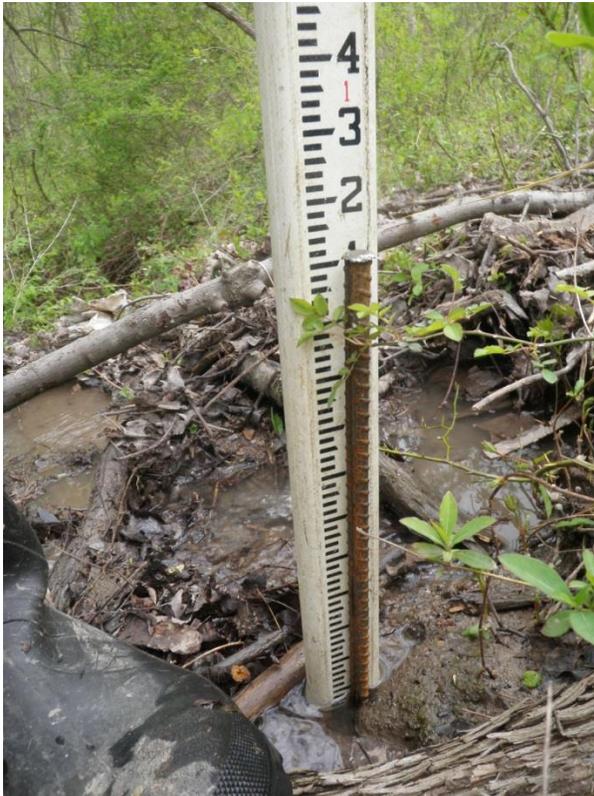
Image 1

A total of three rebar were installed at the upstream limit of each headcut present at the time of the field assessment. All rebar installed was 6-feet-long. One rebar was installed along the mainstem at station 1+44.5 and approximately 1.1' of the rebar remained out of the ground (Image 1). The remaining two rebars were installed at headcuts that delineate the start of Tributary 2 and are approximately 0.5' out of the ground.

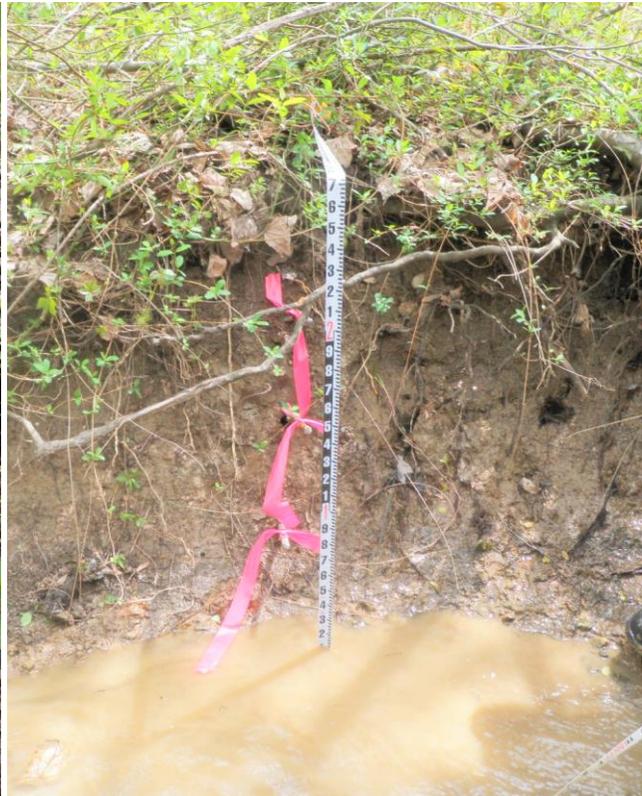
Image 2

In addition to the rebar installed to monitoring the potential migration of the existing headcuts, three bank pins were installed in the mainstem channel. Mainstem bank pins are located within the right bank at 1+48.22, upstream of the current location of the confluence with Tributary 2. The length of each rebar that remained out of the bank was recorded and will serve as the baseline data for comparison

with future measurements. Additional measurements detailing the spacing of the pins were also recorded. The baseline measurements were as follows, where Pin #1 is the closest to the channel bottom and the length of rebar exposed was measured at the bottom of the rebar (Image 2):

Pin #3 – 0.52 rebar exposed

Pin #2 – 0.55' rebar exposed

Pin #1 – 0.52' rebar exposed
