Black Hill Trail Renovation Facility Plan Report

Prepared for:

**The Maryland-National Capital
Park and Planning Commission
Park Development Division**

April 24, 2003

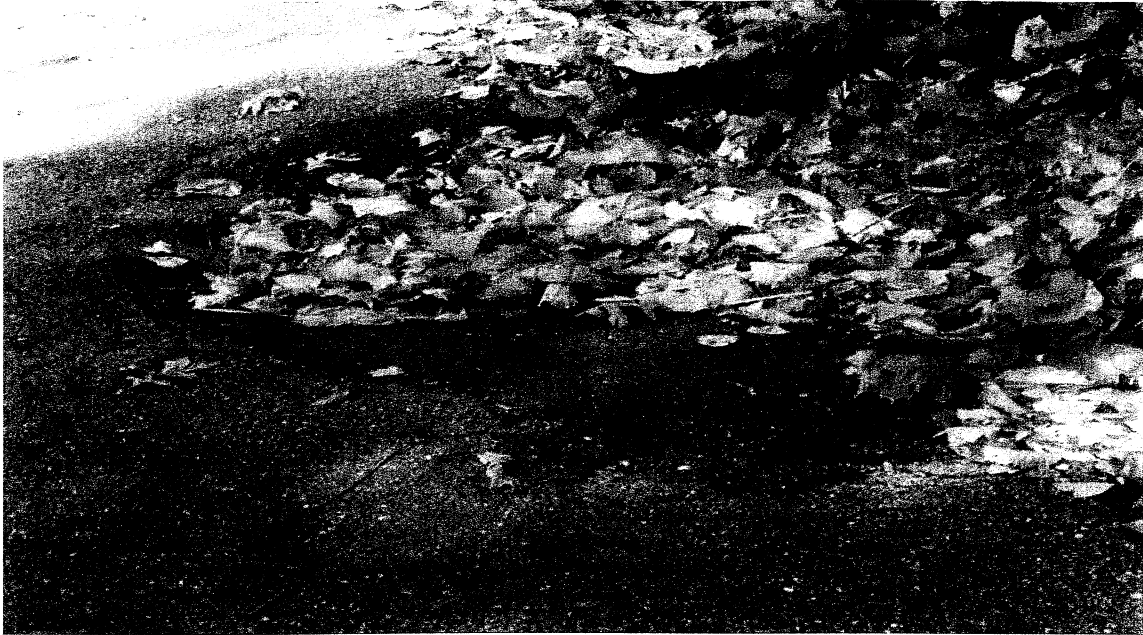
Large portions of this trail are currently failing and require ongoing maintenance to keep the trail safe for users. Most of these areas have been patched but it is clear that there is a need for a long-term solution. We observed areas where the pavement was cracked with grass or weeds growing in the exposed soil. In other areas, the pavement edges have degraded to a surface that is little more than gravel. Finally, there are sites where the base below the pavement has settled and significant depressions have developed. The depth of the asphalt section and base material is inconsistent and in many cases, is inadequate for continued long-term service.

Photo – 1. Pavement Failure – Sink Hole

Because the trail is failing along the entire length, is overall too narrow to safely accommodate the current level of trail use, and includes areas with slopes so steep as to render the trail inaccessible to some users, a recommendation is made to completely demolish and reconstruct the existing trail and pedestrian bridge.

The proposed new pavement section consists of a minimum of six inches of compacted CR-6 gravel, and three inches of new asphalt (2” base course, 1” surface). A bituminous tack coat will be applied to insure good adhesion between the layers.

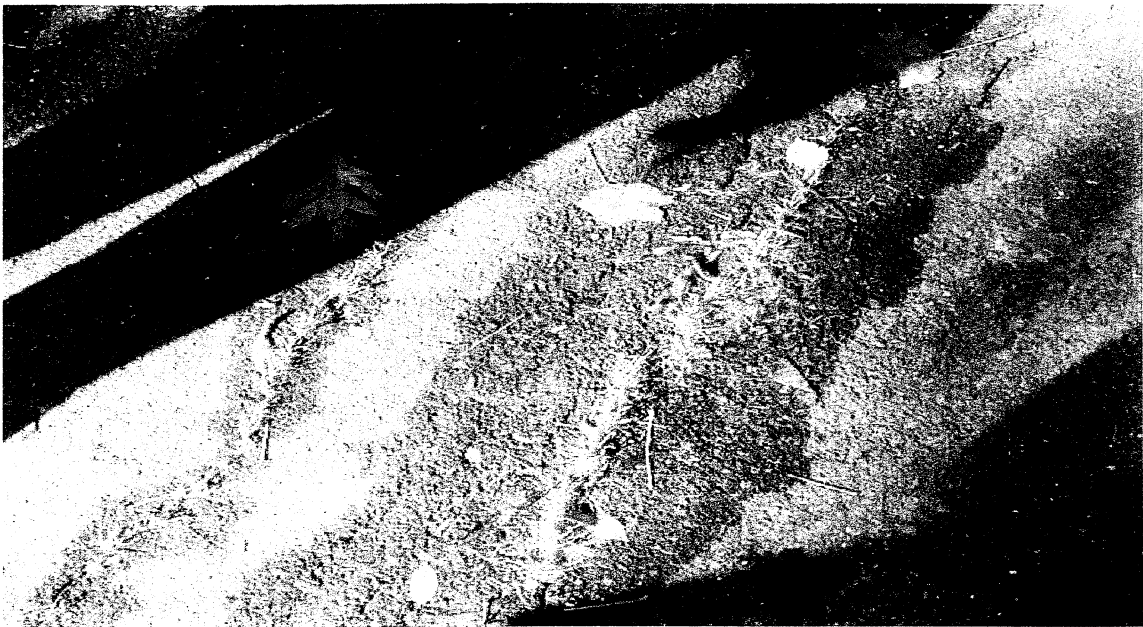
Photo – 2. Pavement Failure – Cracking

As previously discussed, the existing trail pavement is failing in numerous places along its 2-3/8 mile length. Portions of the asphalt trail exhibit failures such as rutting, raveling, cracking, and a crumbling effect known as “alligatoring”. There are also several sinkholes along portions of the trail

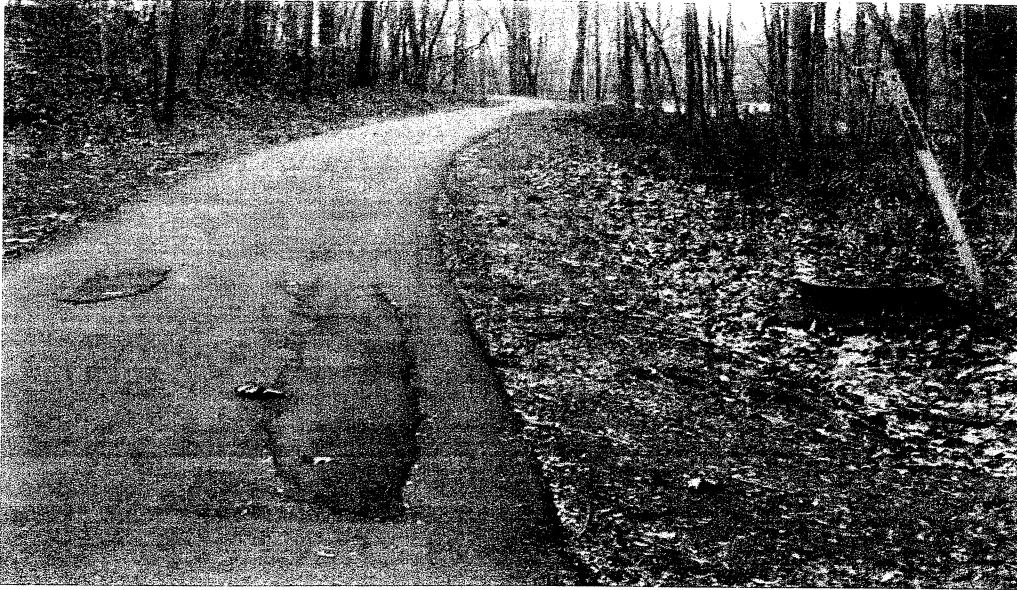
Photo – 3. Pavement Failure

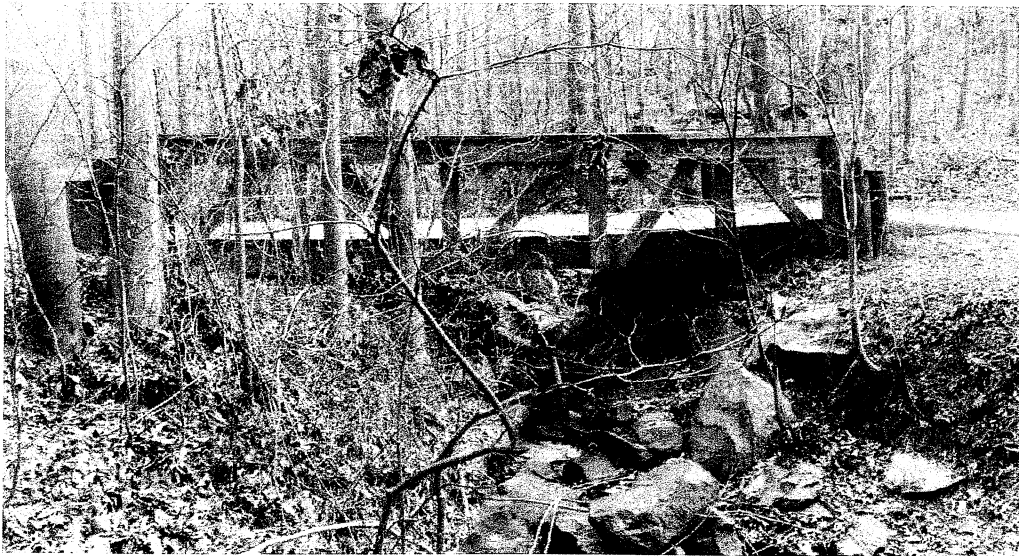
Photo – 1. Existing Wooden Bridge

The condition of the existing wooden bridge is also poor and does not meet the current design standards for bridges in the park system. The bridge is currently not used by park staff to move heavy maintenance equipment from one end of the park to the other. A new ten foot- wide prefabricated steel bridge with a single span of approximately 26 feet is proposed for this location. New concrete abutments will be constructed on both sides of the stream, behind the existing structures to accept the bridge.

Recommendations related to the design of the new bridge were also included. The north abutment can be founded on a shallow spread footing at a depth of three feet for front protection. An allowable bearing capacity of 3,000 psf should be used to design the footing. The minimum width of the footing should be 18 inches. Several alternatives for the south abutment were investigated. The recommended alternative is to partially undercut the fill soil to a depth of seven feet, backfill the undercut with #57 stone, and place the footing on the #57 stone using an allowable bearing capacity of 1,500 psf. Anticipated settlement with this section would be approximately ½ inch.

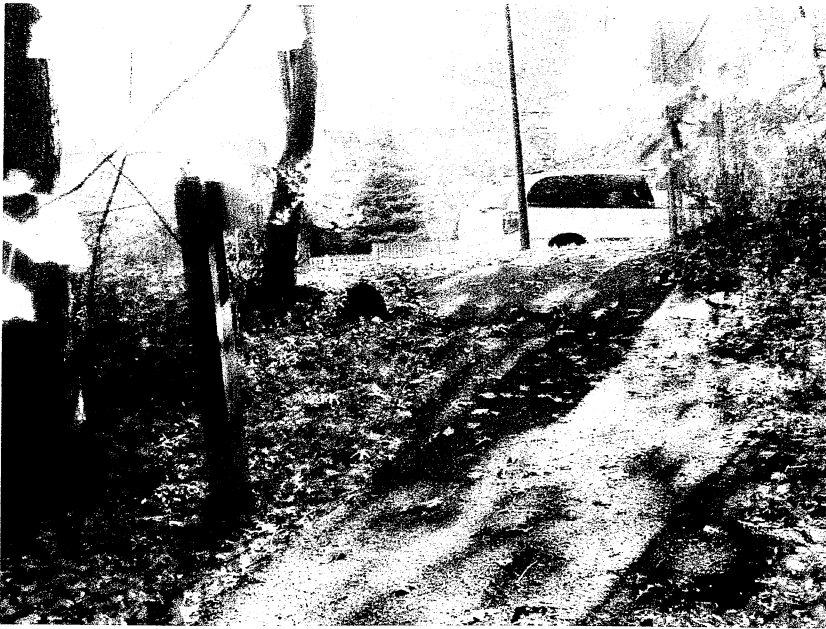
Upon a detailed analysis of topographic information and on-site observations of the existing trail, it was discovered that in several places the profile of the trail exceeds the maximum gradient guidelines for accessible trails. In particular, the access points do not meet these standards. These areas of non-compliance were first identified, then closely studied in an effort to discover options for making the areas accessible with a minimal amount of disturbance to the adjacent wooded edge. This investigation concluded that the majority of the trail could be made accessible. The only area where modifications to make the trail accessible are not feasible is an area of steep slopes near the wood bridge and the trail access connector that leads to Waters Landing Road. These areas would require extensive grading adjacent to an existing cut-bank of the stream and significant disruption to the adjacent forest. For this reason, it was decided that this area should remain as it currently exists in order to avoid extensive tree clearing and the addition of large retaining walls.

Photo – 1. Existing steep slope at access point

The opportunity exists in this area to link the southern and northern accessible portions of the trail. The construction of a bridge/boardwalk across the stream would bypass the steep slopes and create a continuous system fully compliant with the accessibility guidelines. An alternative alignment showing the connection is shown on the plans and preliminary estimates are included in the construction estimate. An in-depth study of this connection was not however included in the scope of this project. Additional geotechnical and topographic studies of this area will be necessary prior to the final design.

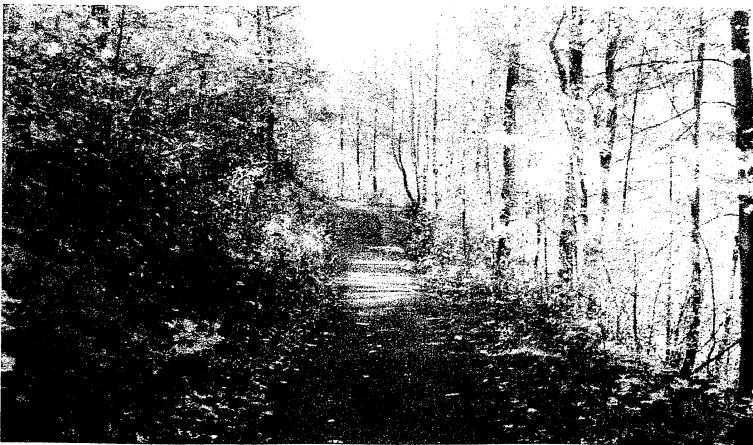
Photo – 1. Limited area for construction operations.

Another constraint is the linear nature of the project. The area that is available for construction operations is in most cases limited to a relatively narrow swath of open land. We identified potential staging areas throughout the project. They are restricted in size by topography and vegetation, will provide for very limited storage of materials, but will allow trucks and equipment to maneuver and to turn around.

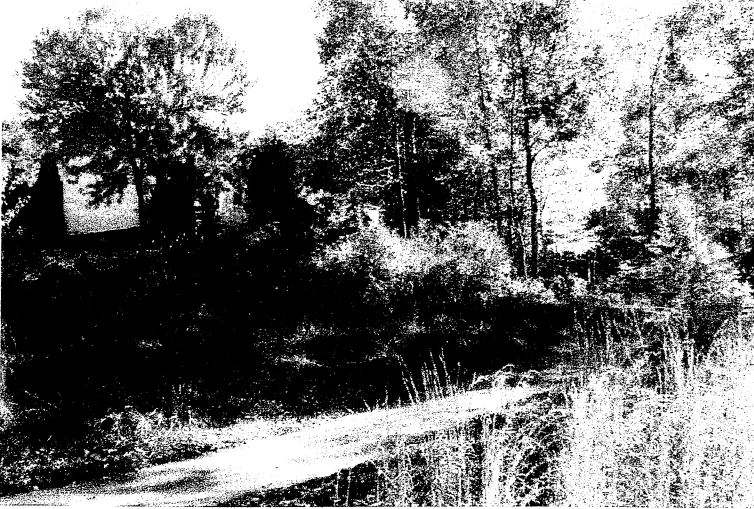
Photo – 1. Potential construction staging area.
