**MONTGOMERY COUNTY DEPARTMENT OF PARKS**  
THE MARYLAND-NATIONAL CAPITAL PARK AND PLANNING COMMISSION

**MEMORANDUM**

**SUBJECT:** Facility Plan for Expansion of Parking Lot and Renovation of  
Hadley's Playground at Falls Road Local Park

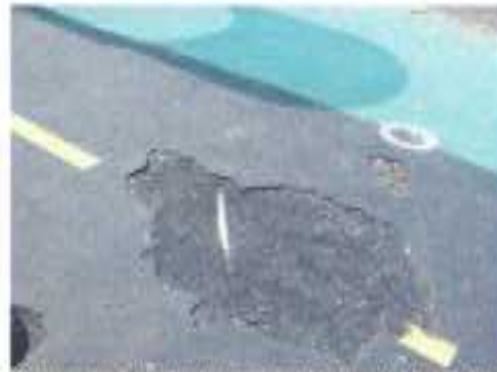
Picture 1 – Typical worn or damaged VitriTurf

There is a significant amount of worn VitriTurf (see Photo 1). These areas present themselves randomly throughout the 'roadway', and at specific equipment ingress and egress points, that is, at points of heavy usage for the play equipment. Although difficult to assess exactly how much area is damaged, the visual assessment might result in up to 6% of the surface requiring repair, or say about 2,600 square feet.

**Patching** - in order to patch approximately 2,600 square feet, either park maintenance forces or a contractor would be needed to provide the labor. Patching existing areas of damage with park maintenance staff may or may not be feasible.

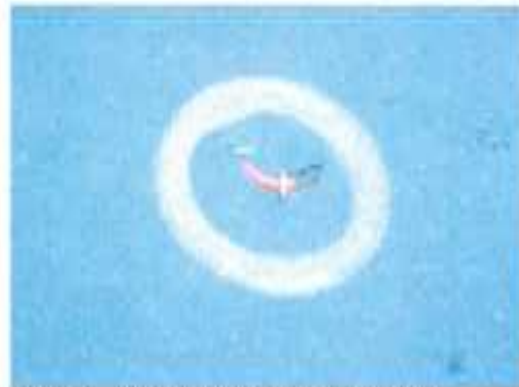
Photo 2: One of several exposed anchors

This damage varies in thickness from 1/8" to 1/2" in most areas to almost 3/4" to 1" depth in some limited areas. There are no significant tripping points due to this abutting condition of VitriTurf / concrete edge, except for some marked anchors (see Photo 2).

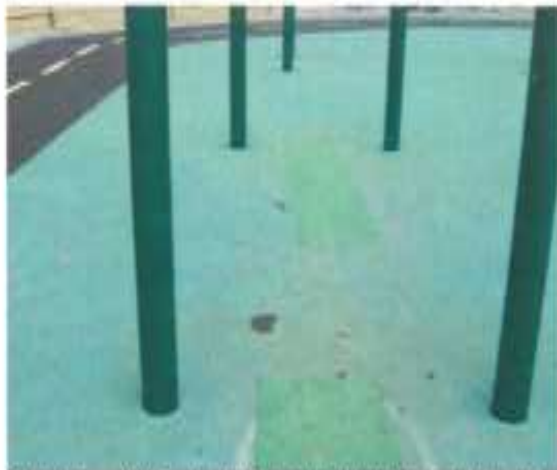
Photo 3 - Material applied adequately to edges of equipment. Note patching of VitriTurf.

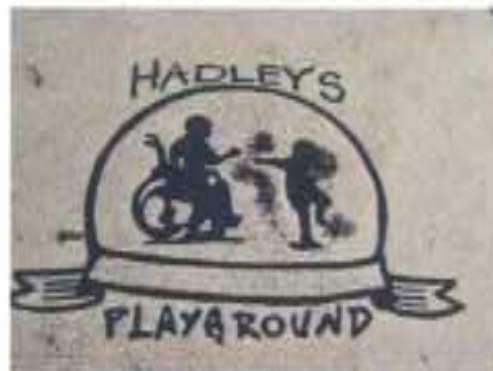
Entry logo in need of minor repair.

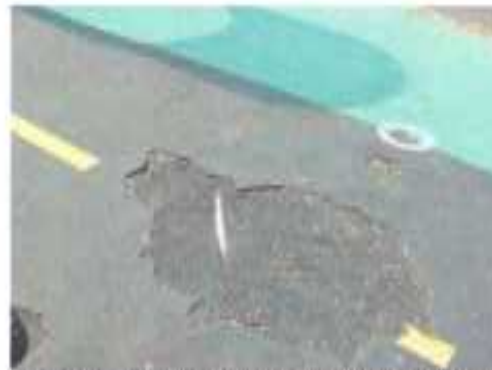
Picture 1 – Typical worn or damaged VitriTurf

There is a significant amount of worn VitriTurf (see Photo 1). These areas present themselves randomly throughout the 'roadway', and at specific equipment ingress and egress points, that is, at points of heavy usage for the play equipment. Although difficult to assess exactly how much area is damaged, the visual assessment might result in up to 6% of the surface requiring repair, or say about 2,600 square feet.

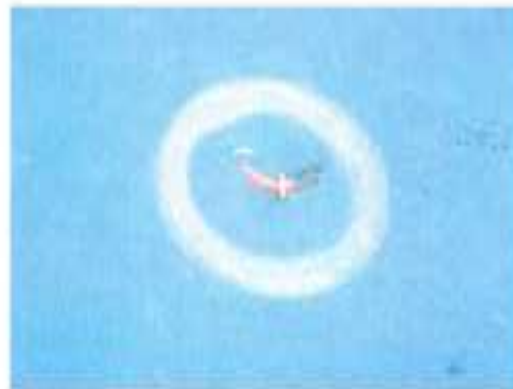
Photo 2: One of several exposed anchors

This damage varies in thickness from 1/8" to 1/2" in most areas to almost 3/4" to 1" depth in some limited areas. There are no significant tripping points due to this abutting condition of VitriTurf / concrete edge, except for some marked anchors (see Photo 2).

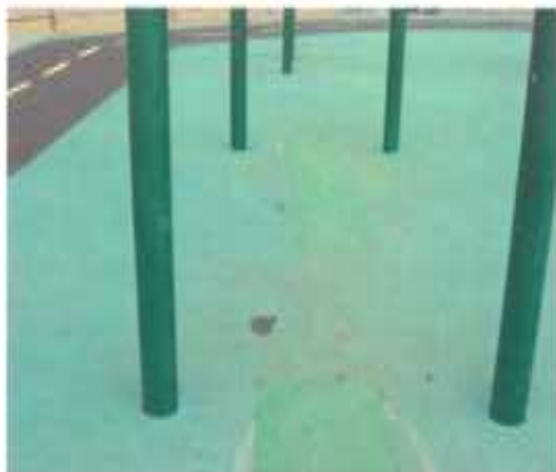
Photo 3 - Material applied adequately to edges of equipment. Note patching of VitriTurf.

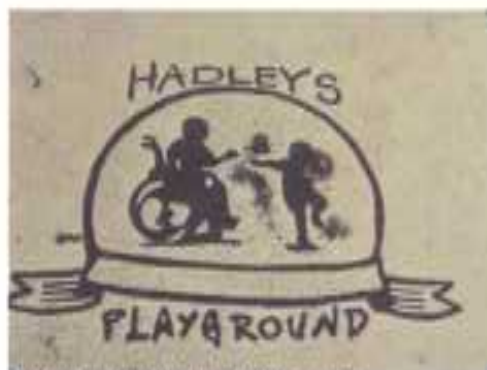
Entry logo in need of minor repair.
