Battery Lane Park

Facility Plan Report

Prepared for:
The Maryland National Capital Park and Planning Commission

July 2009

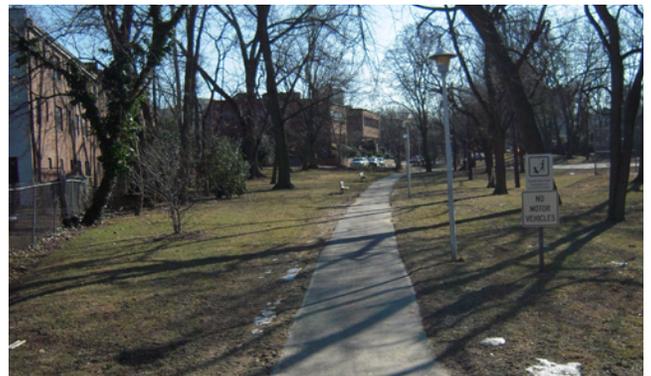
The park's segment of The Bethesda Trolley Trail is too narrow to comfortably accommodate heavy bicycle and

pedestrian traffic. It is also too narrow for the service vehicles used to maintain the park. This trail should be widened to 10' to accommodate these multiple uses. The sidewalk at Battery Lane is also too narrow and has no street trees or green strip separating it from the road. It would benefit from widening and the addition of street trees.

The primary path and bike trail is narrow and should be widened to accommodate pedestrians, cyclists, and service vehicles.

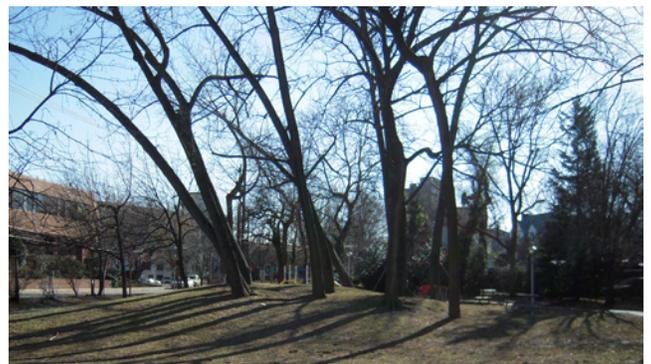
Natural features such as this mature tree canopy and knoll should be preserved.

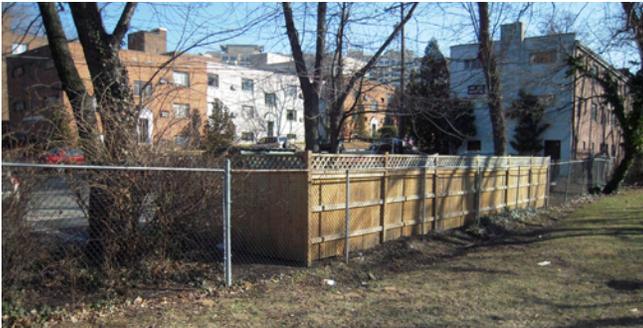
To the east and west, low and mid-rise residential buildings and associated parking lots border the park. Bare chain-link fence separates the park from parking lots and dumpsters. While some evergreen and deciduous trees and shrubs screen the lots and buildings in spots, the park is largely exposed to the fencing, parking lots, and buildings to the east and west. At the north end of the park, along Battery Lane, a dense stand of evergreens blocks views in and out of the park. Along Glenbrook Avenue a narrow dirt slope and small scrubby trees separate the street from

The east and west edges of the park with exposed chain-link fences should be softened with tree plantings.

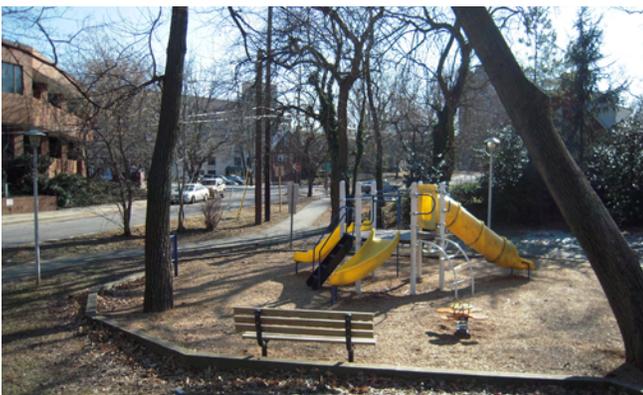
The playground is small and needs updated equipment

The playground is located at the south entrance to the park, measuring approximately 70' x 40'. A low timber wall contains bark mulch, a small swing set and a jungle gym with slides. The playground is small and does not provide a wide variety of play opportunities for different age groups. The playground should be updated and enlarged to accommodate a wider age range and set of activities.

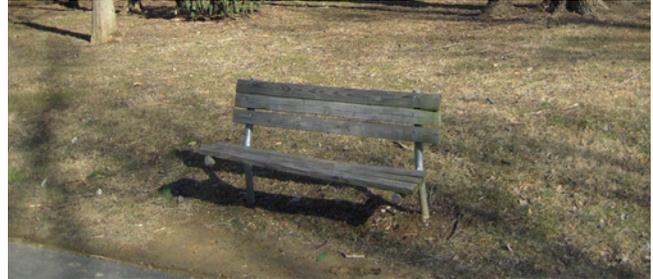
Park seating is scarce and in need of improvement.

There are 7 small wooden benches in the park - two along each path, one near the basketball court, and two in the play area. This seating is insufficient and some benches

are in poor condition. Battery Lane Park's urban surrounds and high level of foot and bicycle traffic warrant ample seating of high quality and durability. The trash receptacles are steel drums fastened to wood supports. More visually pleasing receptacles should be provided.

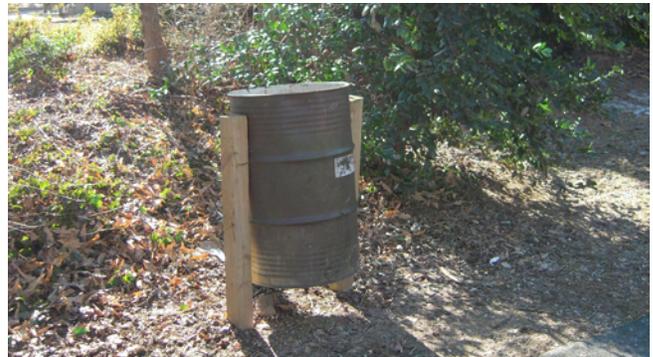
More attractive garbage and recycling receptacles should be provided for the park.

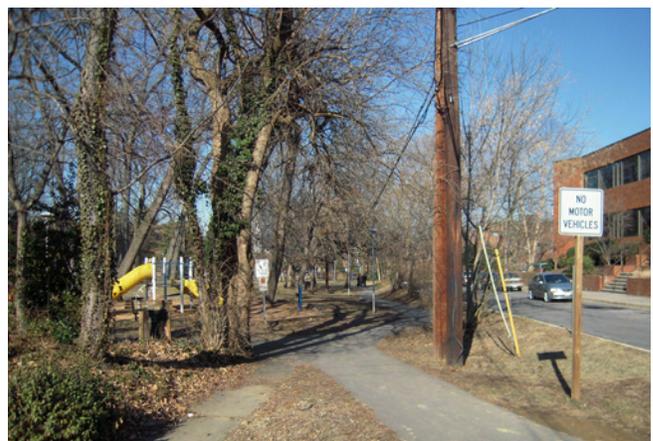
Above ground utilities that traverse the park detract from the park and should be placed below ground.

Overhead utility lines and poles run the length of the park in a north-south direction. Undergrounding these lines would improve the visual character of the park.

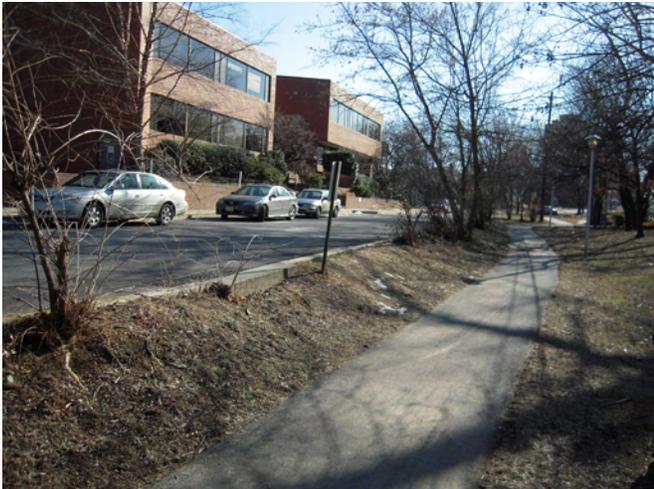
Grade change, erosion, and weedy trees along Glenbrook Road.

There is some erosion at low points of the park along the primary path and near large drain inlets. The primary path sits several feet below Glenbrook Road along the southeast side of park, creating an eroding bank between the path and road.

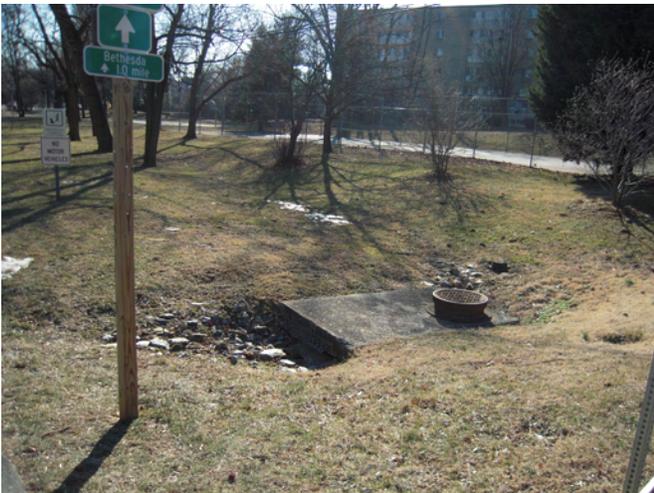
Erosion is occurring around two open throat inlets.

There are currently no stormwater management quality or quantity control measures that are being implemented on the site. There are two concrete open throat inlets located along the Bethesda Trolley Trail that convey the current site runoff into the existing 66" concrete pipe that runs through the site. One is located near the northeast park entrance, the other toward the center of the park. The grass swales that lead to these inlets have eroded and do not meet current State (MDE) and County (DPS) regulated stormwater management design requirements.

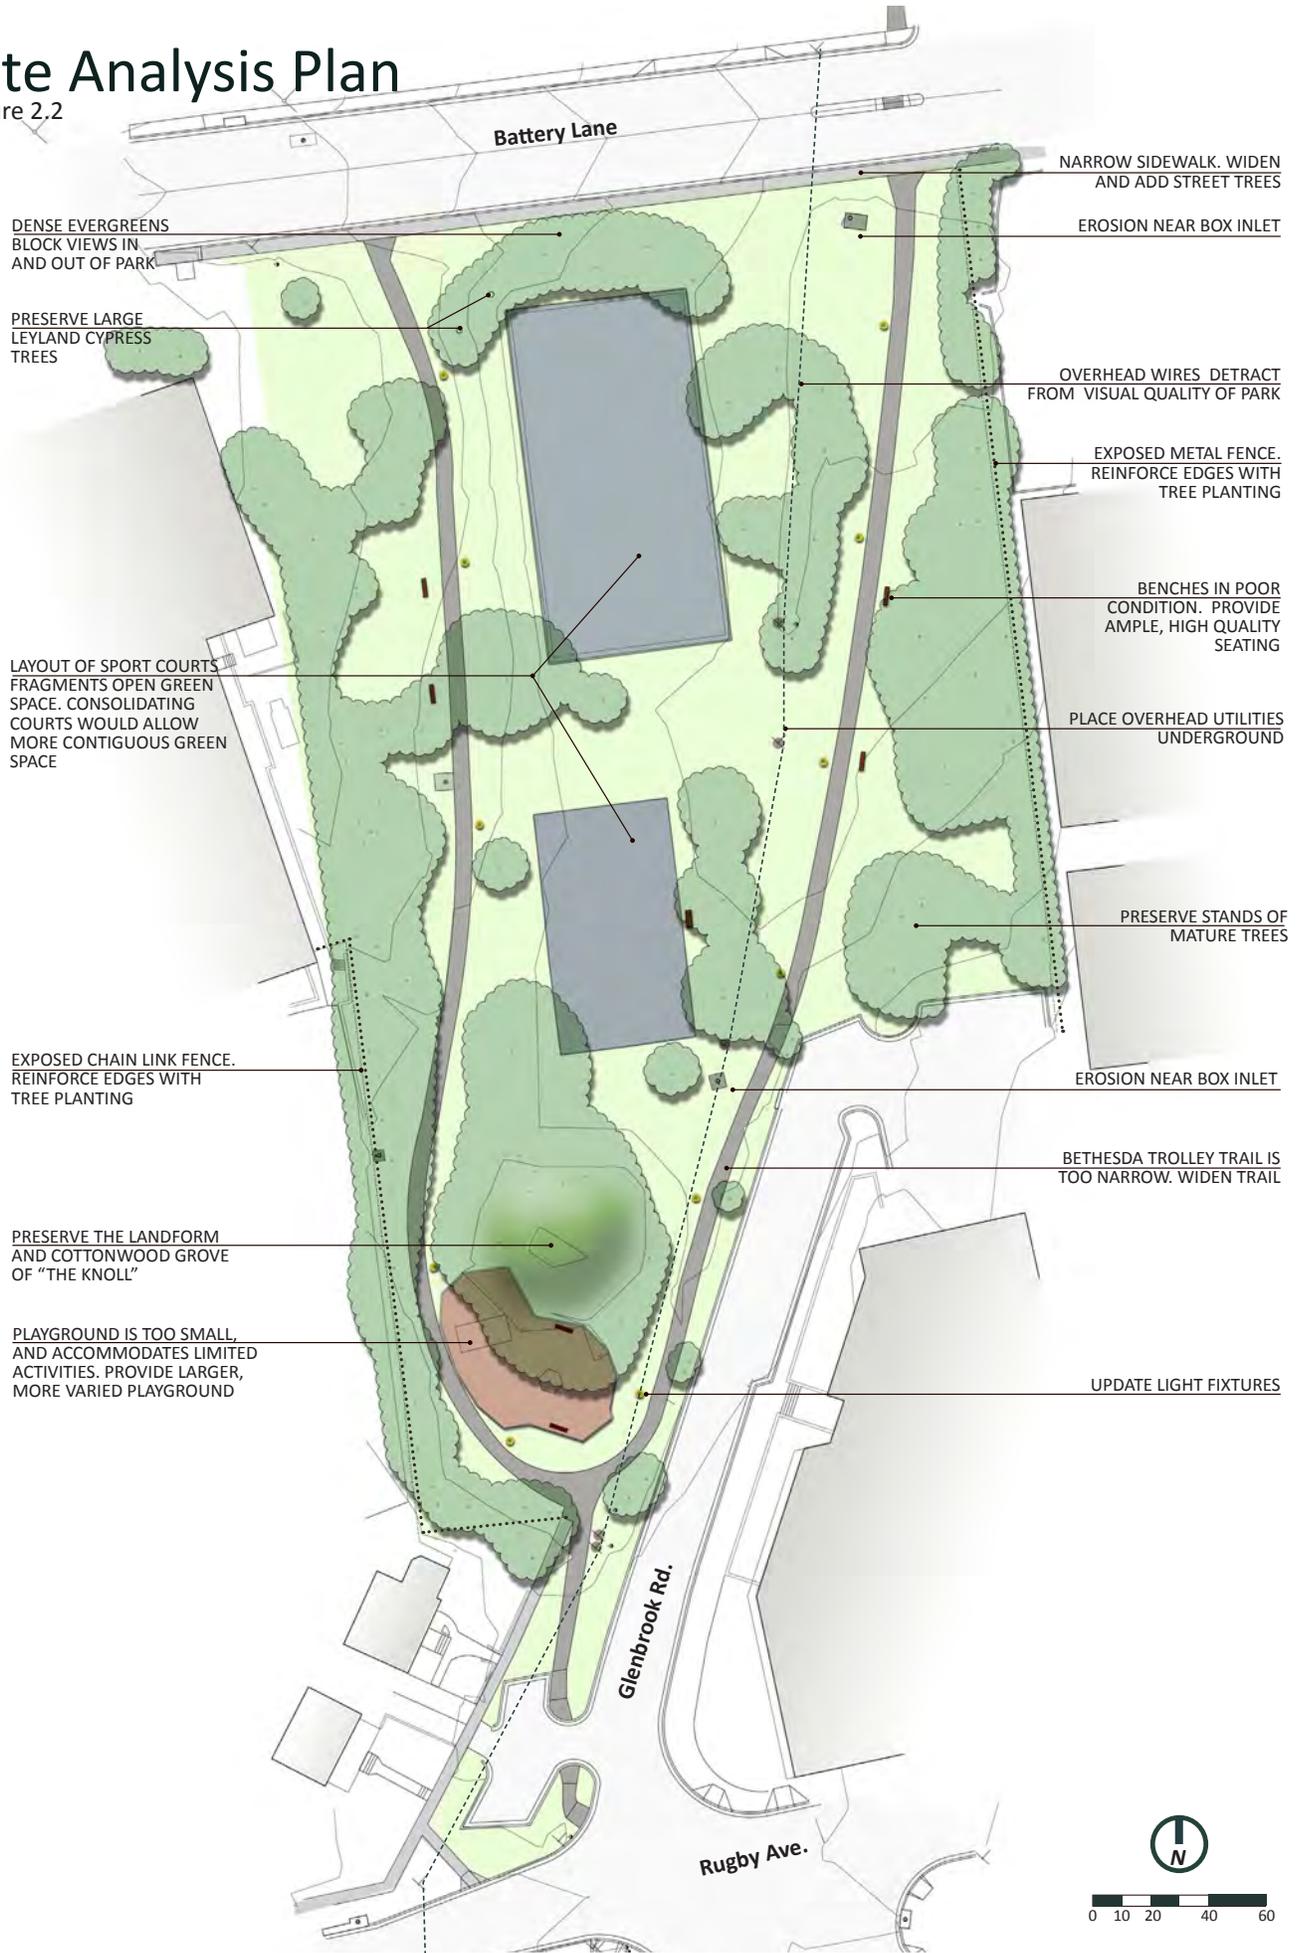
Figure 2.2

DENSE EVERGREENS
BLOCK VIEWS IN
AND OUT OF PARK

LAYOUT OF SPORT COURTS
FRAGMENTS OPEN GREEN
SPACE. CONSOLIDATING
COURTS WOULD ALLOW
MORE CONTIGUOUS GREEN
SPACE

EXPOSED CHAIN LINK FENCE.
REINFORCE EDGES WITH
TREE PLANTING

PLAYGROUND IS TOO SMALL,
AND ACCOMMODATES LIMITED
ACTIVITIES. PROVIDE LARGER,
MORE VARIED PLAYGROUND

NARROW SIDEWALK. WIDEN
AND ADD STREET TREES

EROSION NEAR BOX INLET

OVERHEAD WIRES DETRACT
FROM VISUAL QUALITY OF PARK

EXPOSED METAL FENCE.
REINFORCE EDGES WITH
TREE PLANTING

BENCHES IN POOR
CONDITION. PROVIDE
AMPLE, HIGH QUALITY
SEATING

BETHESDA TROLLEY TRAIL IS
TOO NARROW. WIDEN TRAIL

PLACE OVERHEAD UTILITIES
UNDERGROUND

UPDATE LIGHT FIXTURES
