7206 MEADOW LANE (120100270)

FILE No. 120100270
 7206 MEADOW LANE
 PROPOSED LOTS 37-38 & OUTLOT A,
 BLOCK 5, CHEVY CHASE, SECTION 4
TOWN OF CHEVY CHASE
 PRELIMINARY FOREST CONSERVATION PLAN
 AND TREE SAVE PLAN

Arborist Site Evaluation
7206 Meadow Lane,
Chevy Chase, Maryland 20815
May 19 and 26, 2010
Revision September 20, 2010
Revision December 3, 2010
Revision November 11, 2011

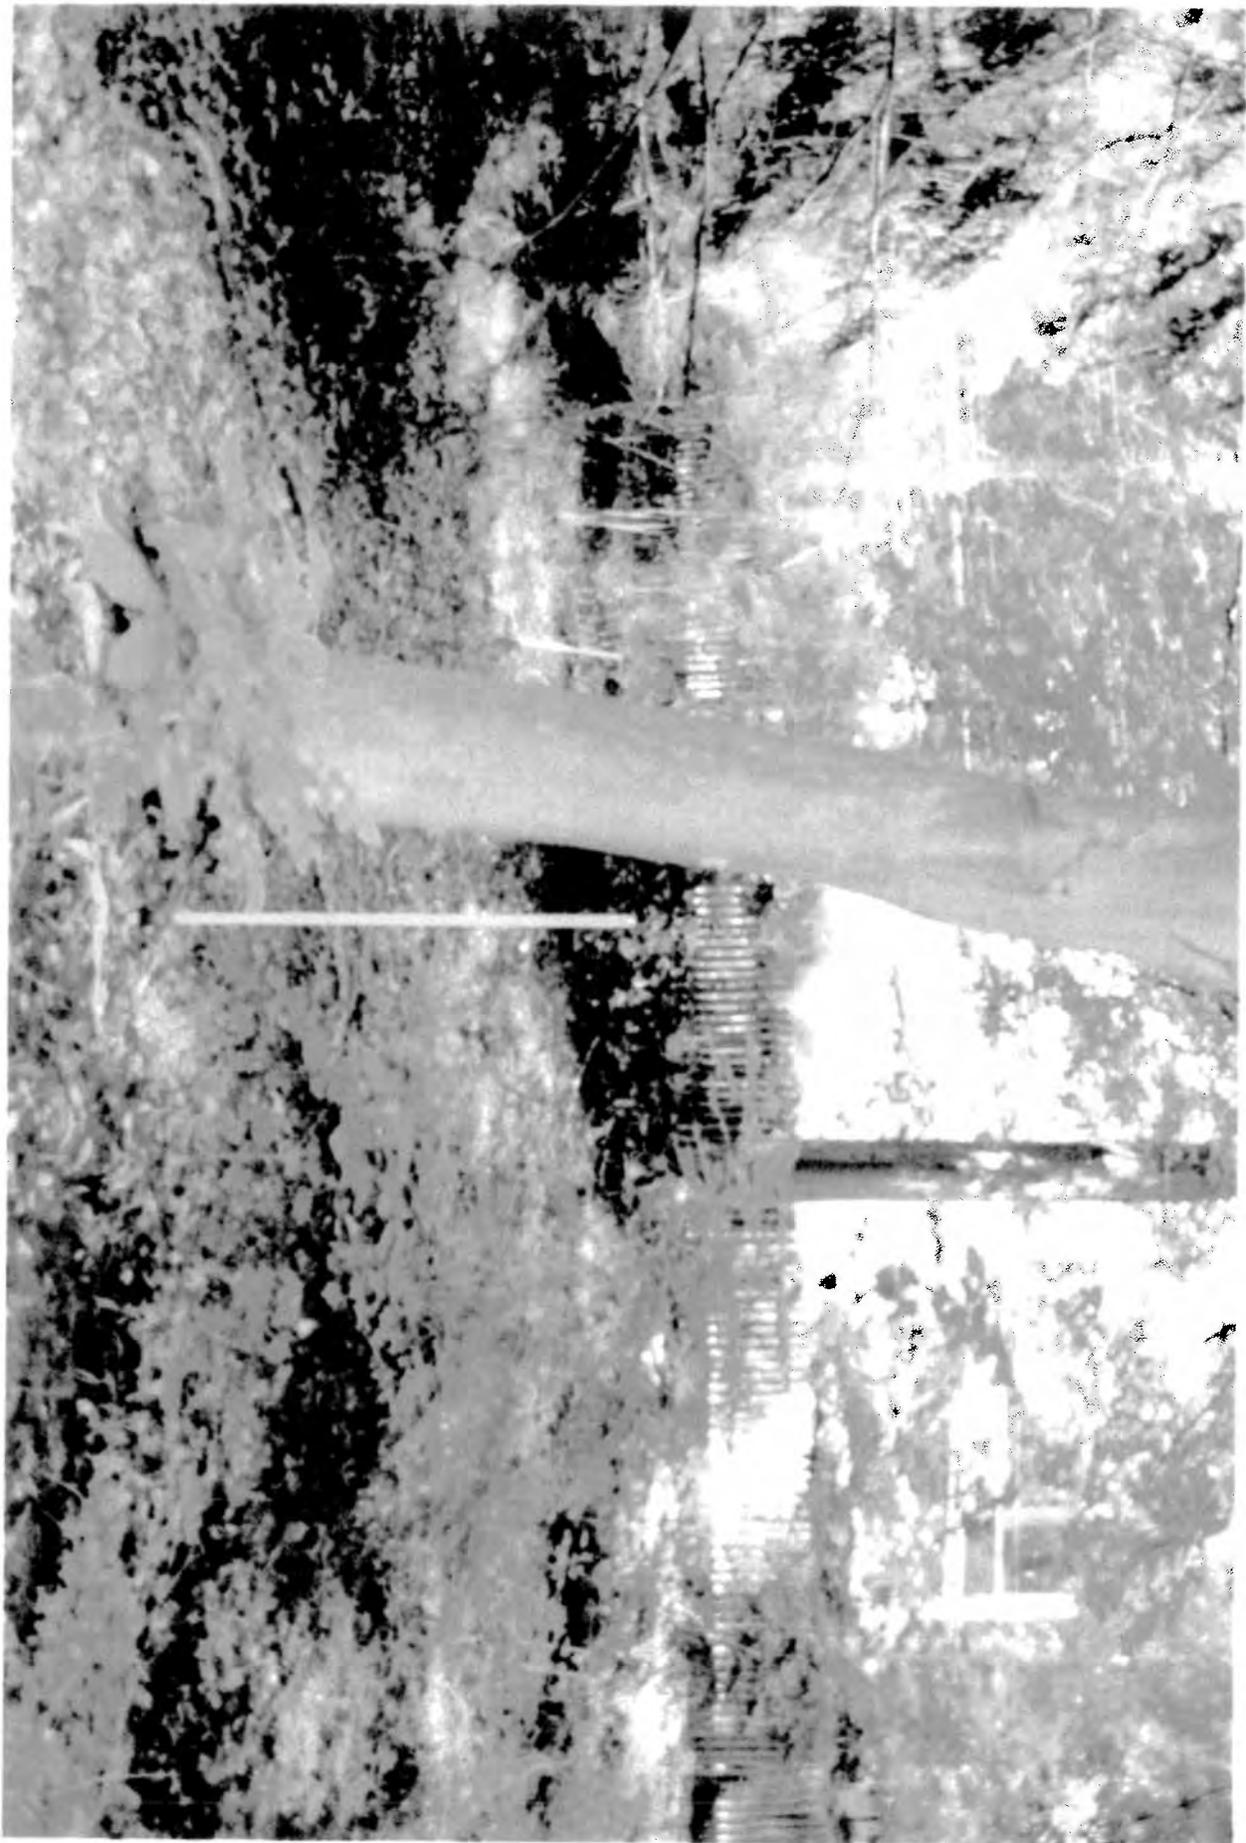
17" beech trunk angle

The trunk of the 17-inch beech leans to the southwest toward the power lines. (See image 7: 17-inch beech trunk angle.) The tree is approximately 50 feet tall. That is tall enough to reach the power lines if the tree fails.

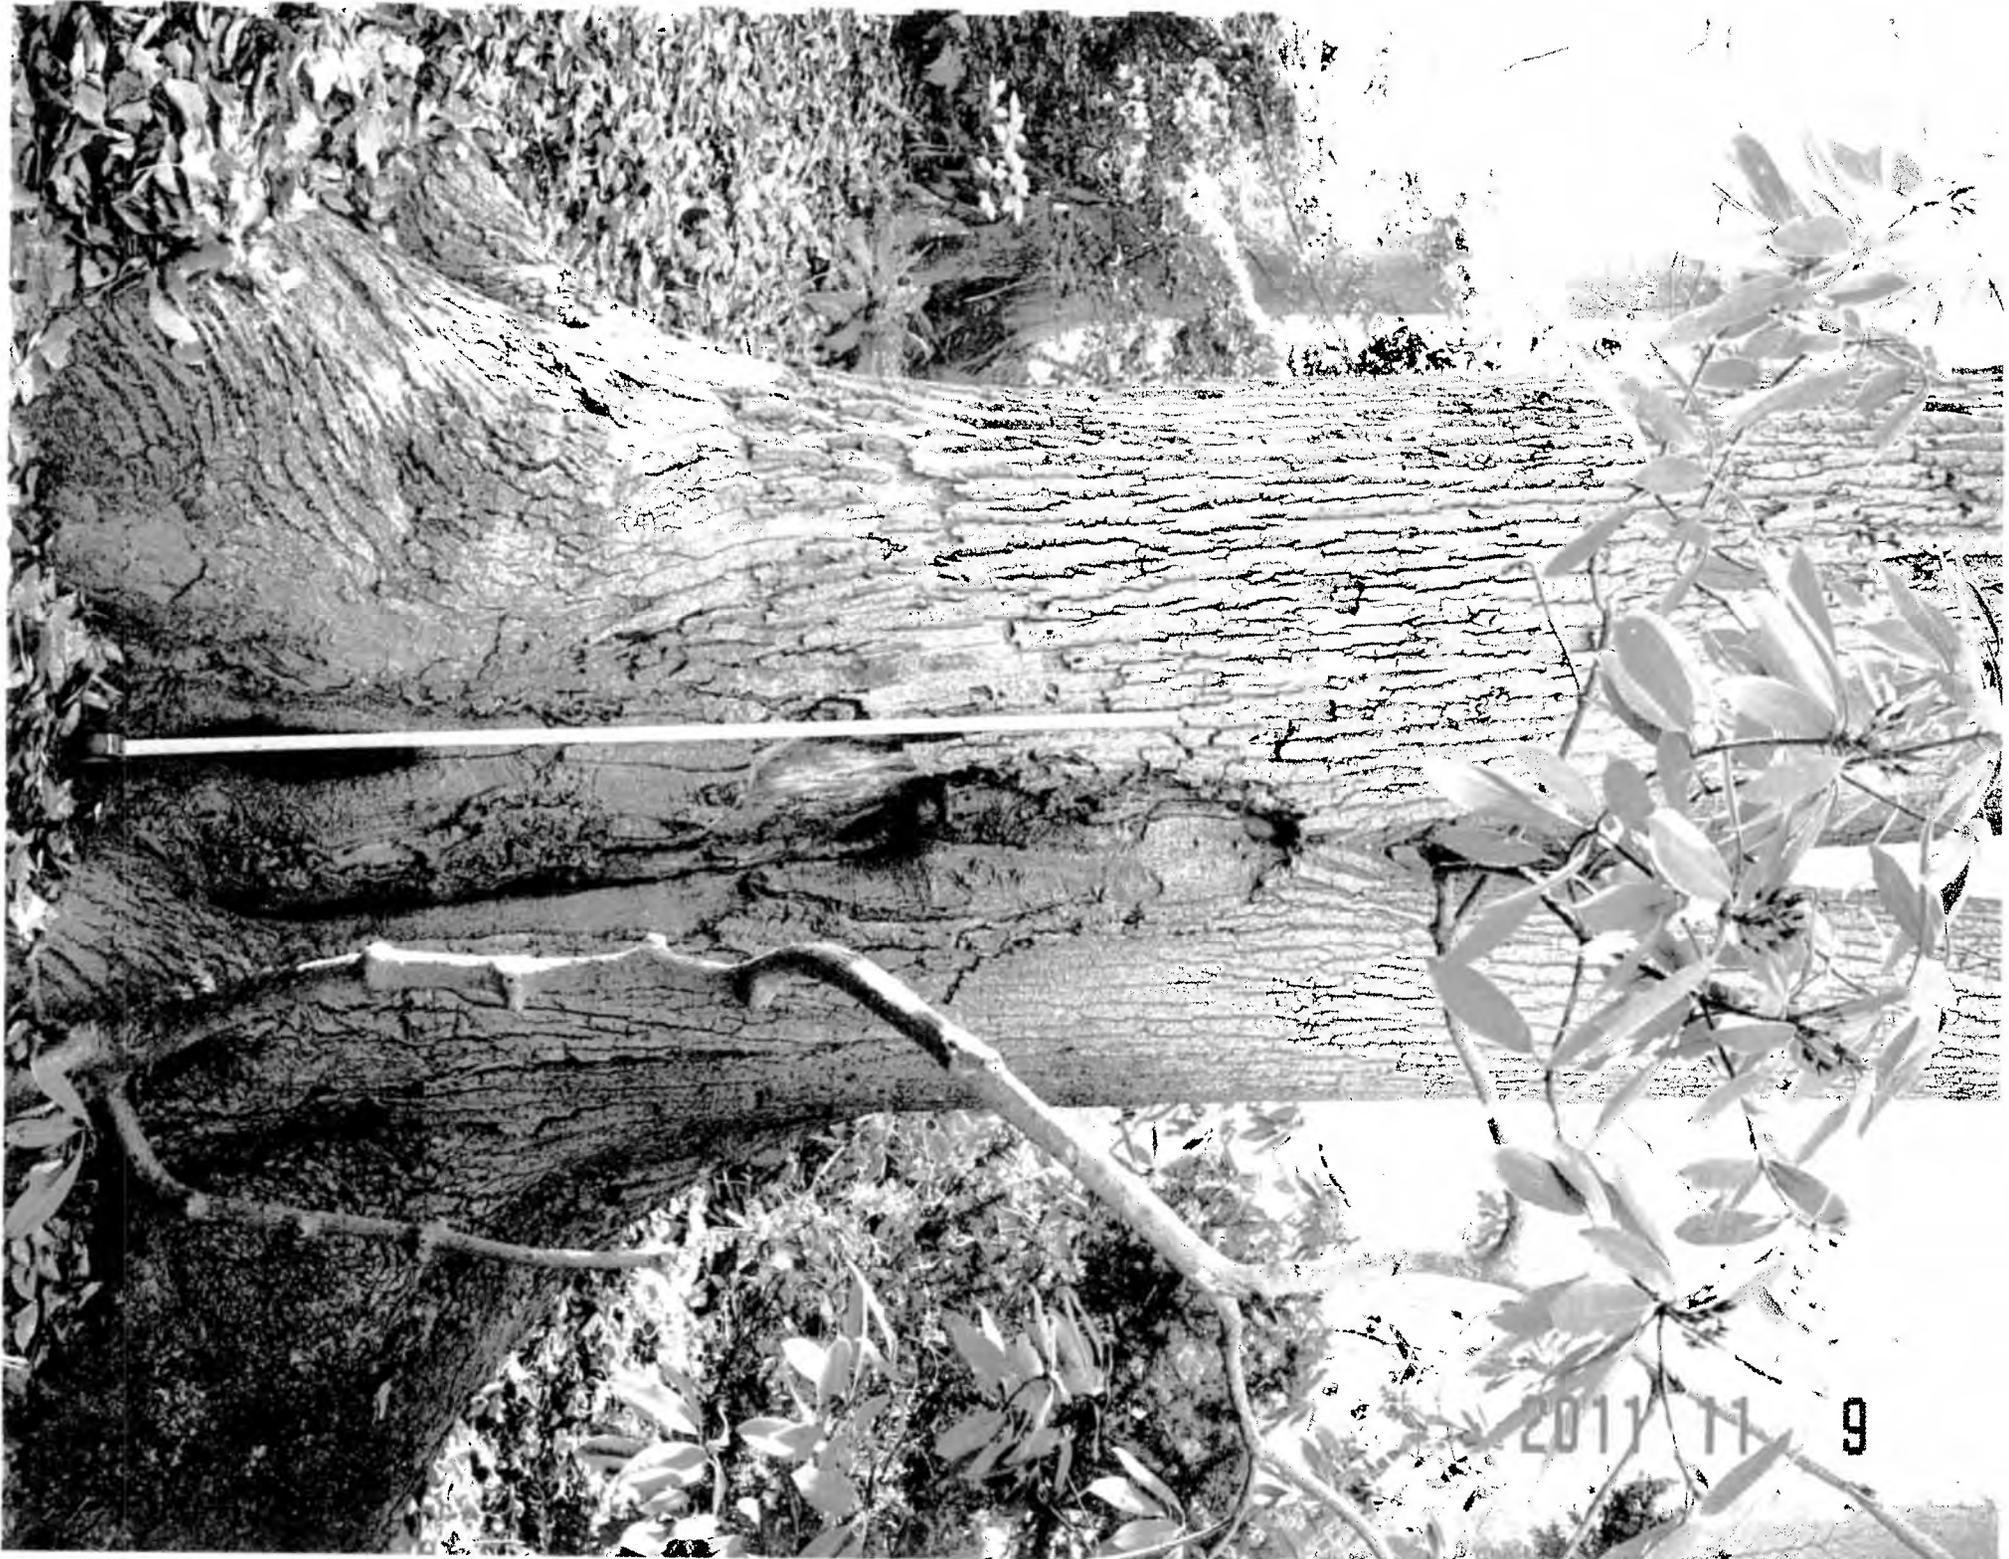
The eastern root flare has two open wounds: one four inches wide and five feet high, while the second is two inches wide and seven feet high (See image 10: Tulip Tree #6). It is very difficult to determine how deep the decay penetrates, because the western side is below the slope of the hillside.

Sounding indicated no appreciable internal decay on the south and west sides. However, the east side has active decay in the trunk. It sounded like a drum. There is no reasonable way to determine how deep this decay penetrates.

This tree (See image 10: Tulip Tree #6) is located in a protected wood line away from the future development. If it fails, it is not likely to hit a high-value target. However, this tree is heavy enough to topple other trees (in a domino effect) in the wood line if it fails.
