Attachment B
CORRESPONDENCE

Forest Stand Delineation Report for

North Branch Trail

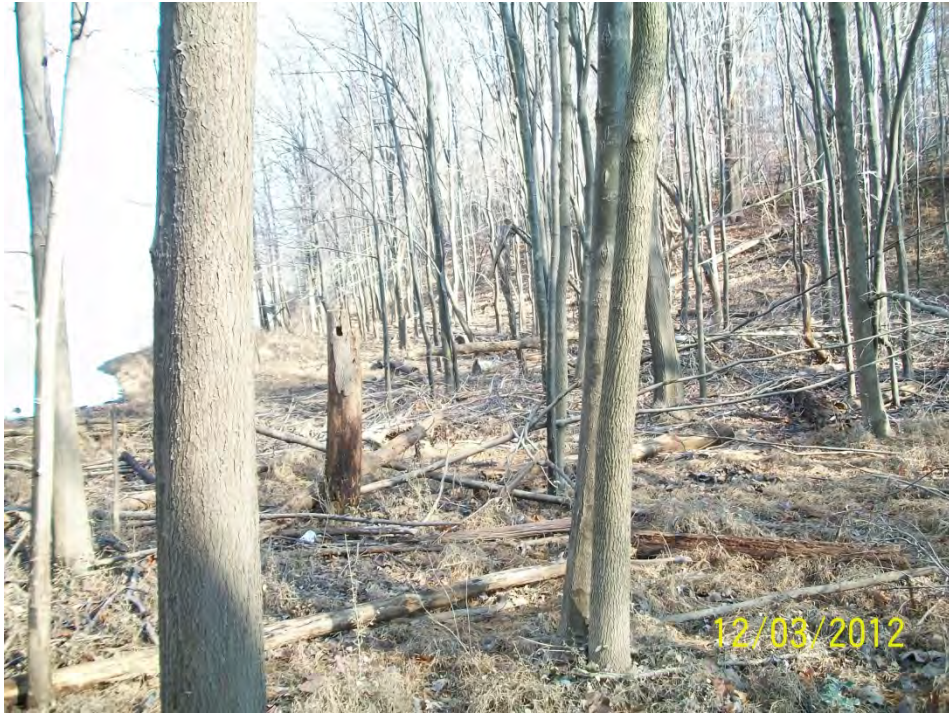
Stand 1 has an estimated 3 tree species and 43 trees per acre. The average DBH of the dominant trees in this forest stand is 7-19.9" inches. Silver maple (*Acer saccharinum*) and Red maple (*Acer rubrum*) are both the dominant and a co-dominant species. Green ash (*Fraxinus pennsylvanica*) was the third tree species within the forest stand, but was observed far less frequently than the maples. The average cover of the understory was approximately 12% and consisted solely of Red maples. Herbaceous and woody ground coverage within Forest Stand 1

was about 62% and primarily composed of Japanese stiltgrass (*Microstegium vimineum*) and Multiflora rose (*Rosa multiflora*). The trees in Stand 1 appear to be in good condition. One (1) significant tree was identified within Stand 1; no specimen tree candidates were identified. This stand has a Good Forest Structure rating with a value of 9. This Good Forest Structural diversity and its value as a buffer qualifies Stand 1 as a Moderate priority area by Montgomery County standards outlined in Trees: Approved Technical Manual.

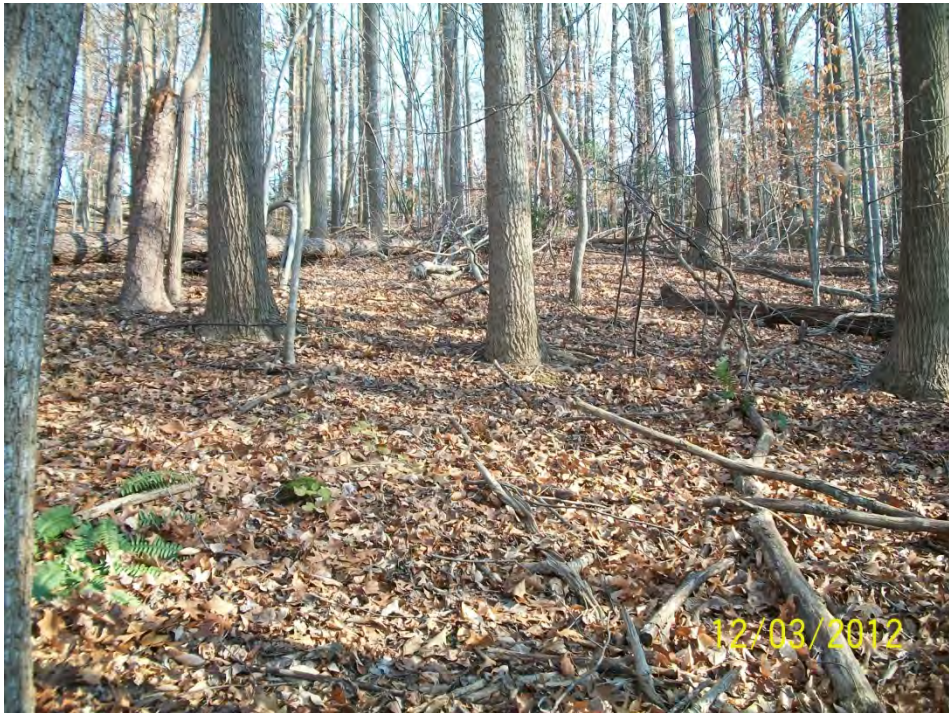
Forest Stand 2

The trees in Stand 2 appear to be in a good condition. A total of 4 specimen tree candidates and an additional 17 significant trees were identified within Stand 2. This stand has a Priority Forest Structure rating with a value of 12. This Priority Forest Structural diversity and the presence of significant and specimen tree candidates within the project study area qualify this as a High priority area by Montgomery County standards outlined in Trees: Approved Technical Manual.

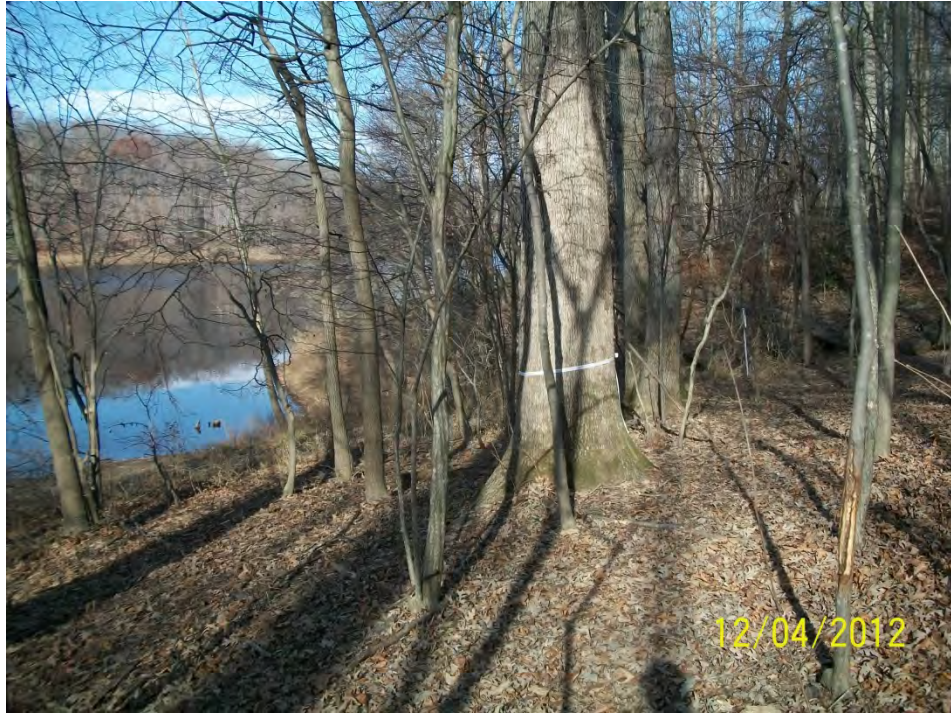
Forest Stand 3 is an unmanaged mid-successional upland forest with approximately 1.97-acres within the study area borders. It is located near the southern end of the study area and borders Lake Bernard Frank on its western side. The soil for this stand is Blocktown channery silt loam, 15 to 25 percent slopes (116D). Blocktown channery silt loam soils have a hydrologic classification of C, and are a very rocky, well-drained soil type. Vegetation native to the area such as Tulip poplar, Red oak, and White oak (*Quercus alba*) were observed during the site inspection.

The trees in Stand 3 appear to be in a good condition. A total of 12 specimen tree candidates and an additional 11 significant trees were identified within Stand 3. This stand has a Priority Forest Structure rating with a value of 12. This Priority Forest Structural diversity and the presence of significant and specimen tree candidates within the project study area qualify this as a High priority area by Montgomery County standards outlined in Trees: Approved Technical Manual.

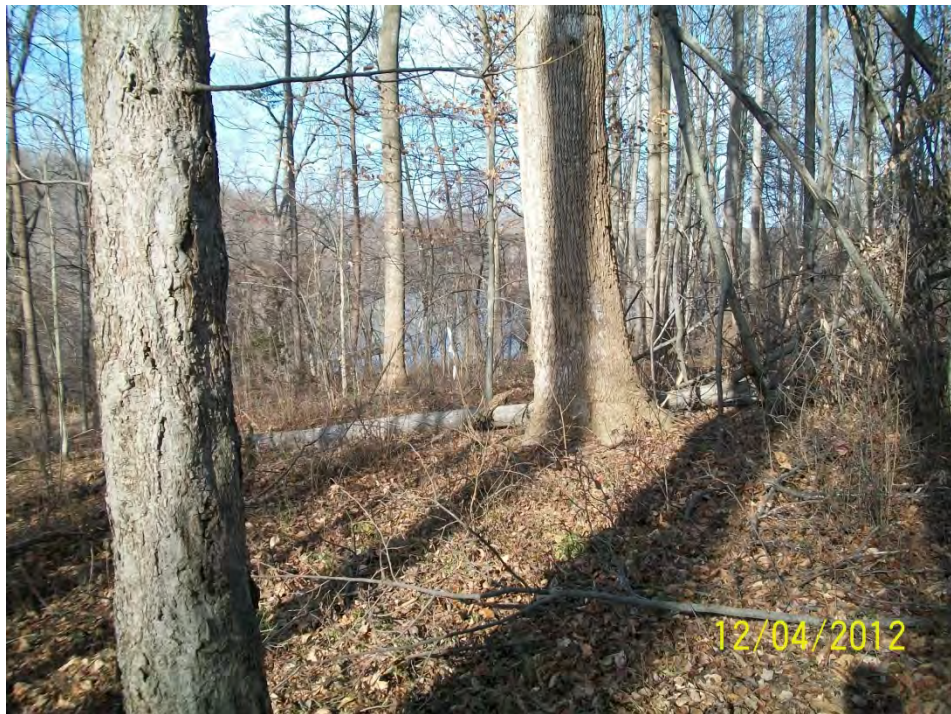
Forest Stand 4

The trees in Stand 4 appear to be in a good condition. A total of 8 specimen tree candidates and an additional 22 significant trees were identified within Stand 4. This stand has a Priority Forest Structure rating with a value of 12. This Priority Forest Structural diversity and the presence of significant and specimen tree candidates within the project study area qualify this as a High priority area by Montgomery County standards outlined in Trees: Approved Technical Manual.

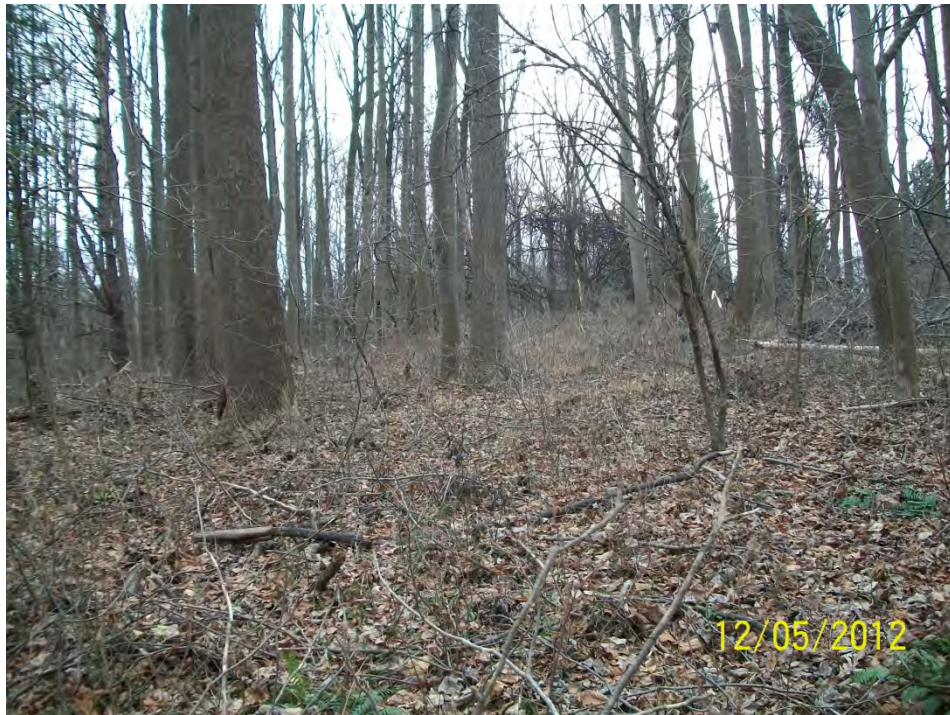
Forest Stand 5 is an unmanaged mid-successional upland forest with approximately 4.12-acres within the study area borders. The majority of soil for this stand is Gaila silt loam, 3 to 8 percent slopes. Gaila silt loam has a B classification and is a very deep, well-drained soil. This stand has a canopy of predominantly Tulip poplars, much downed woody debris due to wind damage in storms, and areas that include many vines and invasives. Stand 5 has an estimated 3 tree species and 233 trees per acre. The average DBH of the dominant trees in this forest stand is 7-19.9 inches. Tulip poplar is both the dominant and co-dominant species. The next most common tree species in Stand 5 is Osage orange (*Maclura pomifera*). Species observed in the understory include Flowering dogwood, Spicebush, and Osage orange. The herbaceous and woody ground coverage was on average 68% within Forest Stand 5 was primarily composed of Multiflora rose and Japanese honeysuckle.

The trees in Stand 5 appear to be in a good condition. A total of 8 specimen tree candidates and an additional 8 significant trees were identified within Stand 5. This stand has a Good Forest Structure rating with a value of 9. This Good Forest Structural diversity and the presence of significant and specimen tree candidates within the project study area qualify this as

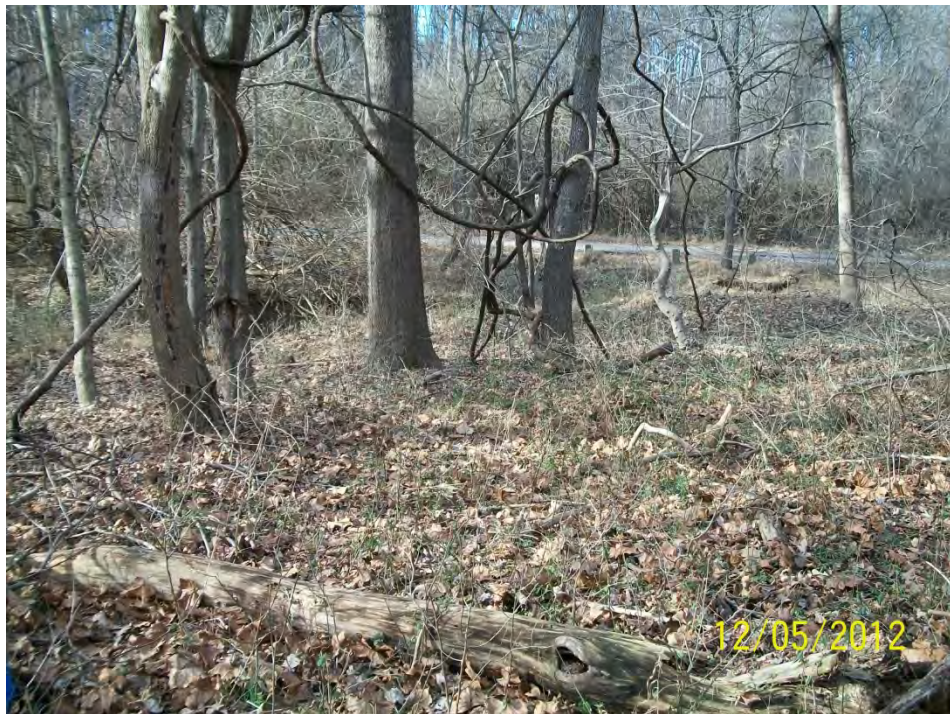
Forest Stand 6

Stand 6 has an estimated 8 tree species and 255 trees per acre. The average DBH of the dominant trees in this forest stand is greater than 20 inches. Sycamores are scattered throughout as a dominant in the canopy. Red maple, Silver maple, and Green ash are abundant. Species observed in the understory include Spicebush, Osage orange, and Multiflora rose. The herbaceous and woody ground coverage was on average 68% within Forest Stand 5 was primarily composed of Japanese honeysuckle and grasses that were unidentifiable due to time of year.

The trees in Stand 6 appear to be in a good condition. A total of 3 specimen tree candidates and an additional 5 significant trees were identified within Stand 6. This stand has a Priority Forest Structure rating with a value of 11. This Priority Forest Structural diversity, the presence of an intermittent stream, and the presence of significant and specimen tree candidates within the project study area qualify this as a High priority area by Montgomery County standards outlined in Trees: Approved Technical Manual.

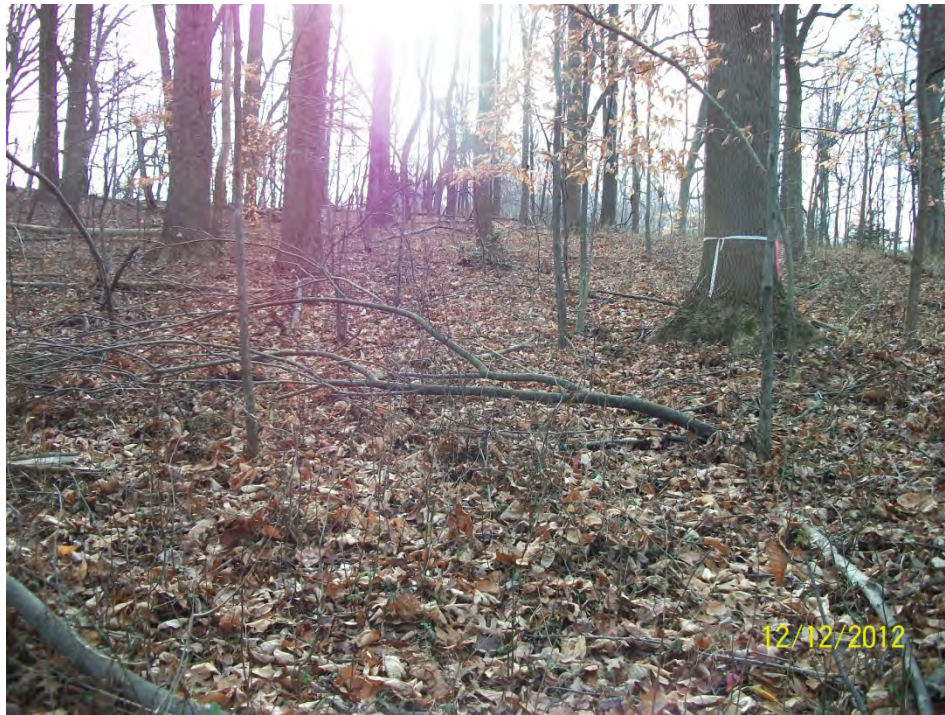
Stand 7 has an estimated 15 tree species and 240 trees per acre. The average DBH of the dominant trees in this forest stand is greater than 20 inches. Tulip poplar is the both the dominant and co-dominant species. The next most common tree species in Stand 5 is Sycamore. Species observed in the understory include Flowering dogwood, Spicebush, Ironwood and White oak. The herbaceous and woody ground coverage was on average 30% within Forest Stand 7 was primarily composed of Multiflora rose and Japanese honeysuckle.

The trees in Stand 7 appear to be in a good condition. A total of 2 specimen tree candidates and an additional 2 significant trees were identified within Stand 5. This stand has a Priority Forest Structure rating with a value of 13. This Priority Forest Structural diversity, the presence of significant and specimen tree candidates within the project study area qualify this as a High priority area by Montgomery County standards outlined in Trees: Approved Technical Manual.

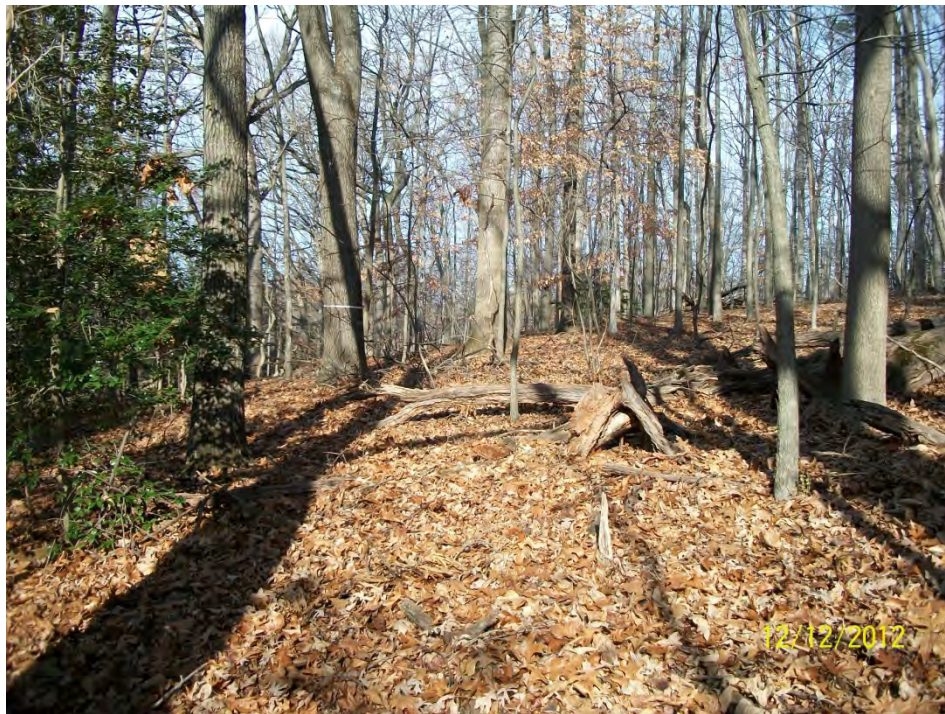
Stand 8 has an estimated 14 tree species and 310 trees per acre. The average DBH of the dominant trees in this forest stand is greater than 20 inches. Tulip poplar is the dominant species with Red oak the co-dominant species. Numerous Hickories were also observed. Species observed in the understory include Ironwood, American holly, Mountain laurel (*Kalmia latifolia*) and Eastern red cedar (*Juniperus virginiana*). The herbaceous and woody ground coverage was on average 5% within Forest Stand 8 and was primarily composed of Japanese barberry.

The trees in Stand 8 appear to be in a good condition. A total of 21 specimen tree candidates and an additional 46 significant trees were identified within Stand 8. This stand has a Priority Forest Structure rating with a value of 12. This Priority Forest Structural diversity and

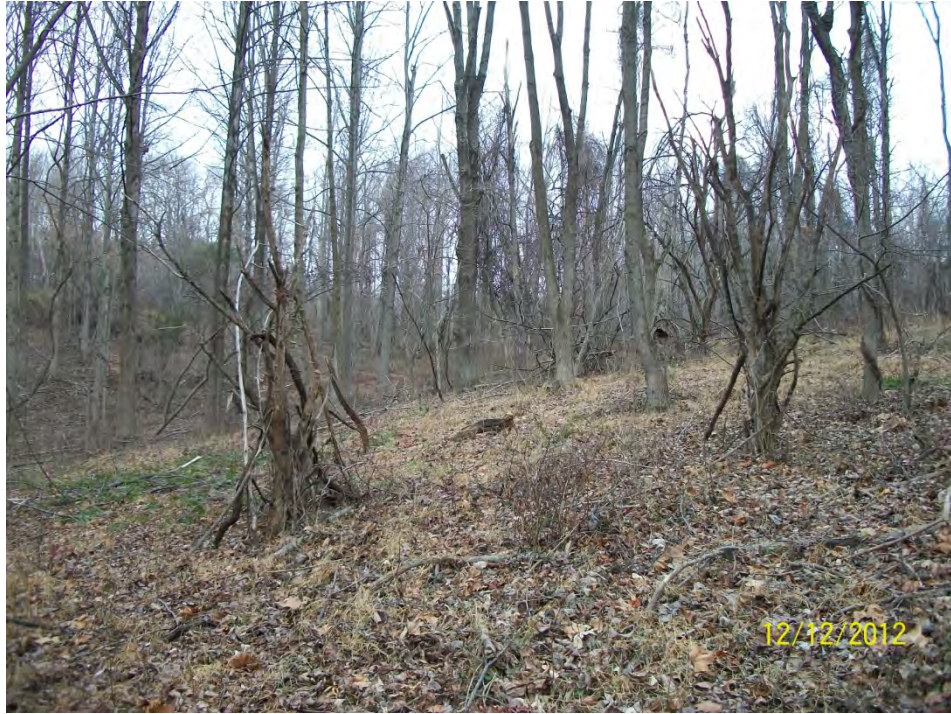
Forest Stand 9

The trees in Stand 9 appear to be in a good condition. One (1) specimen tree candidate and an additional 2 significant trees were identified within Stand 8. This stand has a Priority Forest Structure rating with a value of 12. This Priority Forest Structural diversity qualifies this as a Moderate priority area by Montgomery County standards outlined in Trees: Approved Technical Manual.

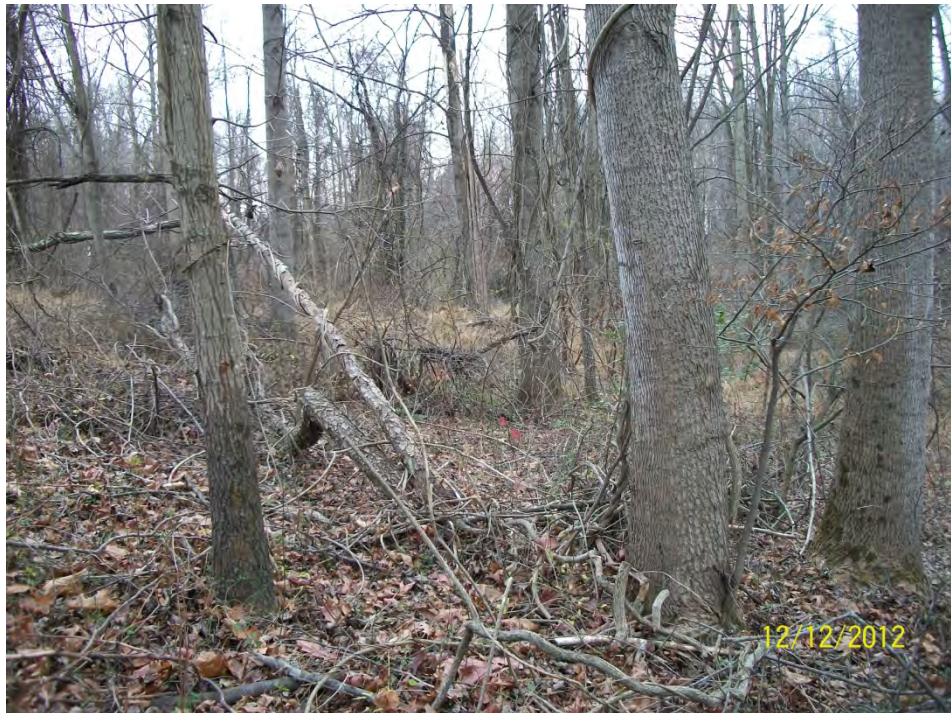
Forest Stand 10

Stand 10 has an estimated 6 tree species and 230 trees per acre. The average DBH of the dominant trees in this forest stand is 7-19.9 inches. Tulip poplar is the dominant and co-dominant species. This stand has a rather open canopy, a scrubby understory and herbaceous and woody ground cover is made up of many invasives such as Japanese barberry, Multiflora rose, and Smilax. There is a high presence of vines such Grape. Other species observed in the understory include Ironwood, Flowering dogwood, American holly and Autumn-olive (*Elaeagnus umbellata*).

The trees in Stand 10 appear to be in fair to good condition. A total of 2 specimen tree candidates and an additional 3 significant trees were identified within Stand 10. This stand has a Good Forest Structure rating with a value of 8. This Priority Forest Structural diversity qualifies this as a Moderate priority area by Montgomery County standards outlined in Trees: Approved Technical Manual.

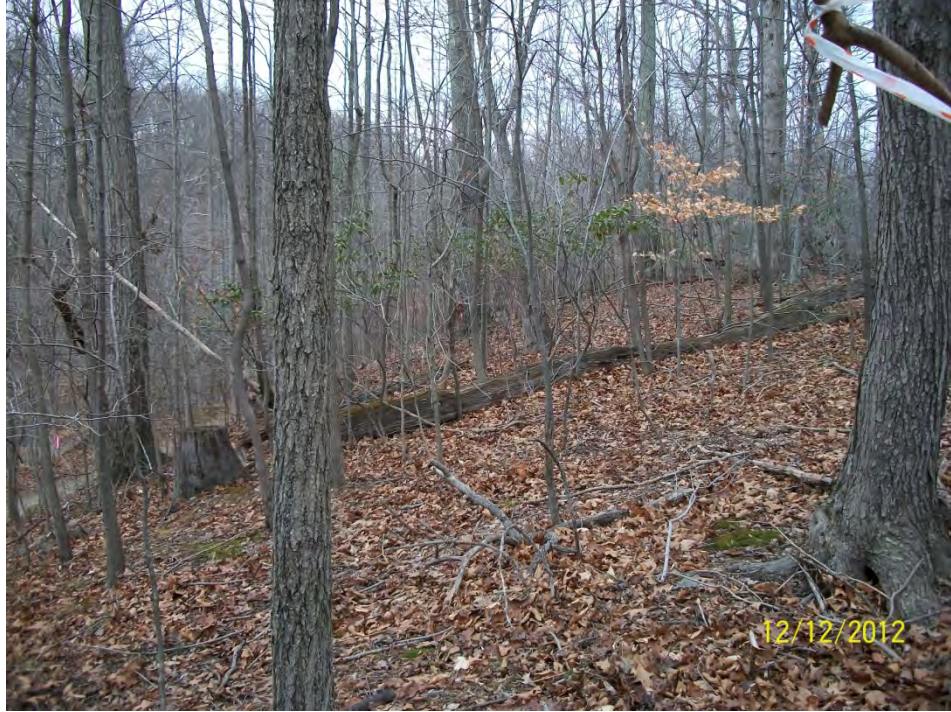
Stand 11 has an estimated 9 tree species and 300 trees per acre. The average DBH of the dominant trees in this forest stand is greater than 20 inches. Tulip poplar and Red oak are the dominant species. Numerous Blackgum and Hickory trees were also observed. Species observed in the understory include Ironwood, Red maple, and American beech. The herbaceous and woody ground coverage was on average 64% within Forest Stand 11 and was primarily composed of Christmas fern (*Polystichum acrostichoides*) and Sedge (*Carex spp.*).

The trees in Stand 11 appear to be in a good condition. A total of 3 specimen tree candidates and an additional 25 significant trees were identified within Stand 11. This stand has a Priority Forest Structure rating with a value of 12. This Priority Forest Structural diversity, the

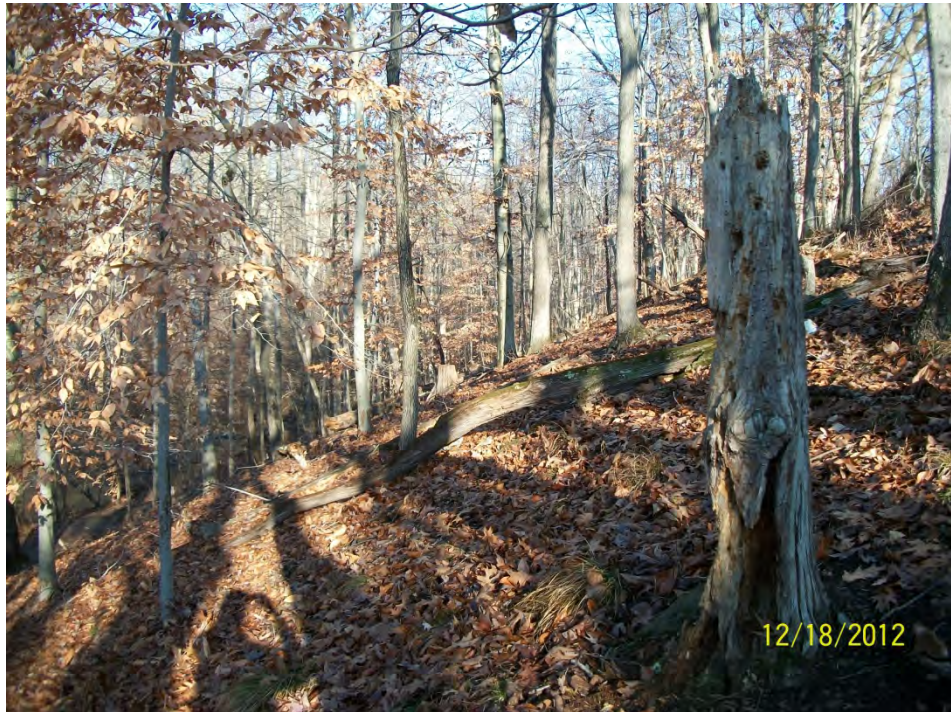
Forest Stand 13

The trees in Stand 13 appear to be in a good condition. A total of 7 specimen tree candidates and an additional 16 significant trees were identified within Stand 13. This stand has a Priority Forest Structure rating with a value of 11. This Priority Forest Structural diversity and the presence of significant and specimen tree candidates within the project study area qualify this as a High priority area by Montgomery County standards outlined in Trees: Approved Technical Manual.

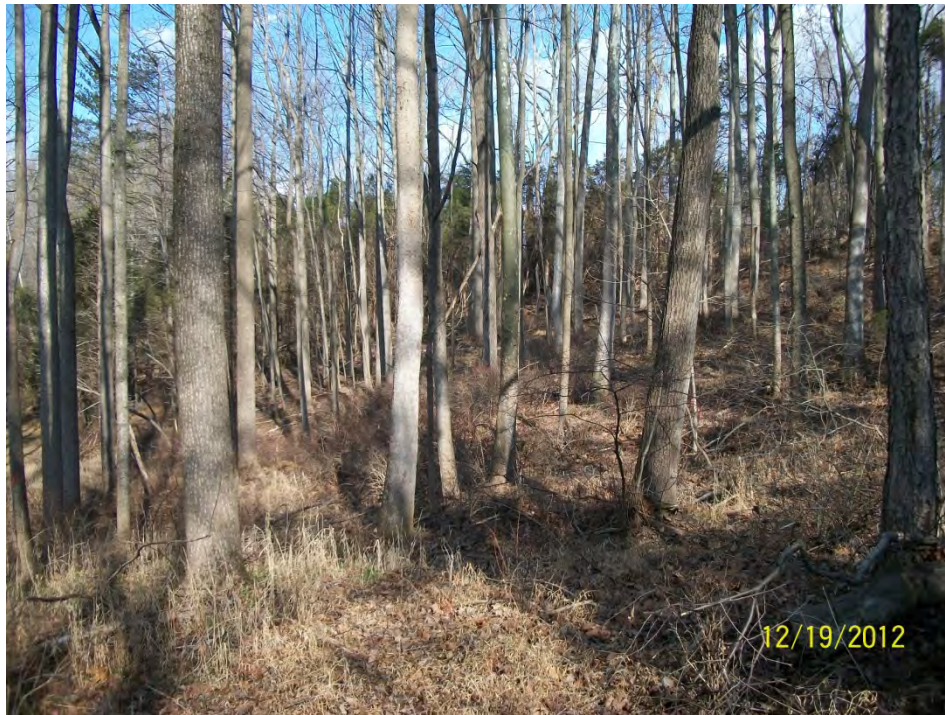
Forest Stand 14

Stand 14 is predominantly Tulip poplars with some large mature Oaks and Sycamores scattered within. The understory is comprised of Ironwood, Flowering dogwood, Spicebush, and Eastern red cedars, and species observed in the herbaceous and woody groundcover include Japanese barberry and Sedge. Stand 14 has an estimated 11 tree species and 307 trees per acre. The average DBH of the dominant trees in this forest stand is 7-19.9 inches.

The trees in Stand 14 appear to be in a good condition. A total of 15 specimen tree candidates and an additional 10 significant trees were identified within Stand 14. This stand has a Priority Forest Structure rating with a value of 11. This Priority Forest Structural diversity and the presence of significant and specimen tree candidates within the project study area qualify this as a High priority area by Montgomery County standards outlined in Trees: Approved Technical Manual.

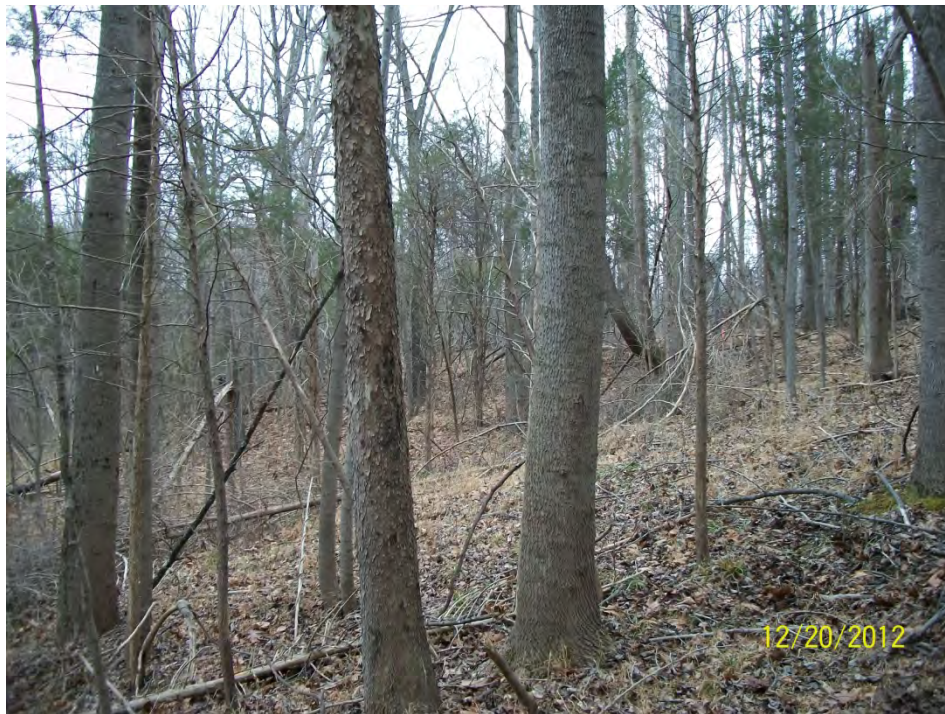
Forest Stand 15

Stand 15 has a rather open canopy and is comprised mostly of Eastern red cedars, with some dominant Tulip poplars and Sycamores scattered throughout. Downed woody debris and vines present such as Grape and Poison ivy are abundant. Species observed in the understory include Spicebush and Japanese barberry. Species observed in the herbaceous and woody groundcover include unidentifiable grasses and invasives such as Japanese stiltgrass, Japanese honeysuckle, and Garlic mustard (*Alliaria petiolata*). Stand 15 has an estimated 7 tree species and 350 trees per acre. The average DBH of the dominant trees in this forest stand is 7-19.9 inches.

The trees in Stand 15 appear to be in a fair condition. A total of 2 specimen tree candidates and an additional 3 significant trees were identified within Stand 14. This stand has a Good Forest Structure rating with a value of 9. This Good Forest Structural diversity qualifies this as a Moderate priority area by Montgomery County standards outlined in Trees: Approved Technical Manual.

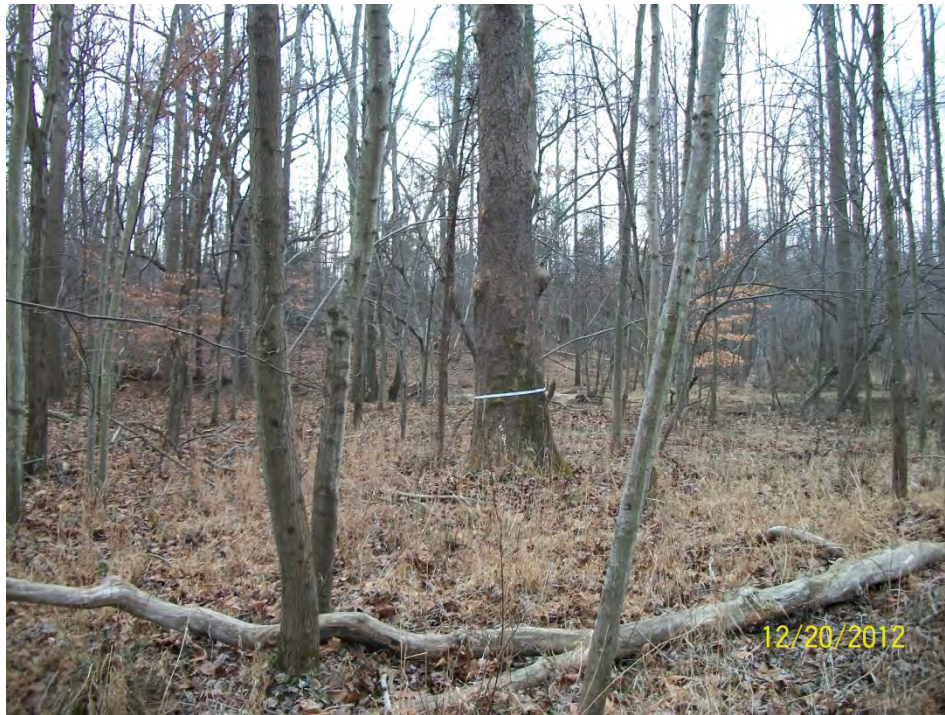
Forest Stand 16

Stand 16 has a rather open canopy and is comprised mostly of Red maples and Green ash, with some dominant Sycamores scattered without. Species observed in the understory include Spicebush and Japanese barberry. The herbaceous and woody groundcover is predominantly unidentifiable grasses and Japanese honeysuckle. Stand 16 has an estimated 7 tree species and 280 trees per acre. The average DBH of the dominant trees in this forest stand is greater than 20 inches.

The trees in Stand 16 appear to be in a good condition. Three (3) specimen tree candidates and no significant trees were identified within Stand 14. This stand has a Priority Forest Structure rating with a value of 11. This Priority Forest Structural diversity, and the presence of an intermittent stream (WUS A) and Wetland AA and their respective buffers qualify this as a High priority area by Montgomery County standards outlined in Trees: Approved Technical Manual.

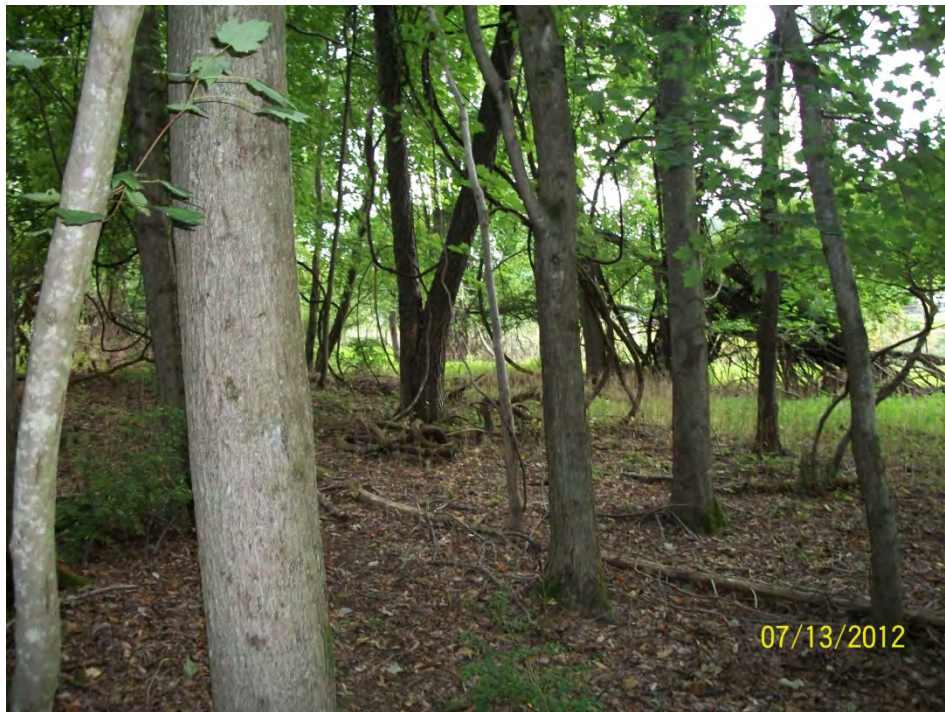
Forest Stand 17

Red maple and Black cherry are the dominant species in the canopy of Stand 17. Species observed in a sparse understory include Spicebush, Green ash, and Japanese barberry. The herbaceous and woody groundcover is predominantly Garlic mustard and Japanese stiltgrass. There is a rather high presence of vines such as Wisteria and Grape smothering trees in this stand. Stand 16 has an estimated 11 tree species and 260 trees per acre. The average DBH of the dominant trees in this forest stand is 7-19.9 inches.

The trees in Stand 17 appear to be in a good condition. A total of 6 specimen tree candidates and an additional 2 significant trees were identified within Stand 17. This stand has a Good Forest Structure rating with a value of 11. This Good Forest Structural diversity, and the presence of an intermittent stream and wetland and their respective buffers qualify this as a High priority area by Montgomery County standards outlined in Trees: Approved Technical Manual.

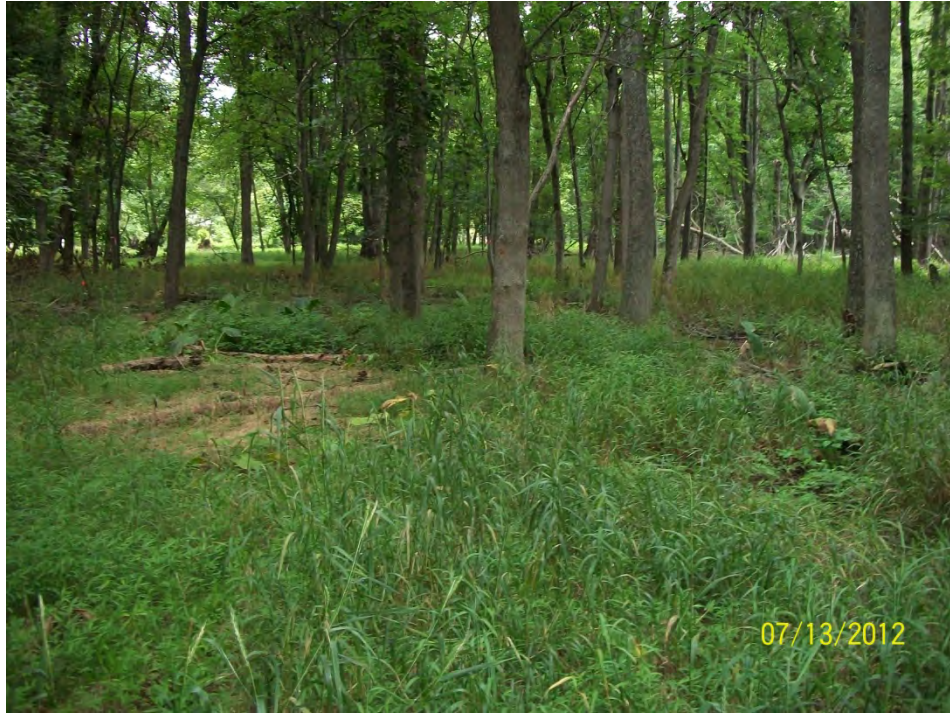
Forest Stand 18

Box elder (*Acer negundo*) and Green ash are the dominant species and Red maple is a co-dominant species in the canopy of Stand 18. Species observed in a sparse understory include Shingle oak (*Quercus imbricaria*) and Red maple. The herbaceous and woody groundcover is predominantly Common woodreed (*Cinna arundinacea*), Garlic mustard, and Japanese stiltgrass. Stand 18 has an estimated 3 tree species and 185 trees per acre. The average DBH of the dominant trees in this forest stand is 7-19.9 inches.

The trees in Stand 18 appear to be in a good condition. Two (2) specimen tree candidates and no significant trees were identified within Stand 18. This stand has a Good Forest Structure rating with a value of 8. This Good Forest Structural diversity and the presence of Wetland A and its buffer qualify this as a High priority area by Montgomery County standards outlined in Trees: Approved Technical Manual.
