7206 MEADOW LANE (120100270)

FILE No. 120100270
 7206 MEADOW LANE
 PROPOSED LOTS 37-38 & OUTLOT A,
 BLOCK 5, CHEVY CHASE, SECTION 4
TOWN OF CHEVY CHASE
 PRELIMINARY FOREST CONSERVATION PLAN
 AND TREE SAVE PLAN

Arborist Site Evaluation
7206 Meadow Lane,
Chevy Chase, Maryland 20815
May 19 and 26, 2010
Revision September 20, 2010
Revision December 3, 2010
Revision November 11, 2011

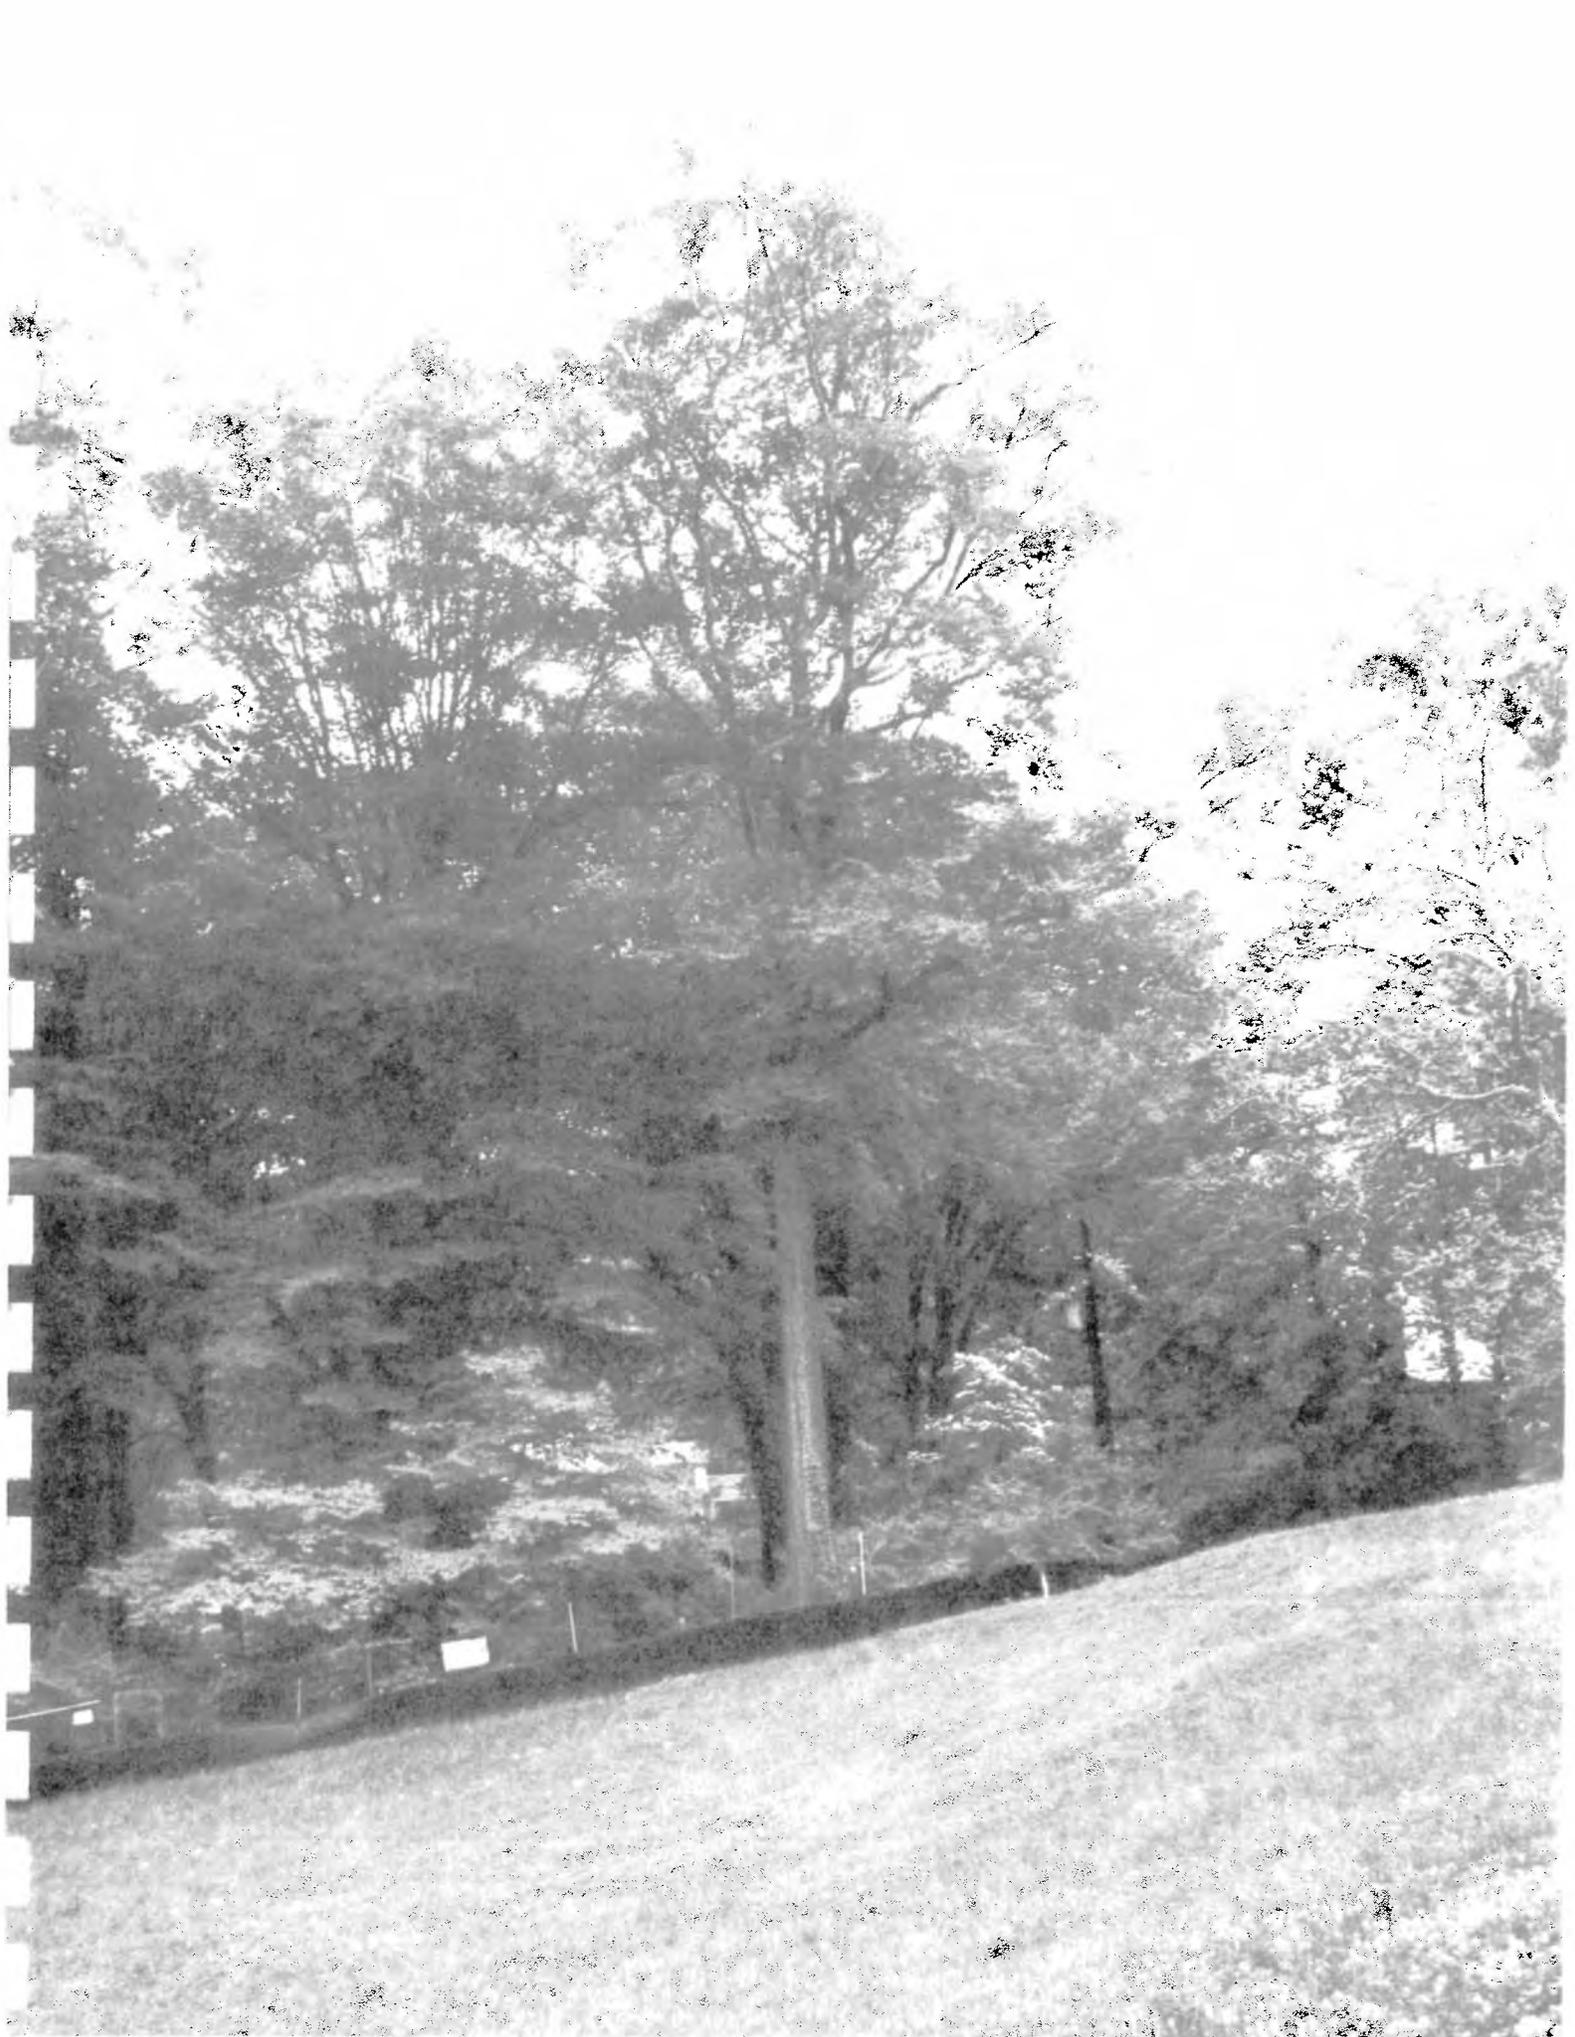
for approximately 30 feet. The tree is approximately 70 feet tall. (See image 1: beech tree #9.)

Limbs are normal in size for this mature tree. They are developed well vertically, but few scaffolding limbs are present horizontally. The west side has fewer scaffolding limbs present. (See image 1: beech tree #9.)

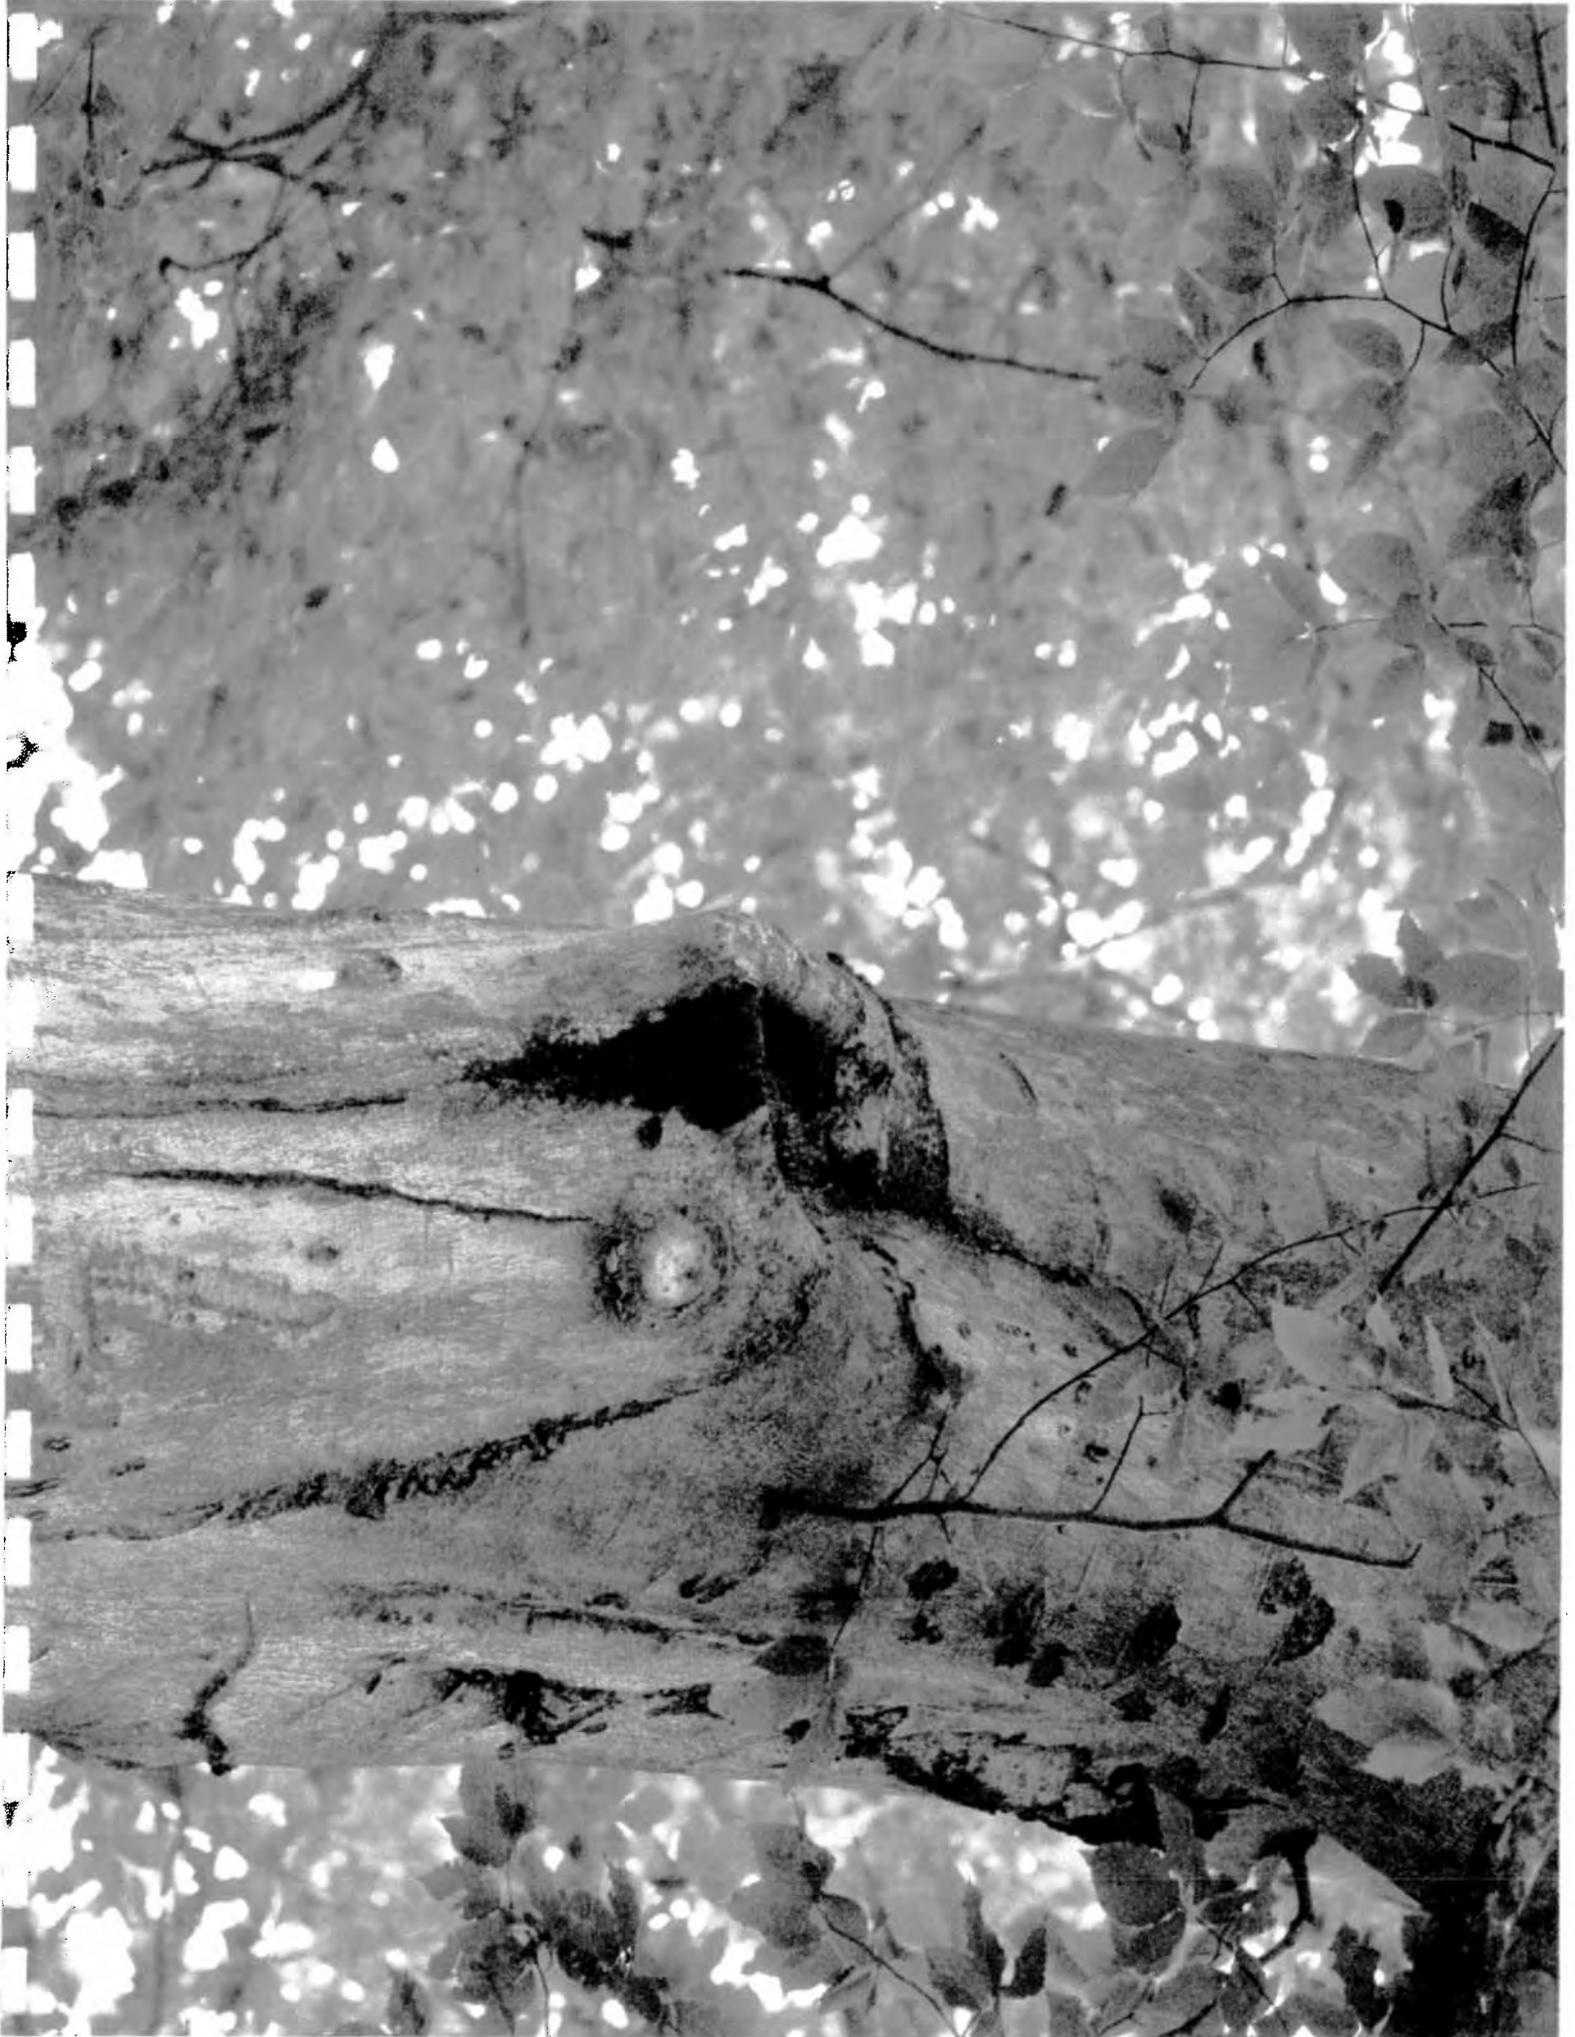
A major scaffolding limb has been lost on the west side of the trunk, 30 feet high. The damage has protruded into the trunk at that point. The damaged trunk has developed callus tissue on the outer edges, but the wound has not closed. (See image 2: lost limb.) This callus growth is similar to a person's scab tissue on an old injury.

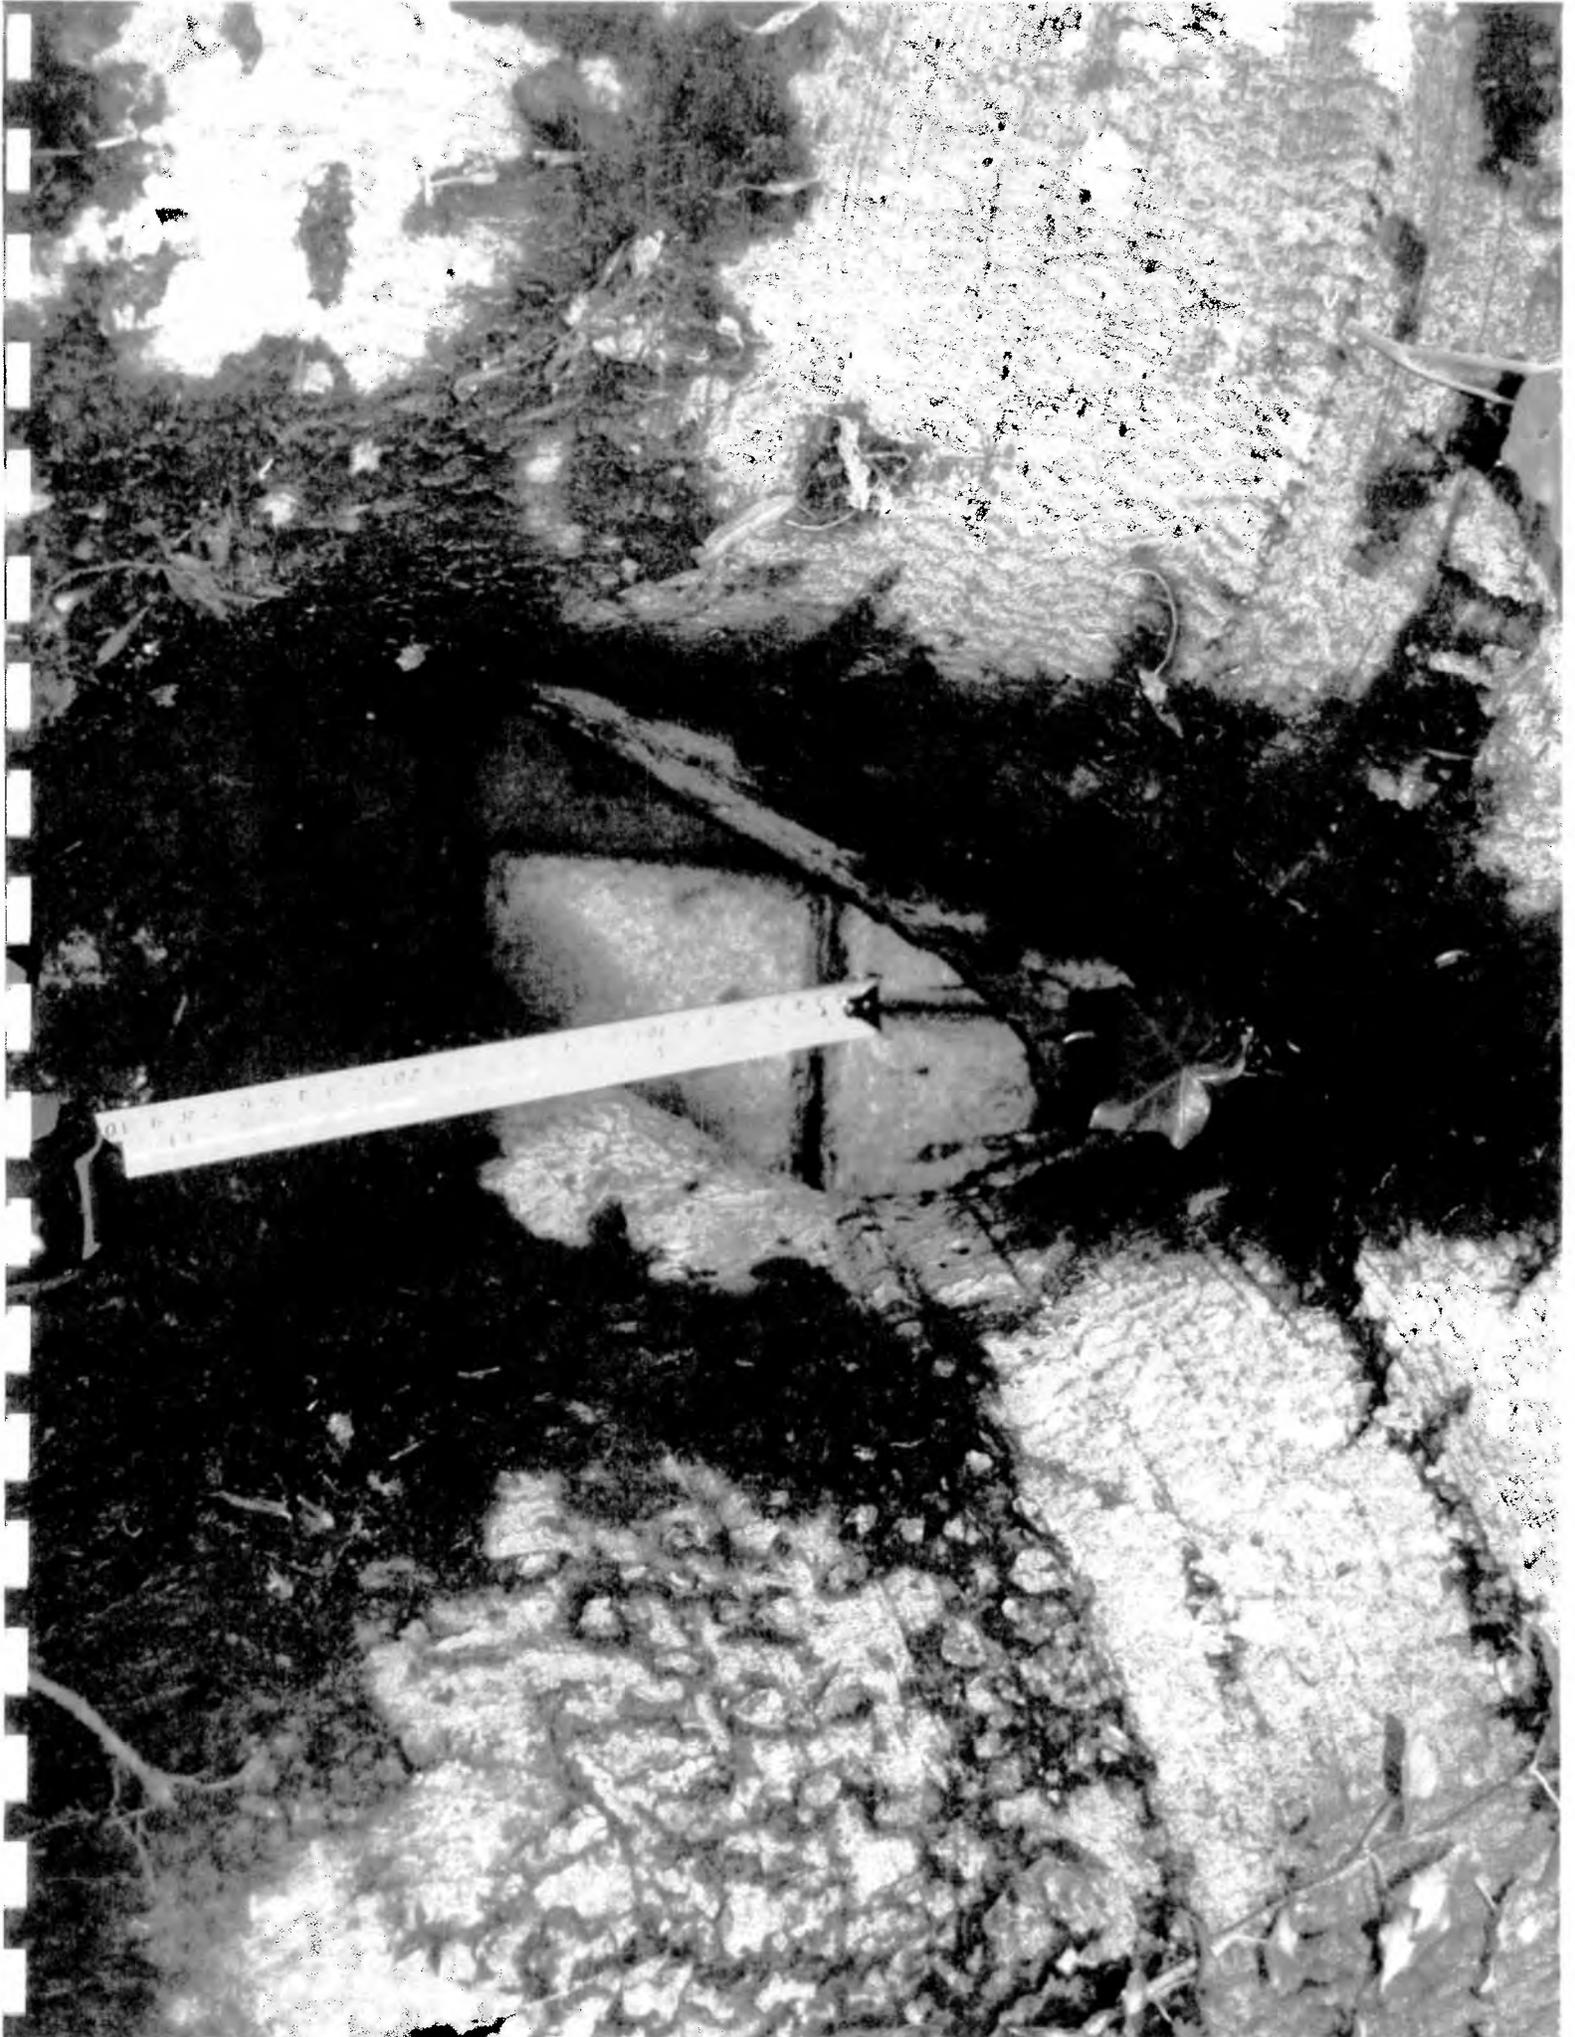
The base of the trunk has a lot of old damage. A stone wall was built inside the trunk years ago. This wall is exposed on the east side of the base of the trunk. (See image 3: stone wall.)

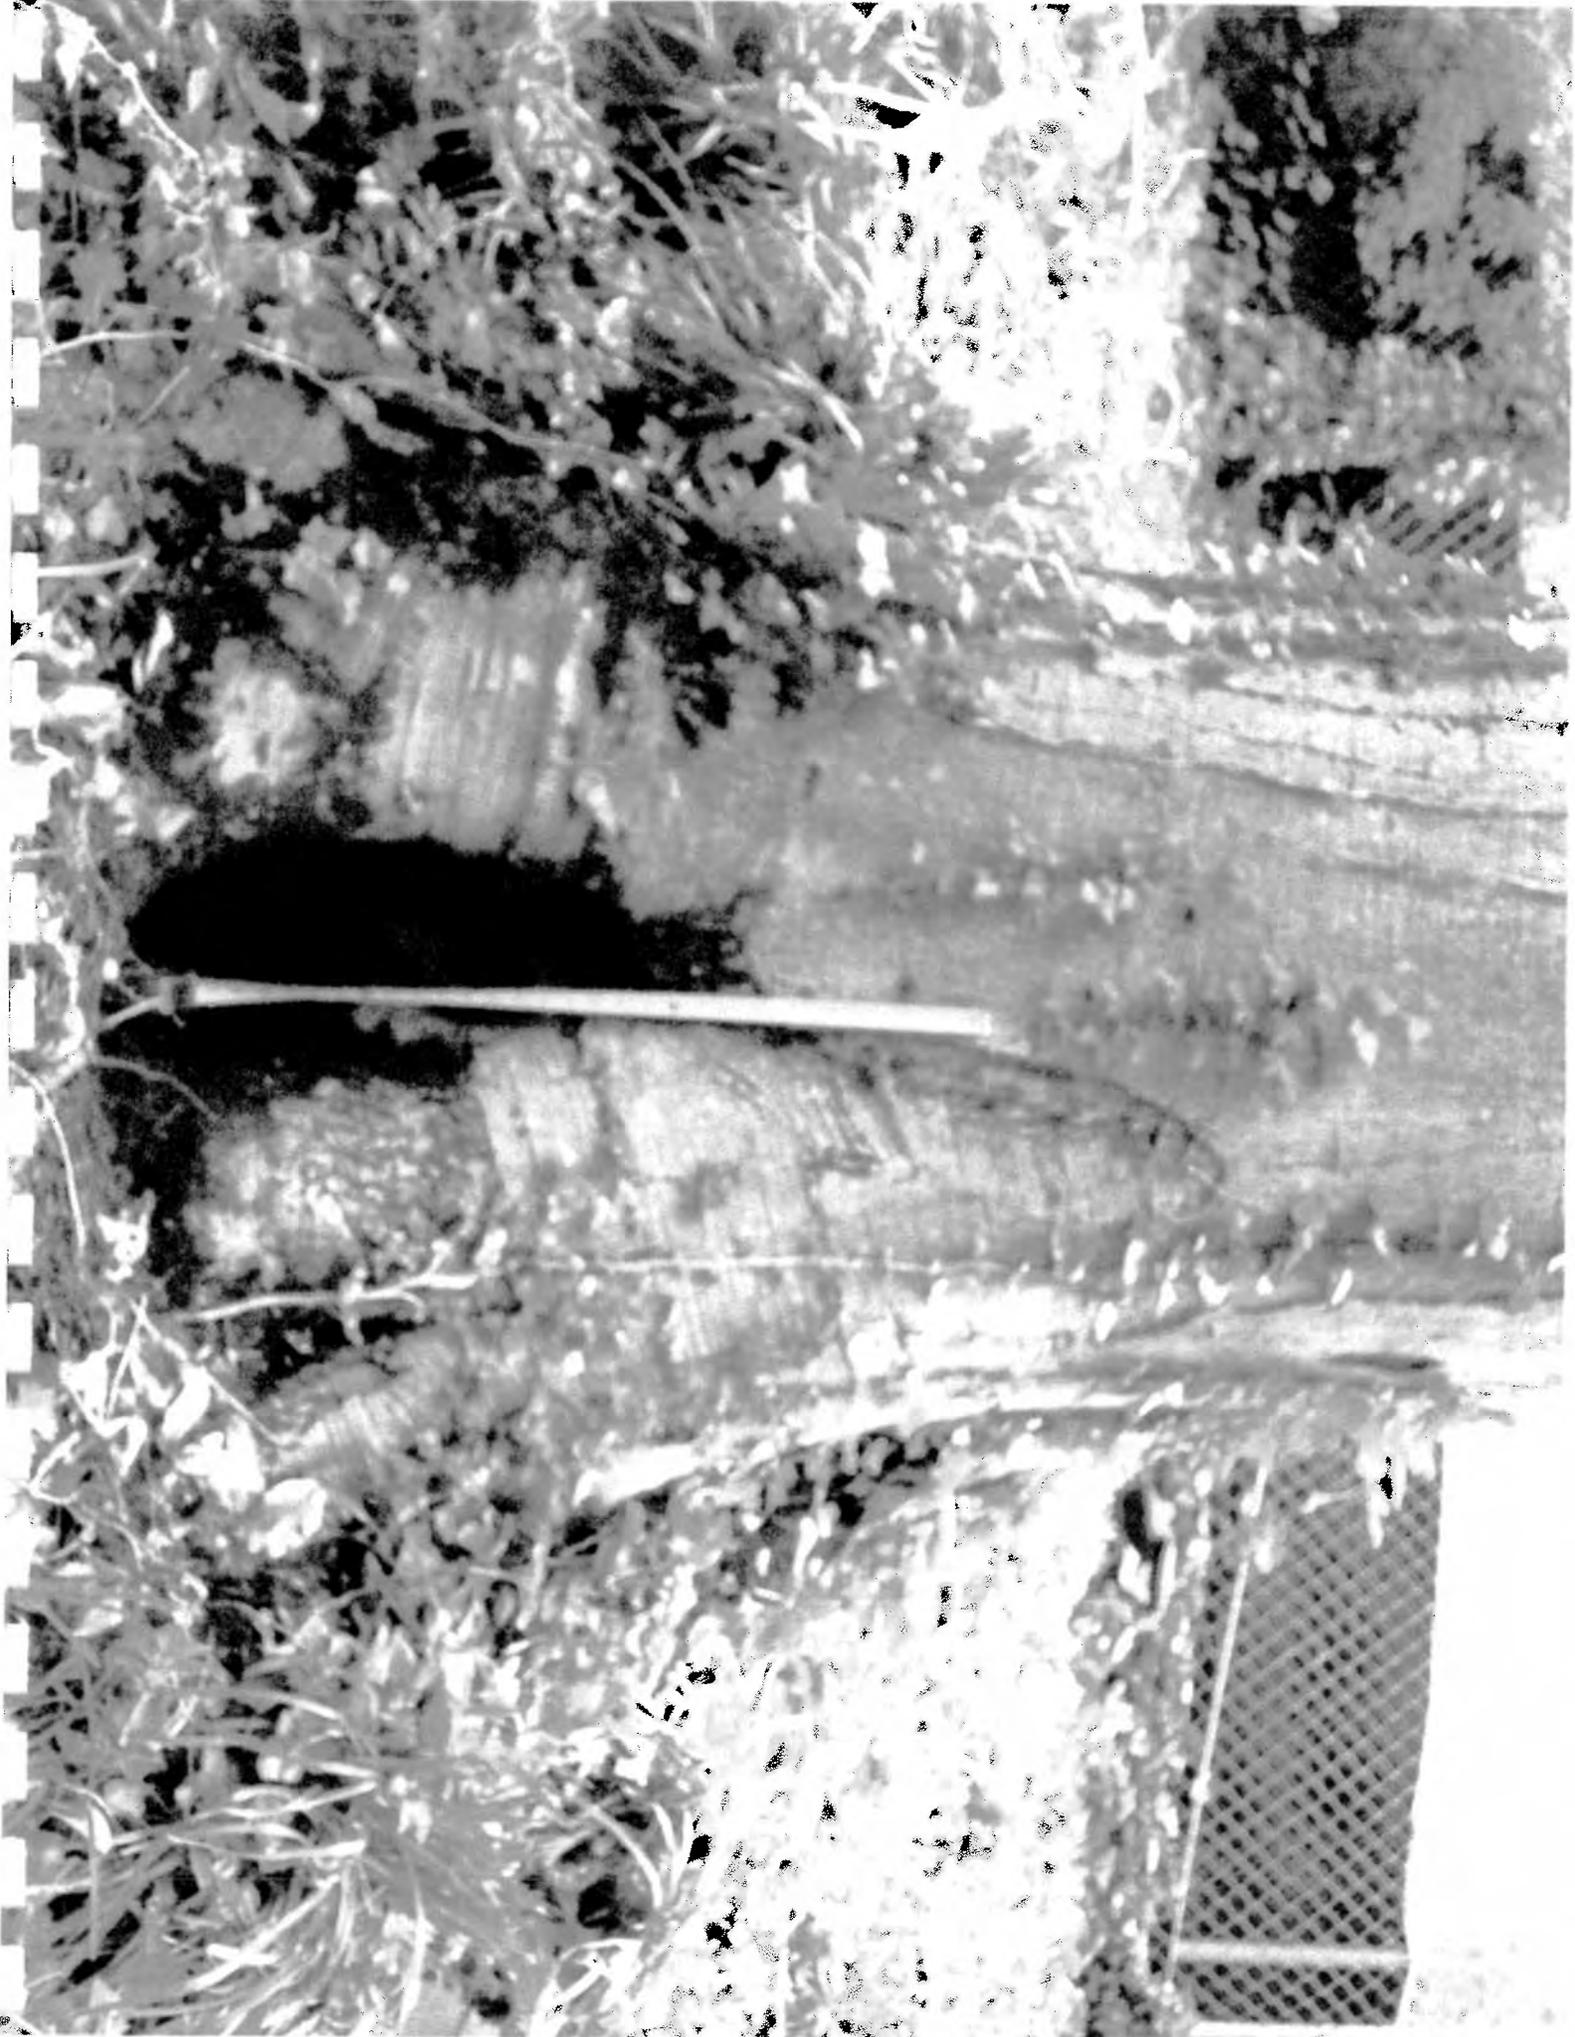
The old wound has healed over the stone wall well at this date. The old wound is still open at the base, but the upper section has closed itself. The original wound extended up the east side of the trunk around four feet high. (See image 4: wound scar.) The dark elliptical area to the right of the tap measurer is the closed upper section of the old wound.

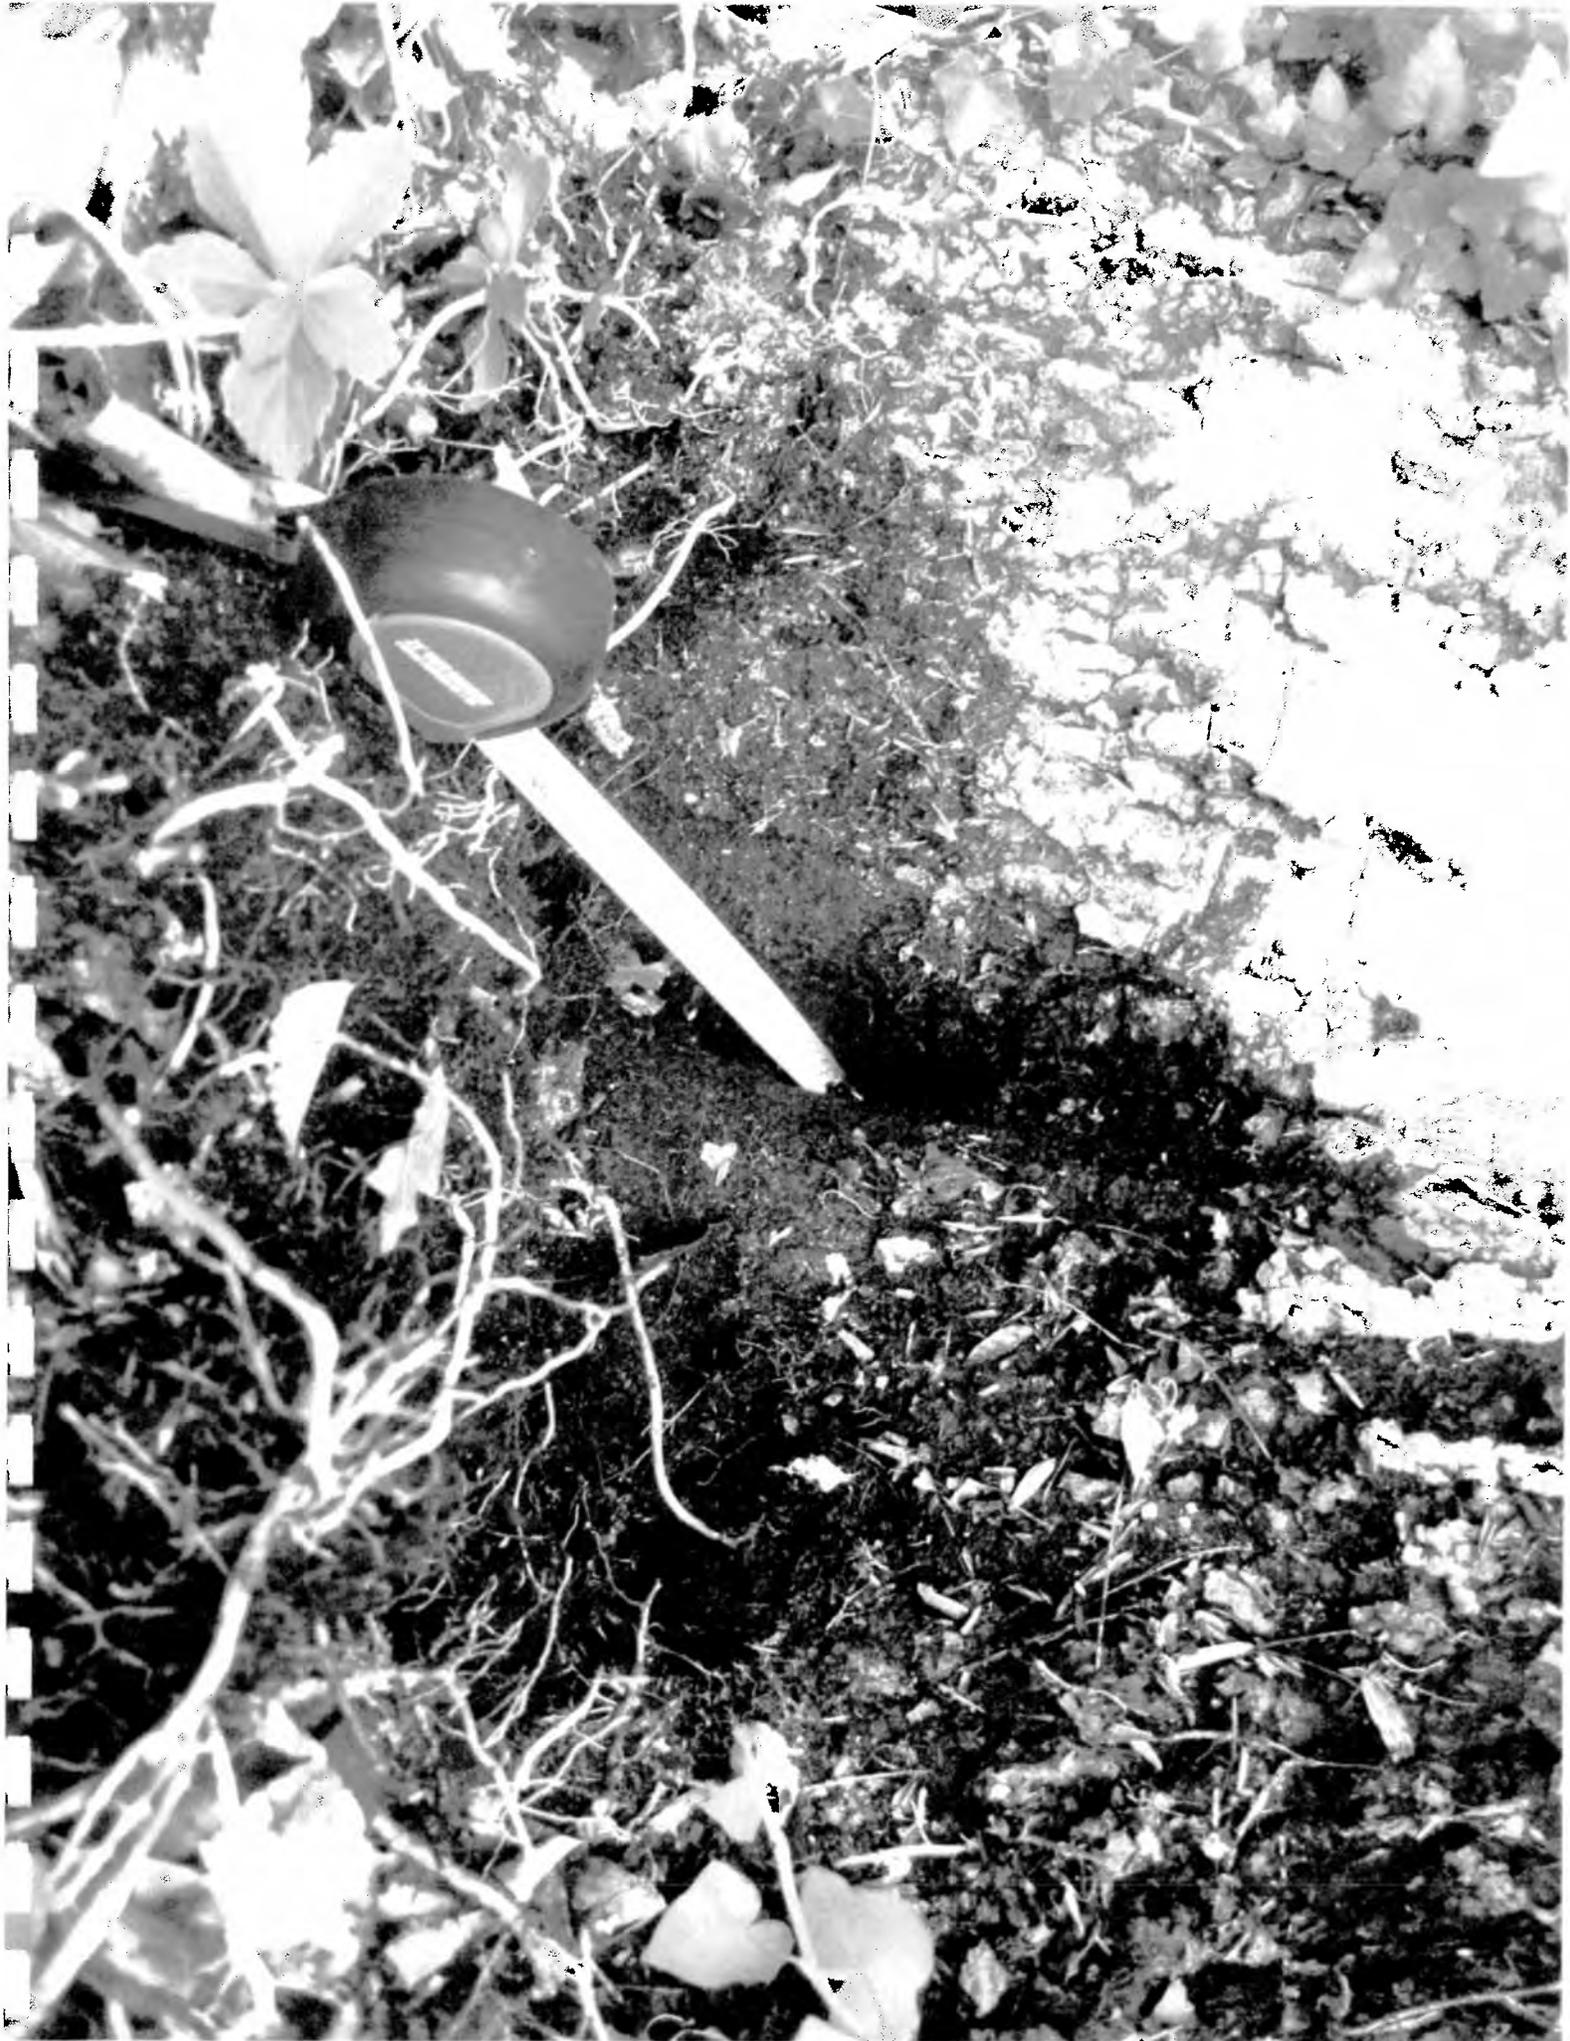
The *root flare* has some older damage. The root flare on the east side was damaged when the old wound damaged the east side of the trunk. (See image 5: decay on west side.) The space between the two root flares on the west side has some minor damage and decay.
