JOSIAH HENSON PARK - FACILITY PLAN REPORT

ARCHITECTURE / ENGINEERING DESIGN

MAY 28, 2013

Architecture/Engineering Facility Plan Report

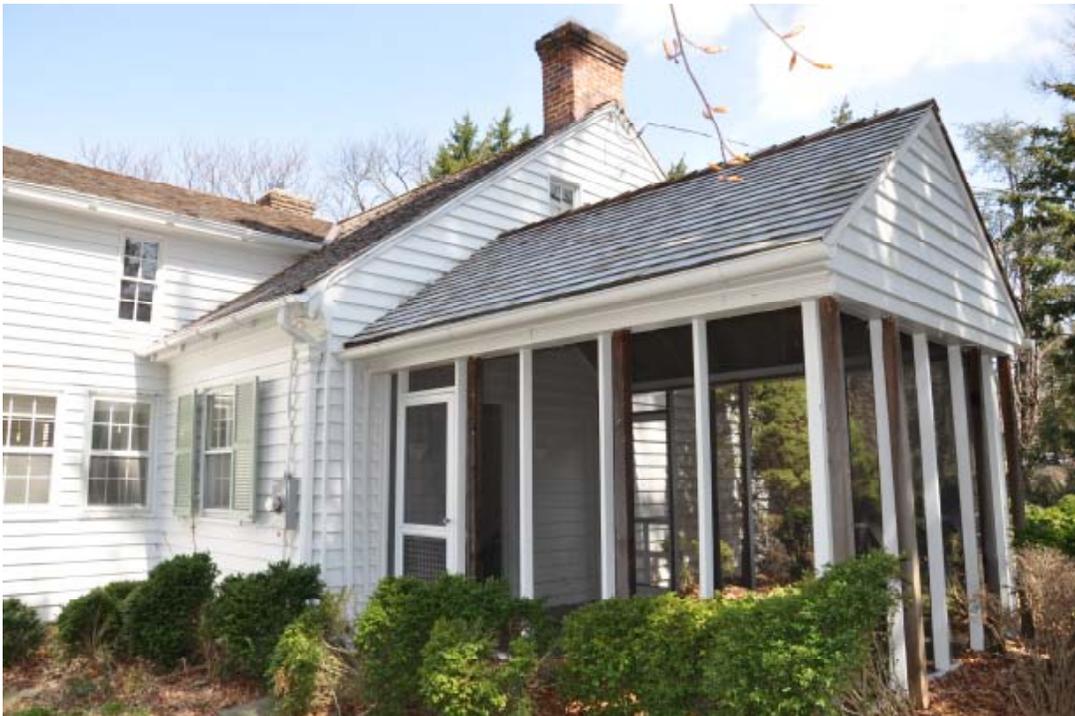
Rear view of historic Riley / Bolten House with screen porch on right and 1935 addition on left

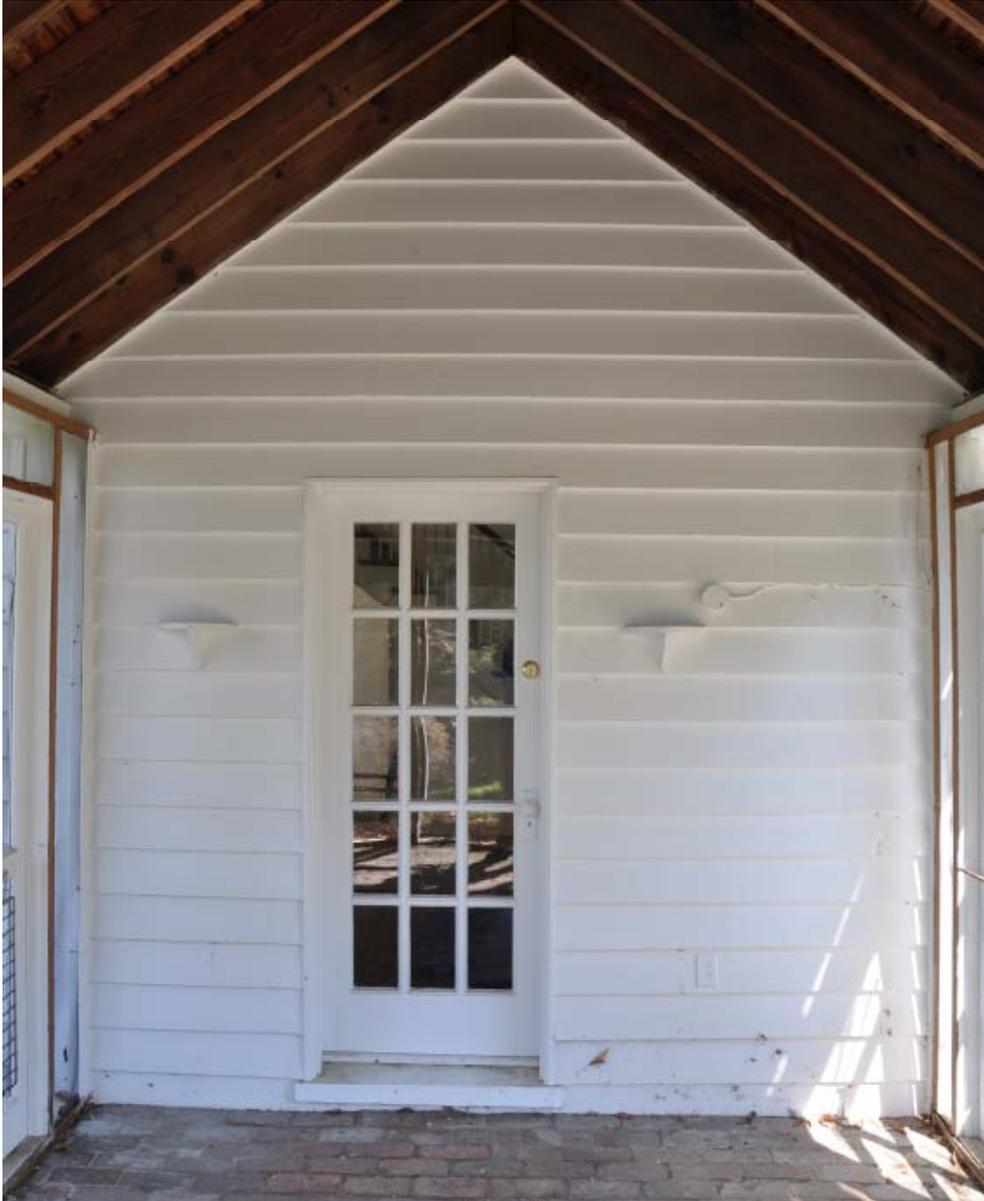
Existing door leading into first floor of house from screen porch.

- Removal of the existing basement stair and half-bath to provide appropriate ADA accessibility and required turning radius.
- Remove pest damaged, exposed wood columns on screened in porch. Completely reconstruct this space to provide one more room for the house (per recommendation 15.b of the HSR). Provide ADA access by constructing a raised floor to be level with the main house. Provide ADA threshold and offset door hinges. Re-swing the door for latch side clearance (if needed). See Book 2, South Wing Program space. Convert screened-in porch for use as program space, and optional entry/exit for visitor thoroughway.
