**MONTGOMERY COUNTY DEPARTMENT OF PARKS**  
THE MARYLAND-NATIONAL CAPITAL PARK AND PLANNING COMMISSION

## MEMORANDUM

**SUBJECT:** Feasibility Study and Driveway Alignment Alternatives for Rockwood Manor Special Park

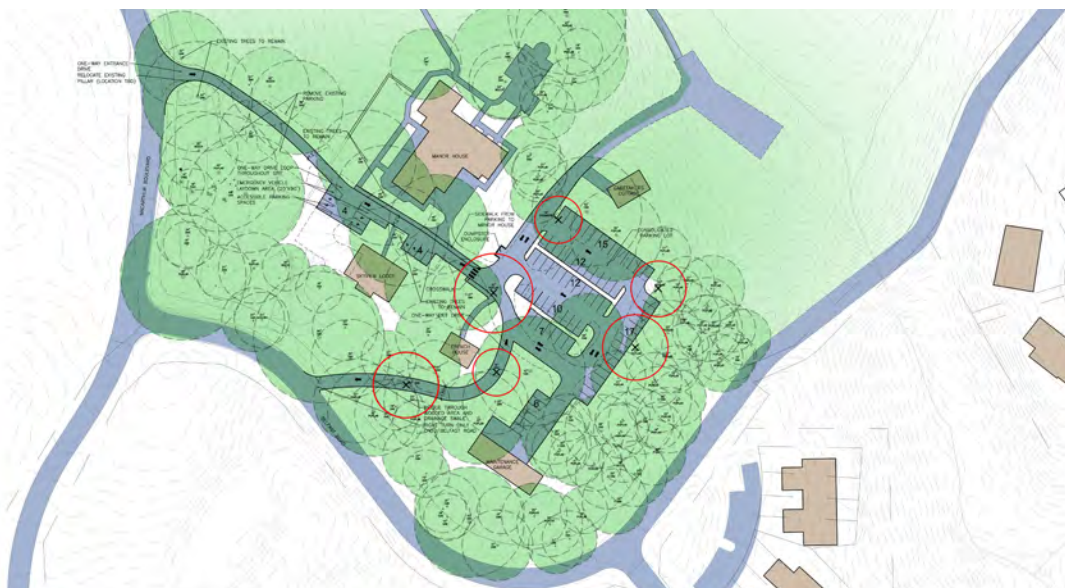
*Driveway alignment Recommended Alternative.*

After speaking with representatives from relevant regulatory agencies as well as facility staff and members of the community, Parks developed a Recommended Alternative that most closely resembles Alternative 1. This Recommended Alternative best achieves all of the goals for the project and provides for additional stopping sight distance along Belfast Road. If approved, next steps will include closer study of the Recommended Alternative to further improve vehicle and pedestrian safety, minimize tree impacts and reduce construction costs.

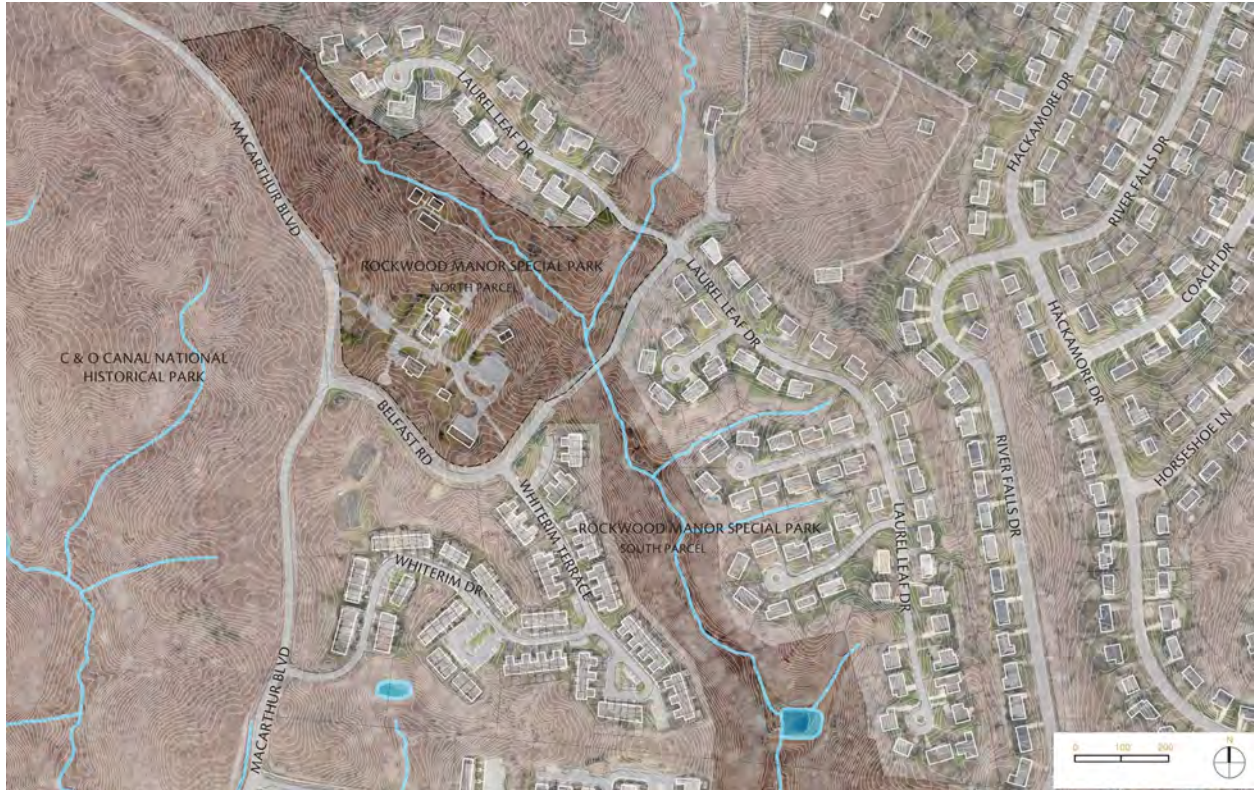
Rockwood Manor Special Park and surrounding area.

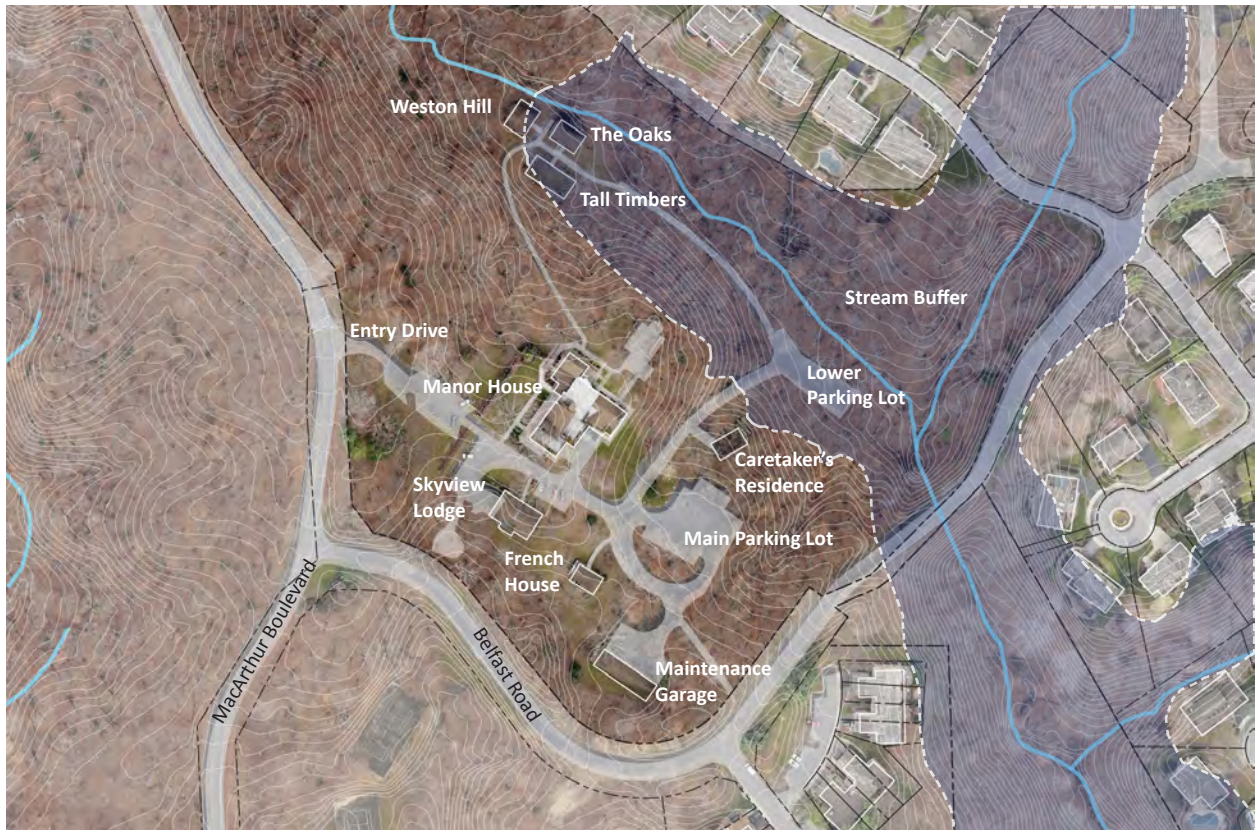
The main developed area of Rockwood Manor Special Park in relation to the existing stream buffer.

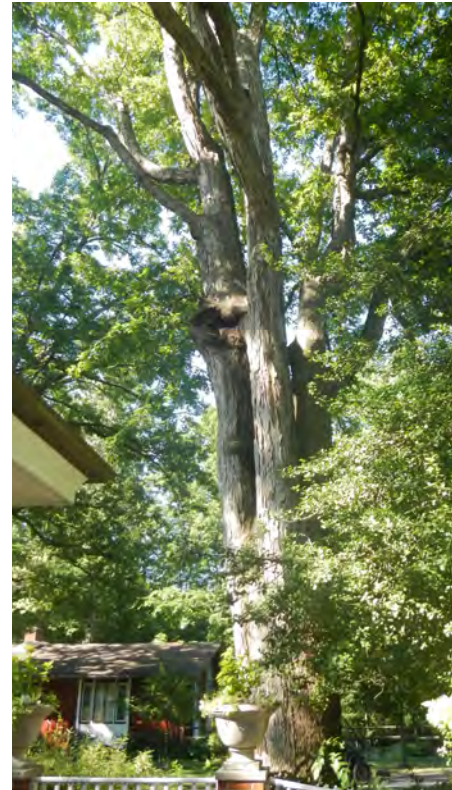
*Left: 1967 photograph of the Manor House. (From Rockwood, A National Girl Scout Program Center (promotional brochure), Girl Scouts of America, 1967). Right: A large cavity has been discovered in the main stem of the oak in front of the Manor House. This cavity has caused enough strength loss in the tree that the main stem requires removal.*

In June of 2016, Parks arboriculture staff determined that the central leader of the 45 inch diameter oak tree closest to the Manor House must be removed due to a large cavity (letter of findings included in Attachment E). The removal of a significant portion of this tree's canopy will have an impact on the character of Rockwood Manor. The removal of additional trees in this area would compound the impact and create a hole in the tree canopy that would in turn affect the shade-loving trees and shrubs that have been growing on this site for decades.

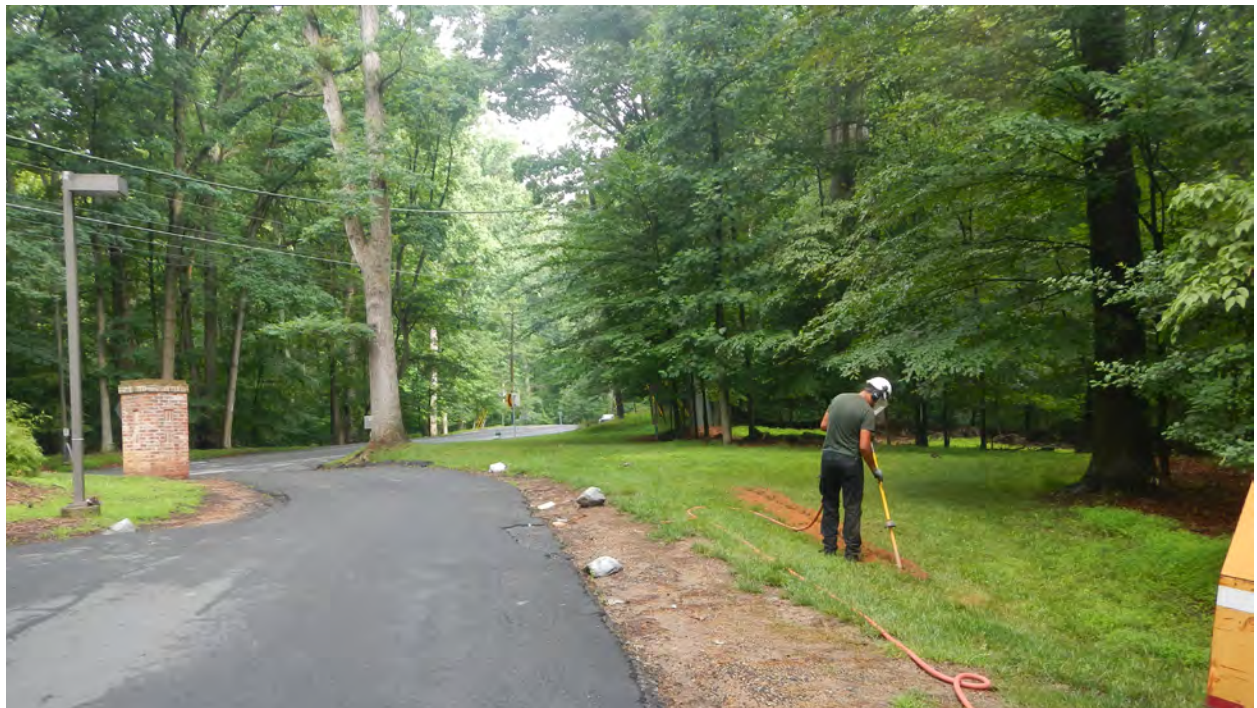
Air spade root investigation operations at the park's vehicular entrance. While investigations within the compacted areas alongside the driveway (where no grass is growing) revealed minimal tree roots, an abundance of tree roots were discovered in the lawn and mulched areas along the park's frontage with MacArthur Boulevard.

Rockwood Manor's frontage along MacArthur Boulevard is lined with several mature canopy and evergreen trees that visually separate the site from the adjacent roadway and create an impressive gateway into the site. Parks staff utilized a supersonic air spade to reveal the location and extent of existing tree roots adjacent to the existing driveway entrance and along the property's western boundary. This investigation discovered relatively few major tree roots in the compacted areas immediately adjacent to the vehicular entrance. In contrast, investigations along the property's MacArthur Boulevard edge revealed intertwining tree roots relatively near the surface throughout the area. While minor improvements could be made to allow an additional two to three feet of pavement along the existing entry drive (enough to allow a fire truck to enter the site and stay within the limits of paving), any effort to widen the driveway to fully allow two-way traffic or to create a second point of entry along MacArthur Boulevard would necessitate the removal of at least one significant tree.

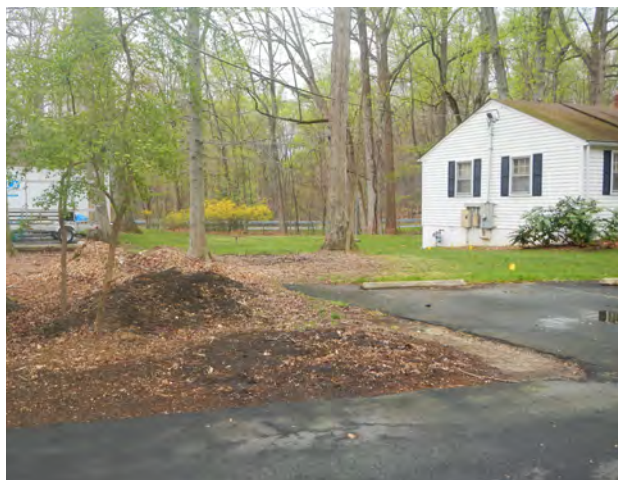
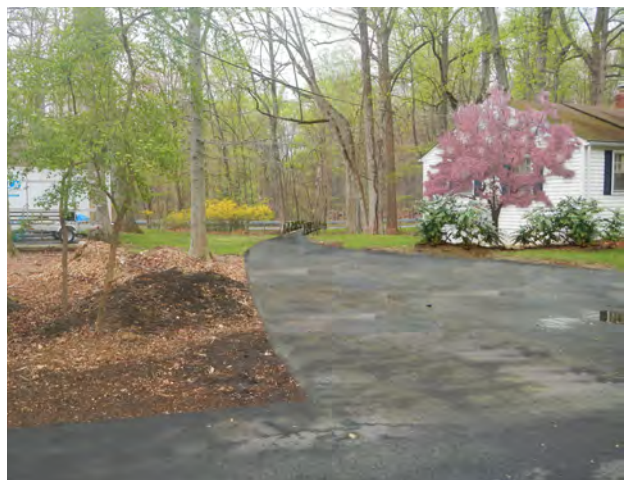
*Left: View to Belfast Road, looking between the French House and the Maintenance Garage. Right: Proposed one-way exit to Belfast Road.*

- A new one-way exit driveway is constructed between the French House and the Maintenance Garage, bridging over the drainage swale that runs along the southwest edge of the property and connecting to Belfast Road. The exit driveway turning radii and signage are configured to encourage right turn movements and make a left turn movement difficult. *Note: this driveway location complies with the 100-foot minimum required distance for a commercial driveway from a road intersection and the 200-foot sight distance requirement.*

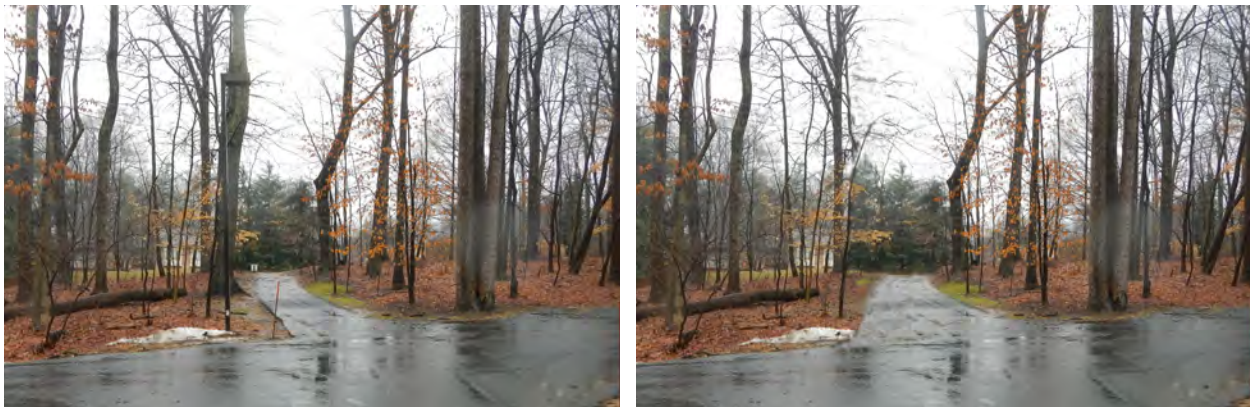
*Left: Existing asphalt path from the parking lot to Belfast Road. This path connects to Belfast Road across from the intersection with Whiterim Terrace. Right: Proposed exit driveway to Belfast Road, across from Whiterim Terrace.*

- A small entry court/drop off area is created in front of the Manor House. This space doubles as a lay-down area for emergency vehicles.
- A new sidewalk is constructed in front of the Manor House, connecting the parking lot to the building's main entrance.
- Dumpsters are relocated from the loading dock to an enclosure adjacent to the parking lot.
- The existing asphalt trail leading from the parking lot to the intersection of Belfast Road and Whiterim Terrace is widened to become a vehicular exit.

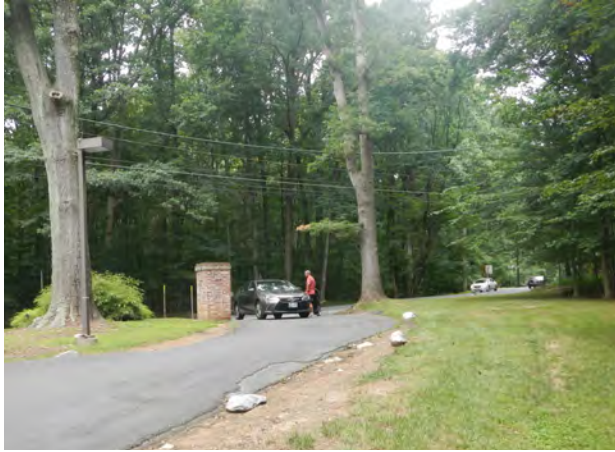
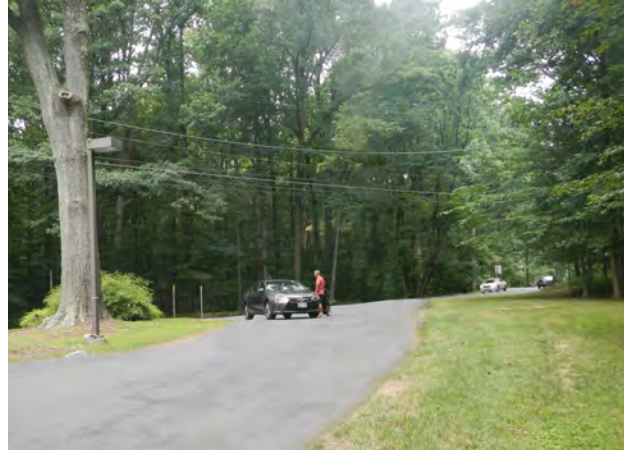
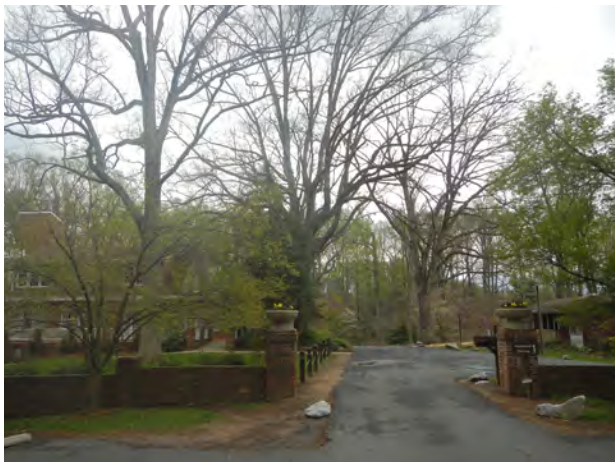
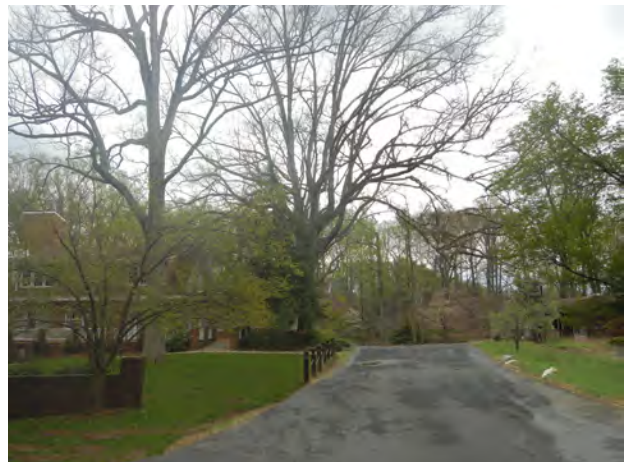
*Top Left: Existing entry/exit drive onto MacArthur Boulevard. Top Right: Widened two-way entry/exit drive. Note the removal of the tree on the right and the brick pillar on the left. Bottom Left: Existing view toward the Manor House. Bottom Right: View toward the Manor House with a widened, two-way driveway. Note the large oak tree on the right and original entrance walls have been removed.*

- The existing driveway alignment is widened to fully accommodate two-way traffic from MacArthur Boulevard to the parking lot at the rear of the site.

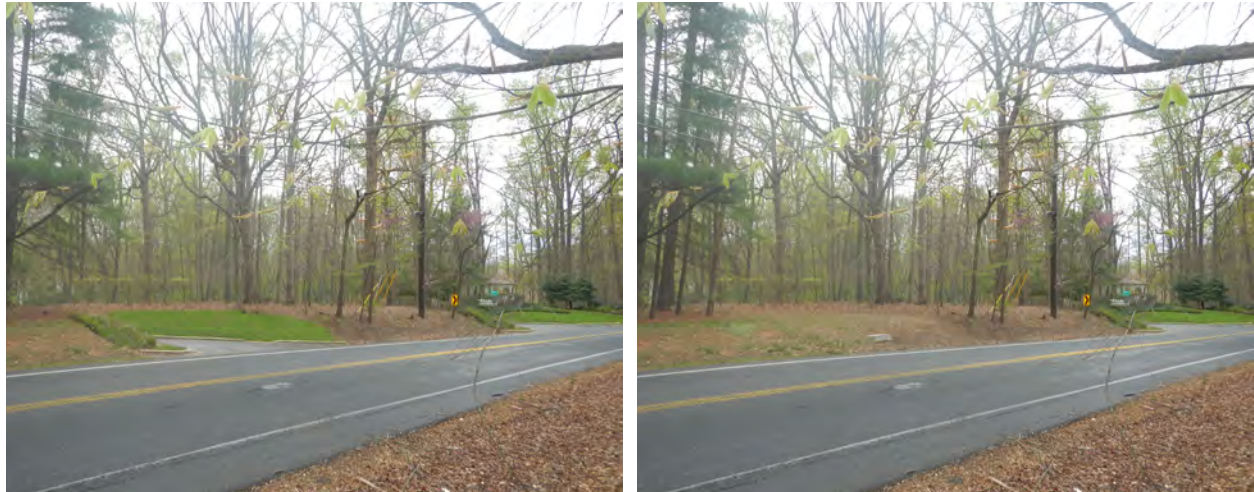
*Left: Existing view along MacArthur Boulevard. The intersection of Belfast Road is in the background. Right: View of the proposed entrance along MacArthur Boulevard. Note how close the proposed entrance would be to Belfast Road.*

- The existing driveway becomes an exit-only drive.
- A new entry-only driveway is constructed on MacArthur Boulevard, closer to the intersection with Belfast Road.
