**Maryland Historical Trust
Maryland Inventory of
Historic Properties Form**

Inventory No. M: 35-155

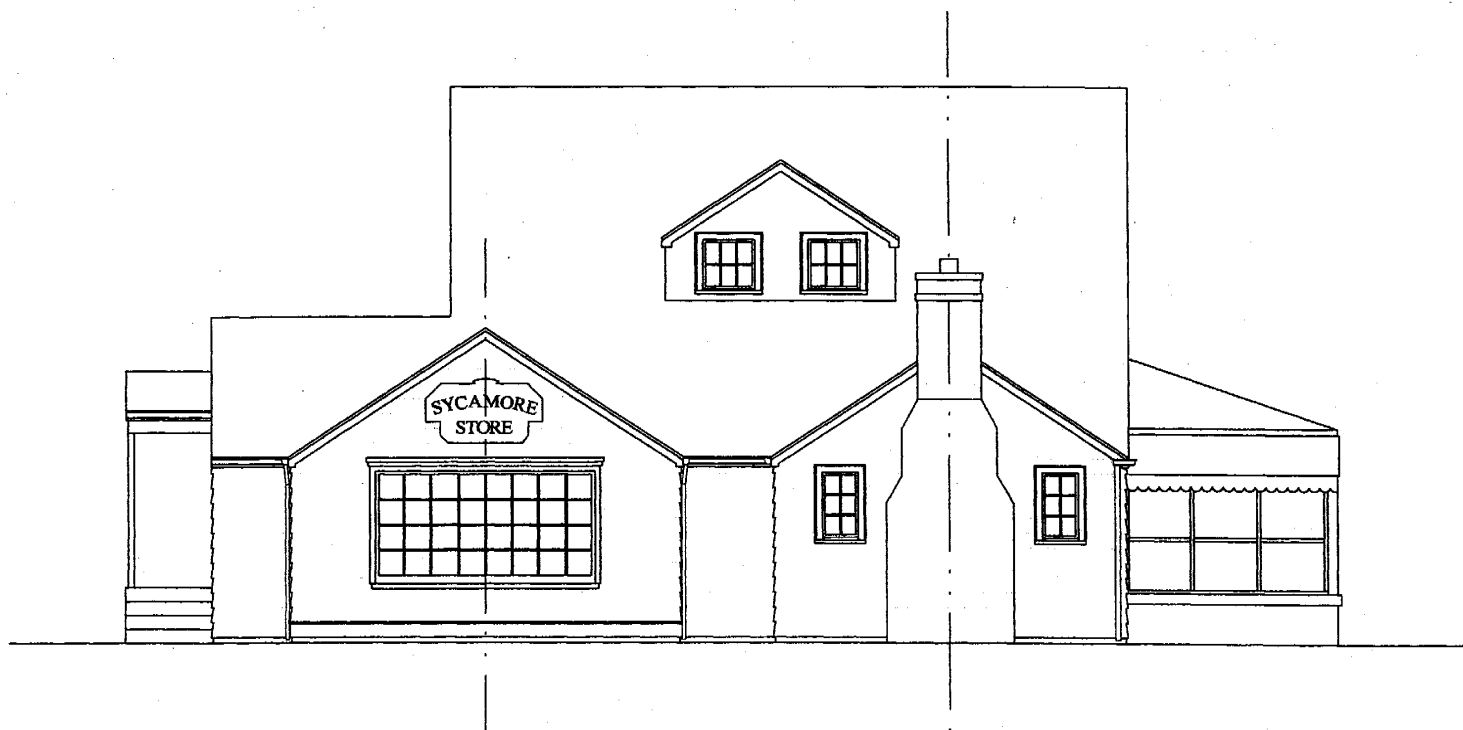
Figure 4. Front (West) Elevation. The two front gables and the porches to either side are all additions from 1925. Note the dormer in the roof of the original bungalow, behind. Drawing by Jason Gagen, copyright 2004 by Brenneman & Pagenstecher, Inc.

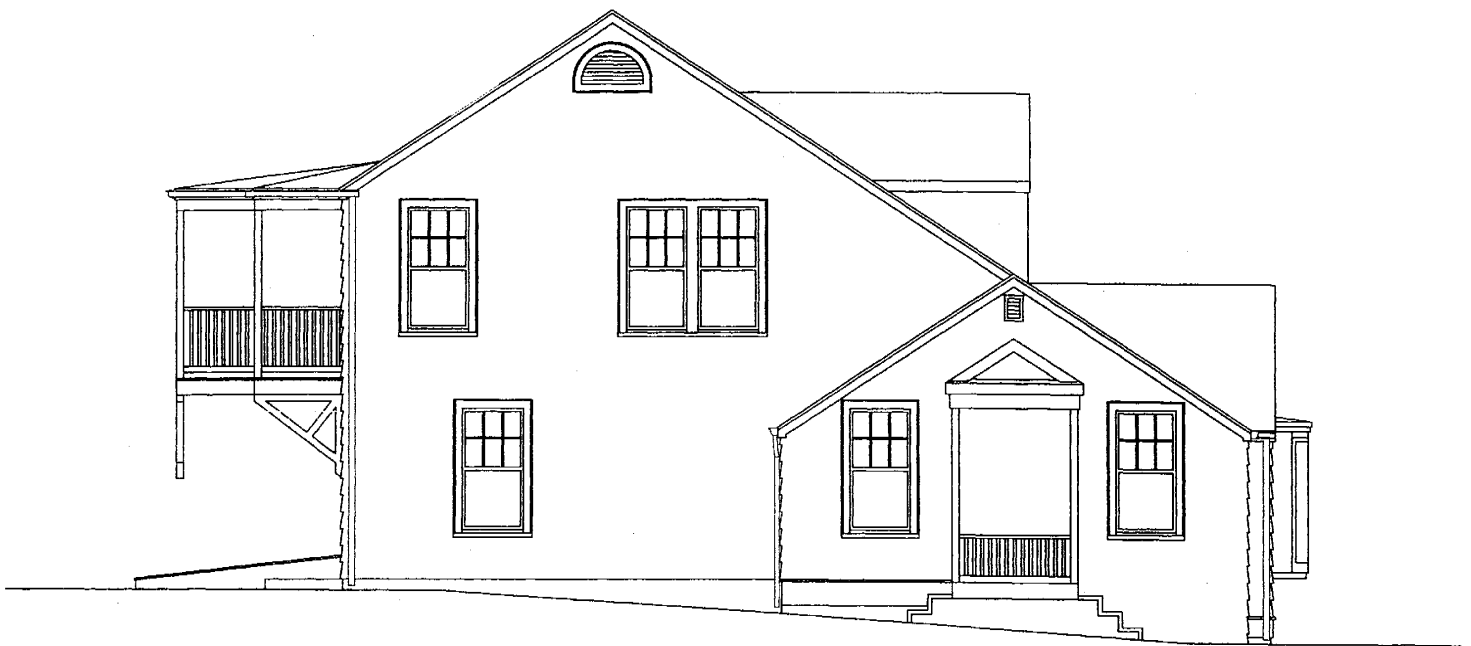
Figure 5. Left (North) Elevation. The projecting bay and portico on the right are part of the 1925 addition. The roofline of the original bungalow was raised in the late 1930's from a 5/12 pitch to an 8/12 pitch to provide more headroom on the second floor. Porch and bump out at left are part of the 1930's renovation as well. *Drawing by Jason Gagen, copyright 2004 by Brenneman & Pagenstecher, Inc.*

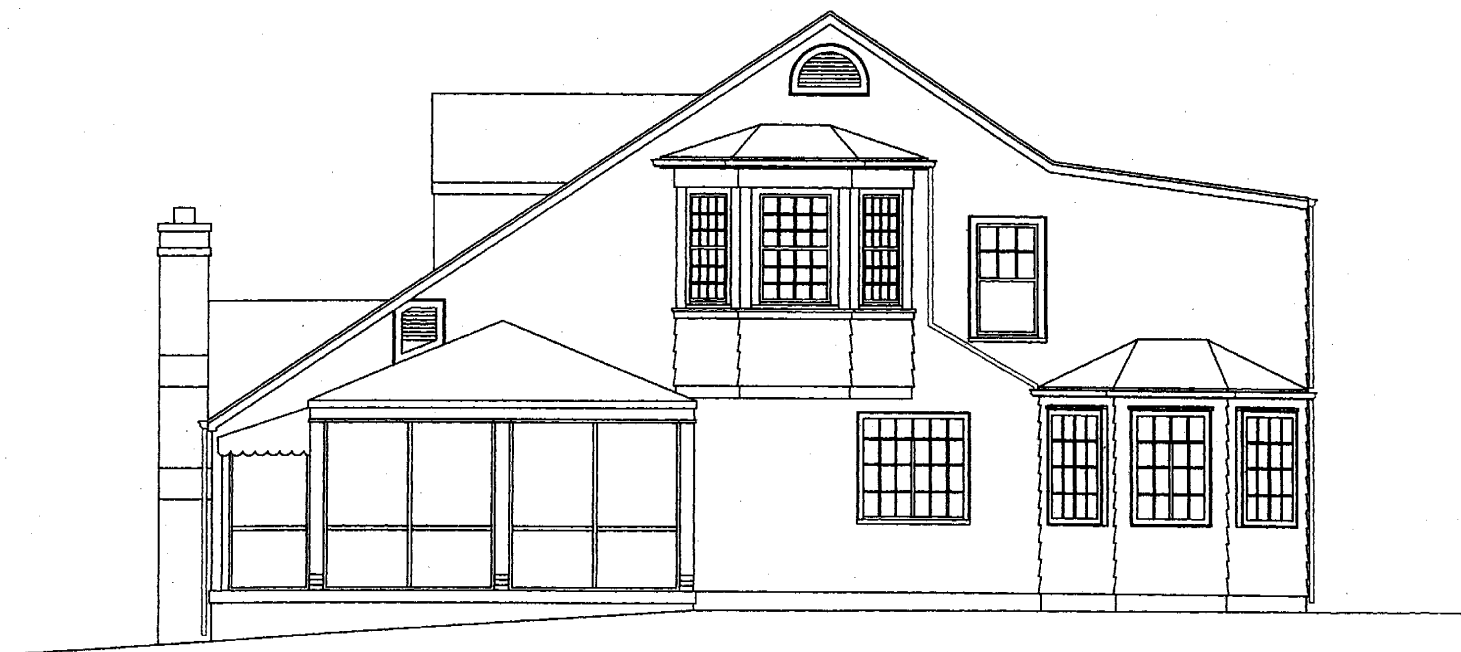
Figure 7. Right (South) Elevation. Both bays are additions from the 1930's. Drawing by Jason Gagen, copyright 2004 by Brenneman & Pagenstecher, Inc.
